TO: James L. App, City Manager
FROM: Meg Williamson, Interim Director of Public Works
SUBJECT: 21st Street (Westside) Reservoir
DATE: March 2, 2004

21st Street Reservoir Roof Replacement

Project Status 21st Street Reservoir Roof Replacement

21' ST STREET RESERVOIR

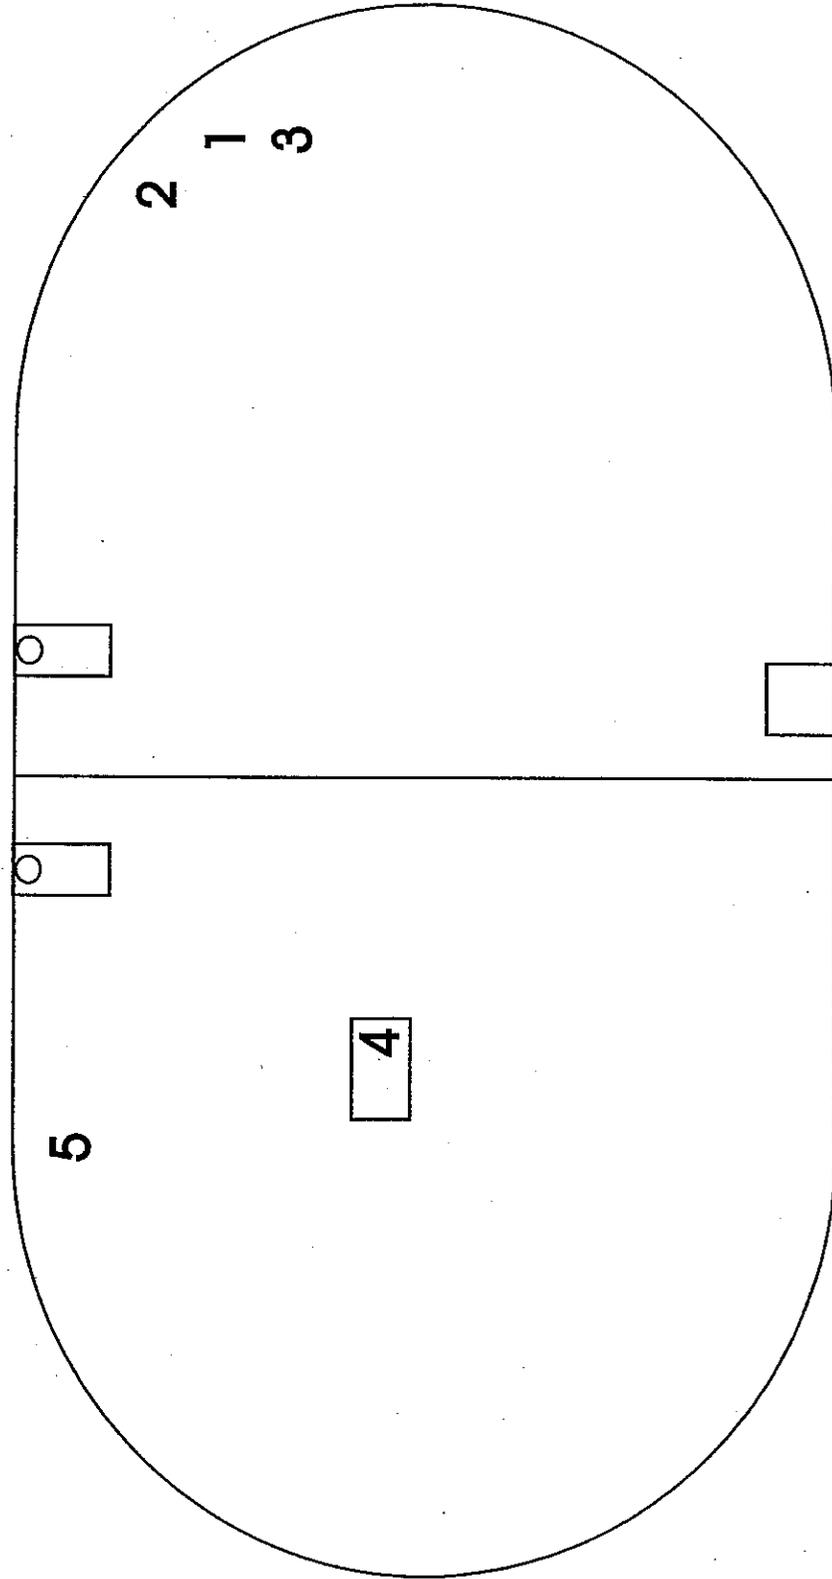
21'ST STREET RESERVOIR
CITY OF PASO ROBLES

12-21) After a thorough evaluation of the internal liner, five leaks were discovered in the visual range. Three were located in the West cell and two in the East. These leaks are numbered on the reference diagram included at the end of the report.

- Leak #1 - Highest flow - 2-3 G.P.M. estimated
- Leak #3 - Slight to moderate flow - 1 G.P.M. estimated
- Leak #4 - Slight to moderate flow - 1 G.P.M. estimated
- Leak #4 - Slight flow - Less than .25 G.P.M. estimated
- Leak #5 - Slight flow - Less than .25 G.P.M. estimated

- Leak #1 is seen in photographs (#12-15);
- Leak #3 is seen in photograph (#16);
- Leak #5 is seen in photographs (#17-18);
- Leak #4 is seen in photographs (#19-21);
- Leak #2 is seen in included video.
