**SUBJECT: REQUEST TO REMOVE ONE OAK TREE - 1612 OAK STREET (STEVENS)**

To: City of Paso Robles  
From: Chip Tamagni, A & T Arborists  
Re: Hazard Oak at 1612 Oak Street  
CC: Calvin and Sara Stevens, Owners

**Review of Quercus agrifolia**

**Second Opinion**

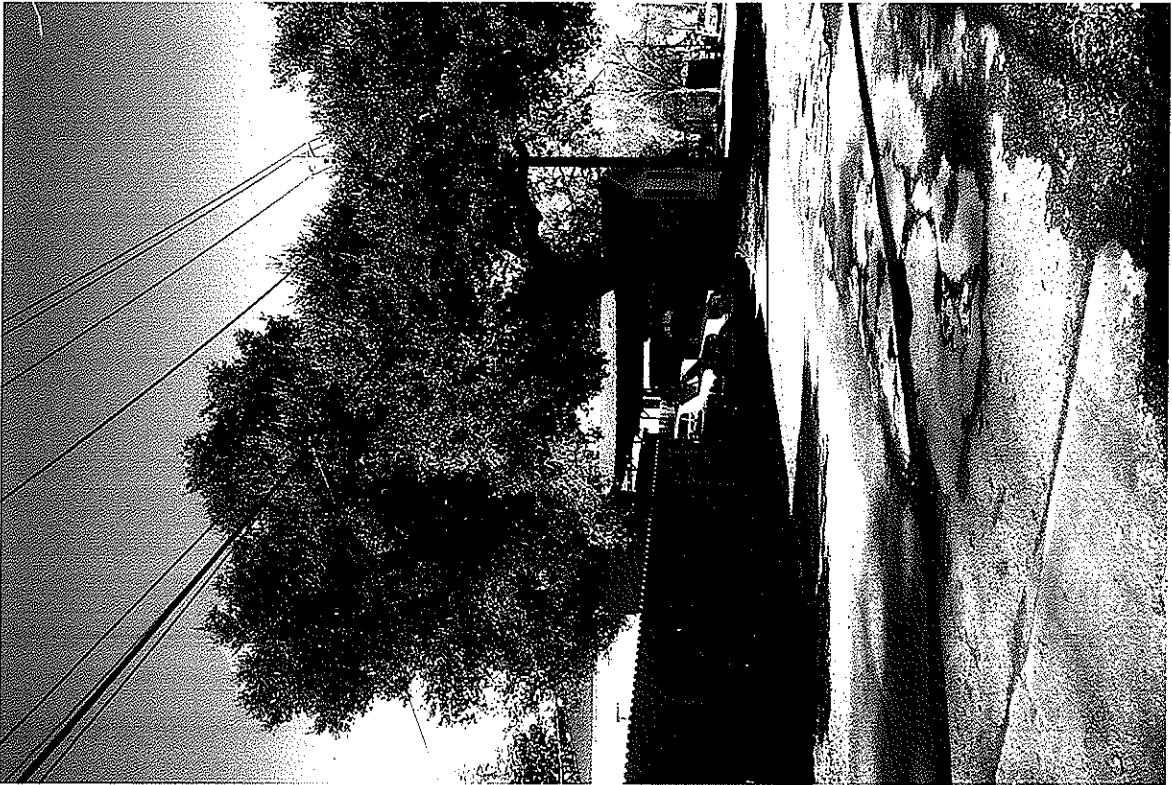
Exposed  
Roots

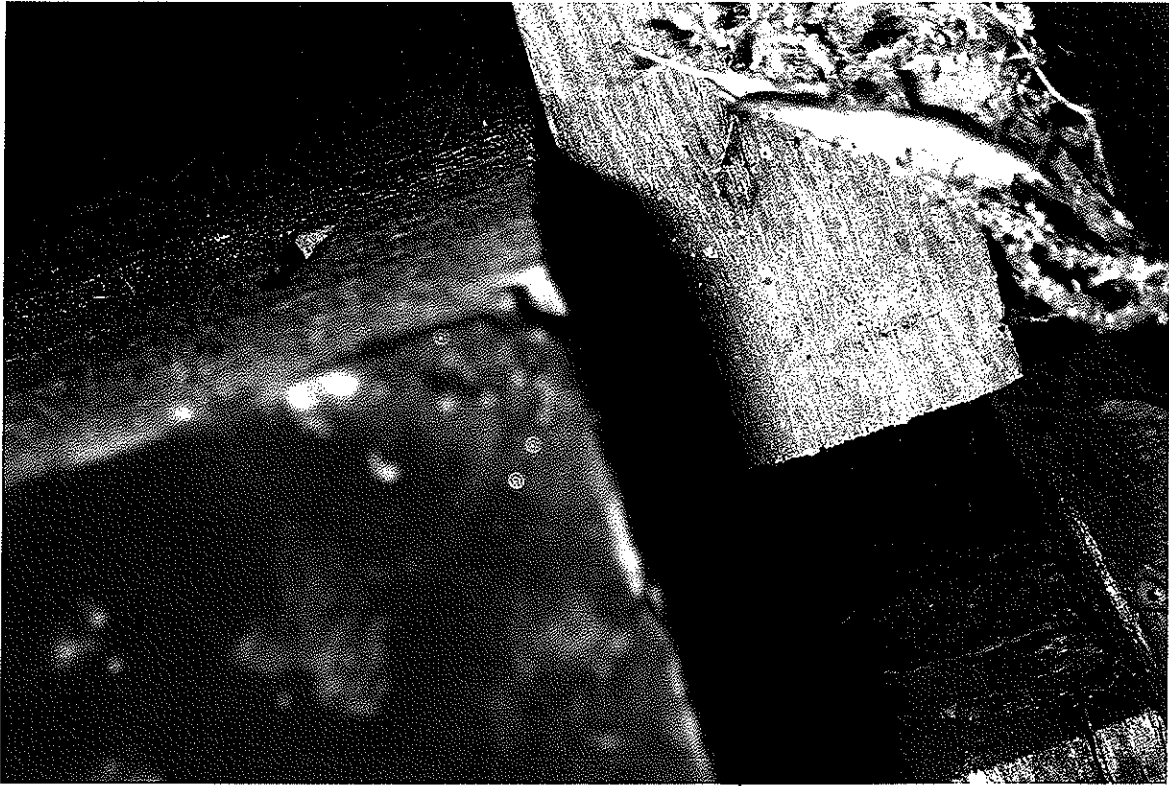
*Illustrating Movement into context*

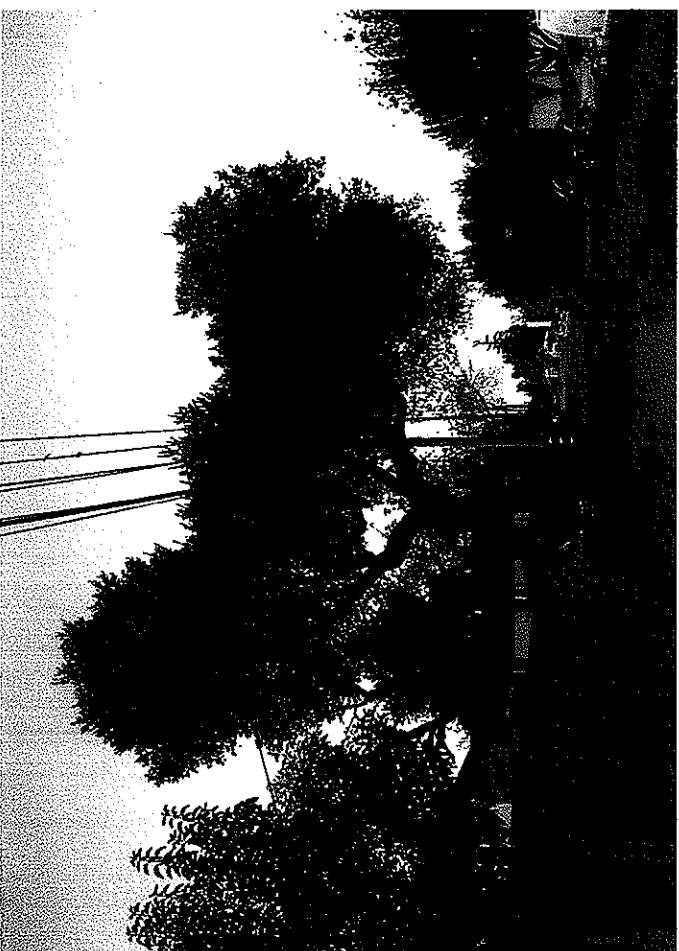
**Photo #1** - Visible is the pruning job conducted by the Power, Telephone, Cable Companies etc., or their representative, deforming the tree considerably. Also the recent pruning, to decrease the weight on the West side is clearly visible. If only the main limb on the West side were to be removed the tree would still lean towards the house and the tree would look even worse than it does right now.

Due to our inspection and finding that this tree is less than sound we recommend, unfortunately, that the tree be removed. If new trees are required to be planted, by the City, in its place they should be maintained from the date of planting so that this kind of poor maintenance shall not happen again.

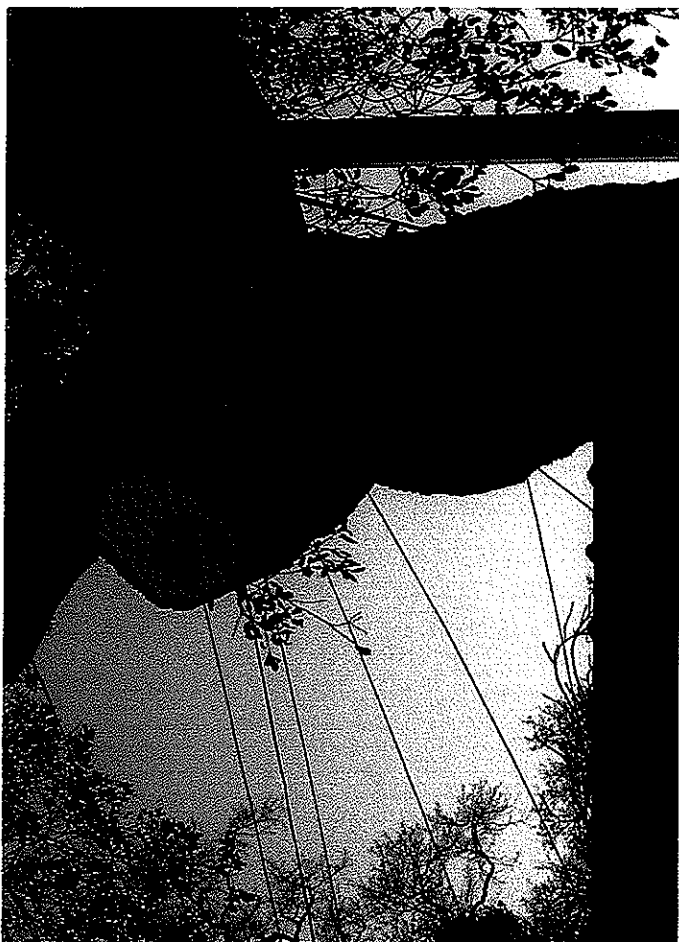
**Photo #2** - Rot has progressed inside the tree from the main branch that has been removed.

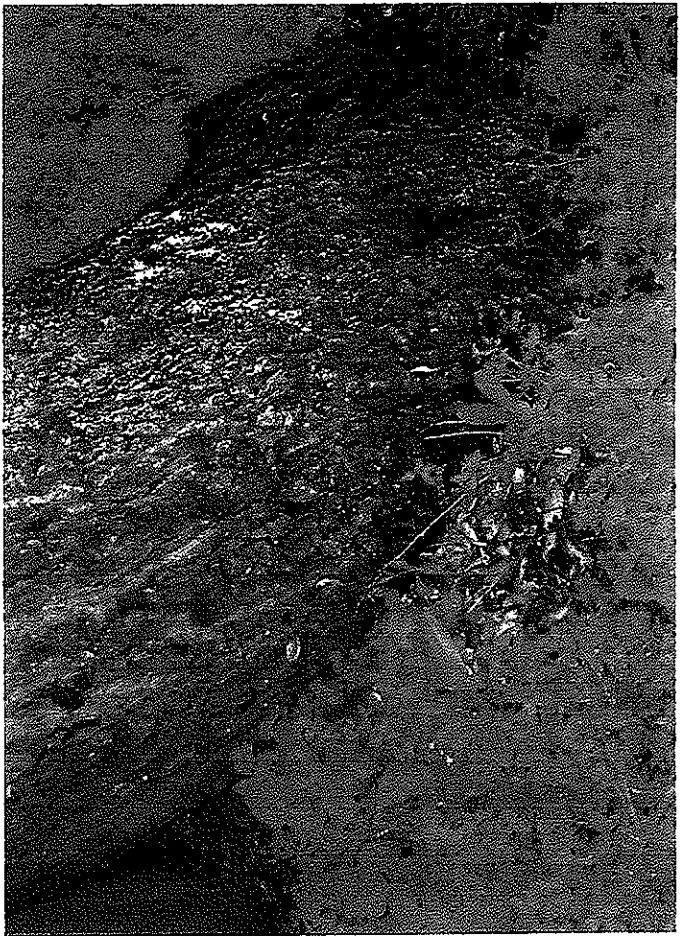
4

**Photo #4** - The root system appears to be growing in only two visible directions. Nothing appears to be growing into the direction of the Alley. Only an airspade would be able to actually determine this for sure, however, visual inspection does not reveal a support system in this Easterly direction.

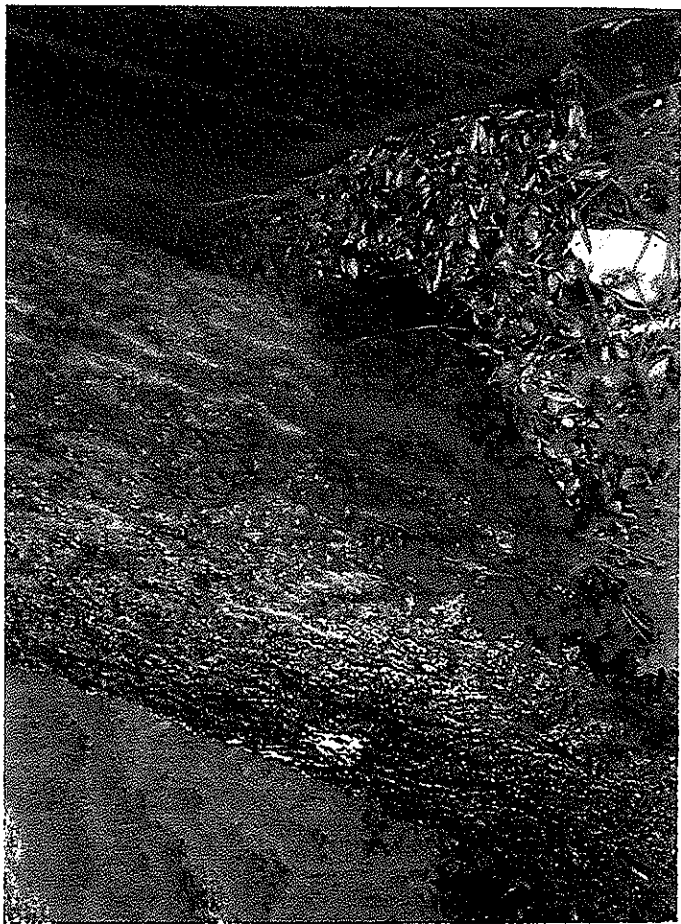
8

**Photo #8** - Soil buildup on the Westerly direction causing damage to the trunk/ground connection point. Note the bark deterioration on this side.

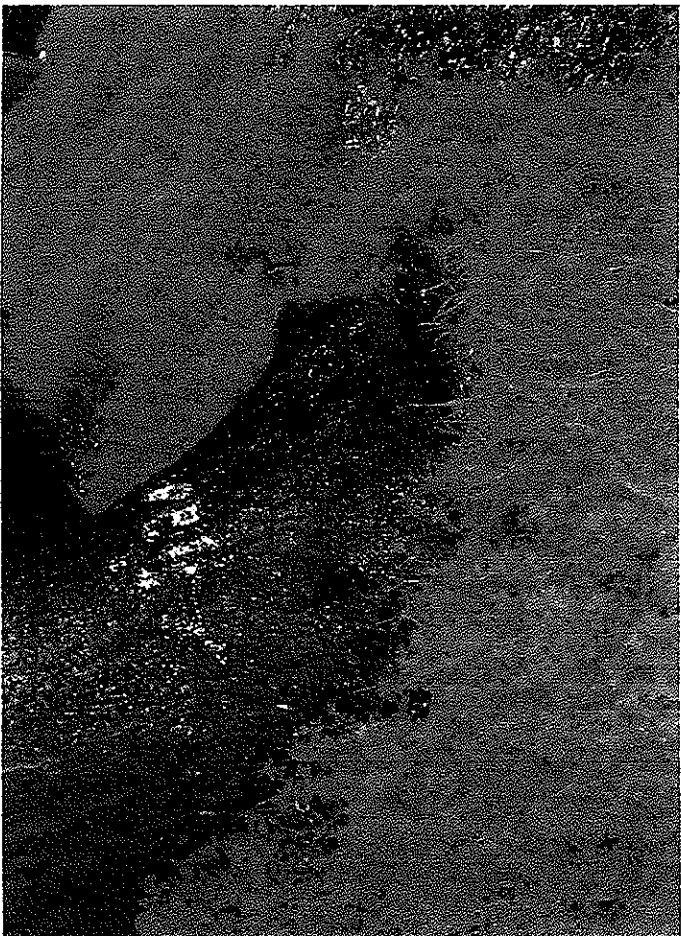
5

**Photo #5** - A view of the root/collar attachment area from the opposite direction indicating the same as had been stated in Photo #4.

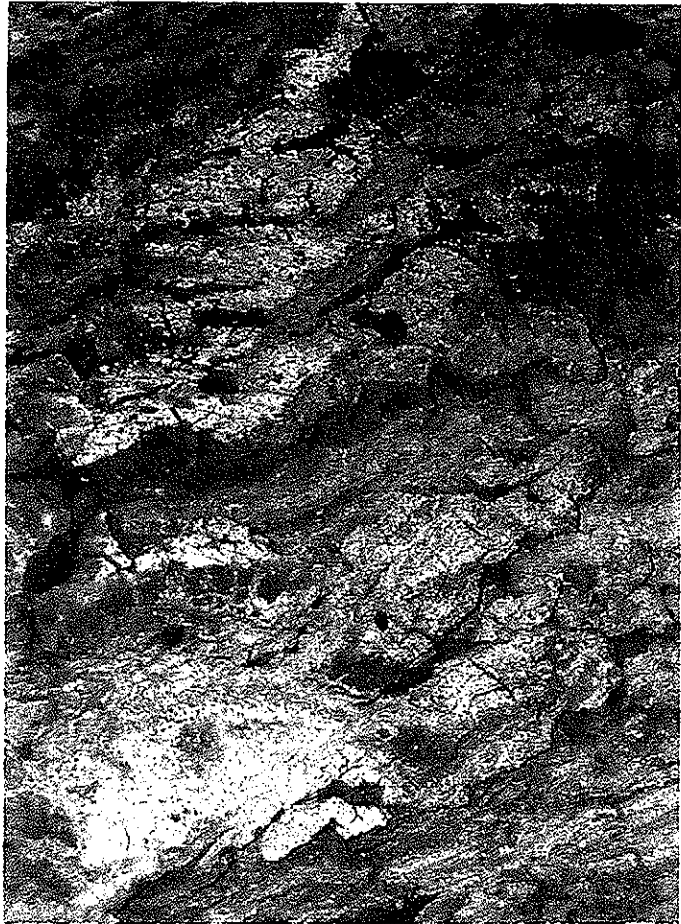
6

**Photo #6** - Bores were noted up and down the trunk indicating a tree under stress.
