TO: JAMES L. APP, CITY MANAGER
FROM: RON WHISENAND, COMMUNITY DEVELOPMENT DIRECTOR
SUBJECT: OTR 05-008 - REQUEST TO REMOVE TWO OAK TREES
(CARDINALE/MORRIS)
DATE: MAY 2, 2006

Needs: For the City Council to consider a proposal by Joe Cardinale and Dick Morris, to remove two healthy oak trees on the property located on the south side of 4th Street, just west of Oak Street (see attached Vicinity Map, Attachment 1).

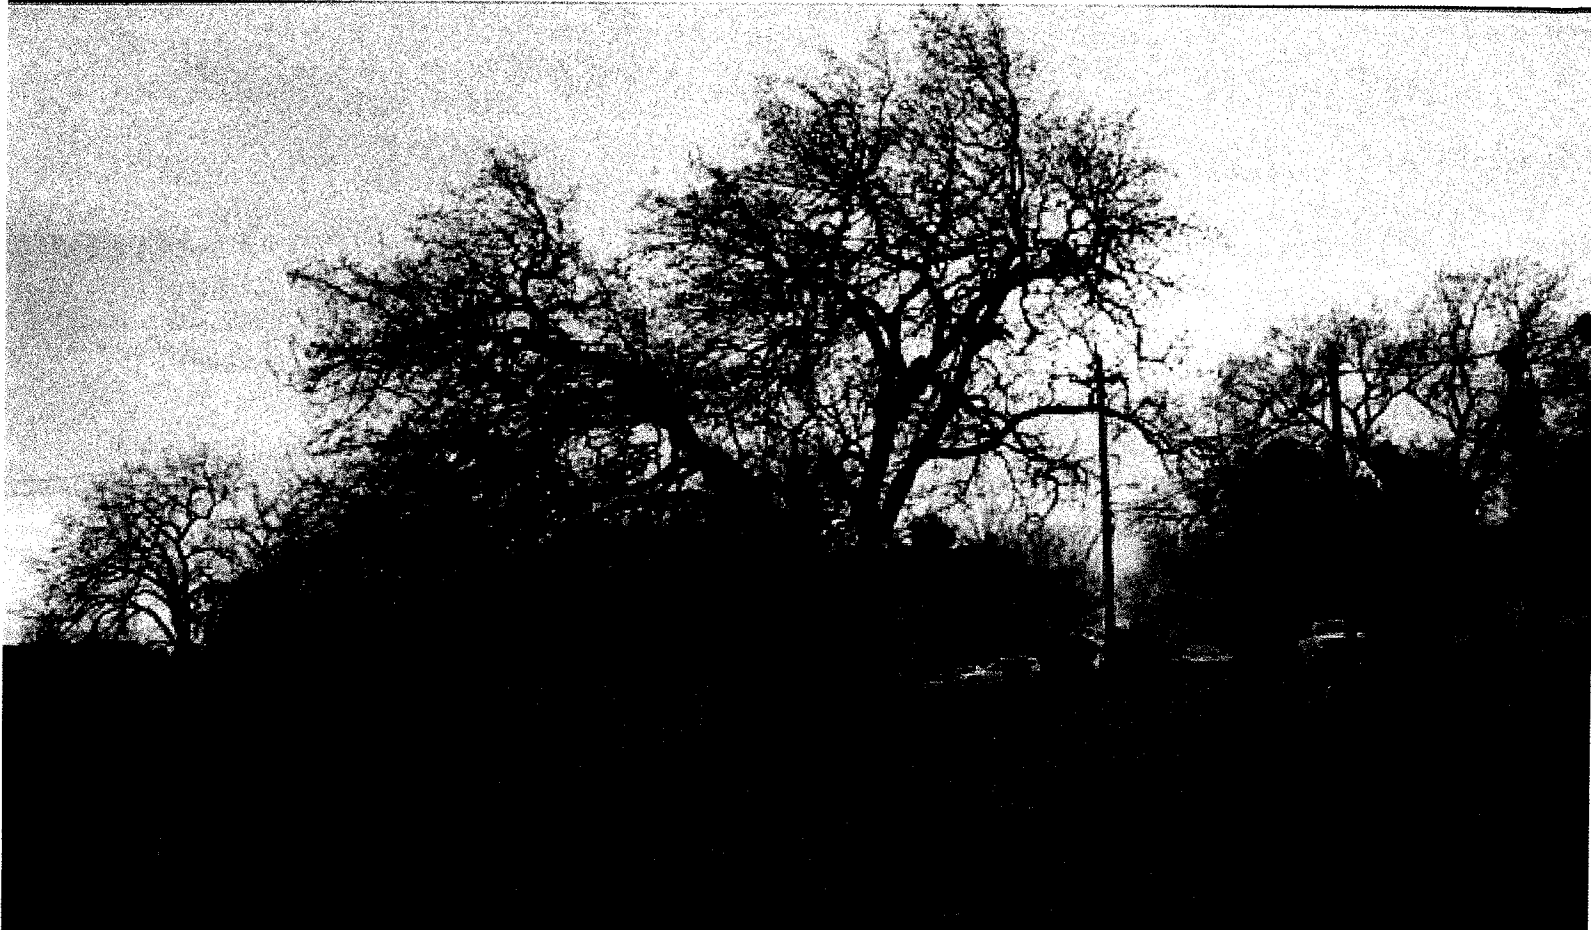
Attachment 2 (c)
Photos
OTR 05-008
(Cardinale/Morris)

Tree A & B
View from east looking towards Vine

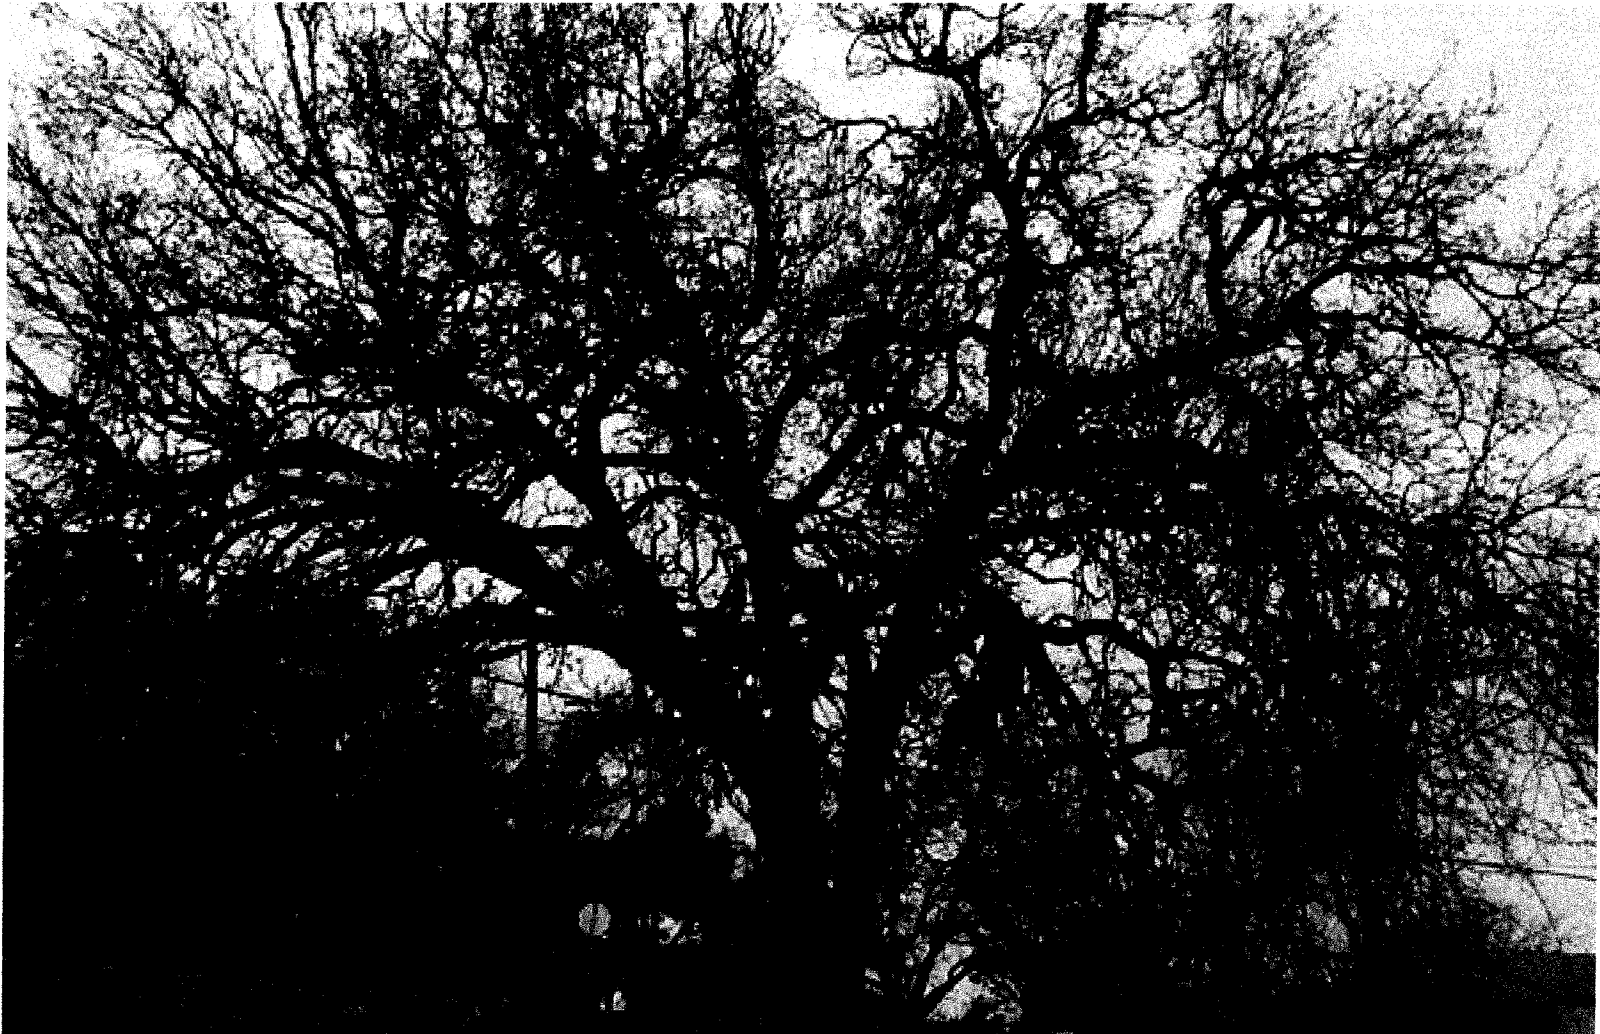
**Attachment 2 (e)
Photos
OTR 05-008
(Cardinale/Morris)**

Tree B
Looking north towards 4th street

Tree **B**-(*Quercus douglasi*) 3X stem 14", 12", 6" DBH, 30' ht., located on the North slope several feet above the flood zone and approximately 30' from the East property boundary. This tree is showing advanced stages of rot and decay, the major portion of its crown containing mostly dead branches. I estimate this tree to be approximately 70% in decline.

Tree **B**.. This tree is in an advanced stage of decline. Because of its' location it would pose a hazard to both people and structure. I recommend this tree be removed.

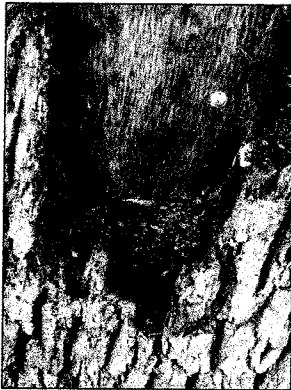
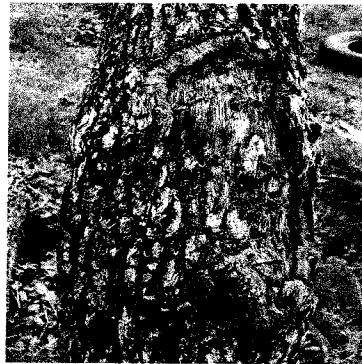
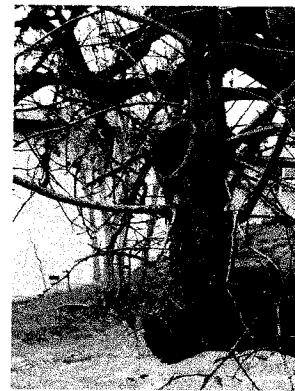
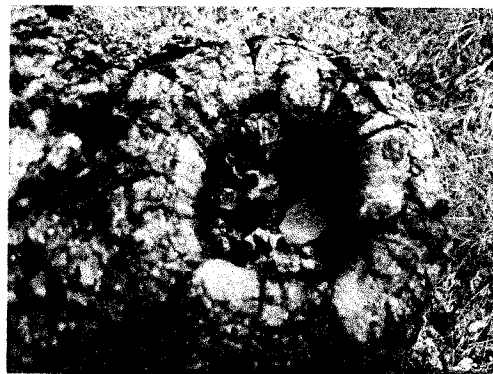
The pictures on page four are examples of various types of damage done to the trees over the years. If you look closely, you will find that in some of the cases the tree made an attempt to seal itself from its injuries. There is a tan colored callous material formed around the wound. In some of the pictures you will see that the tree was unable to protect itself with that callous material. These unprotected areas are where the various pathogens were able to enter the tree.

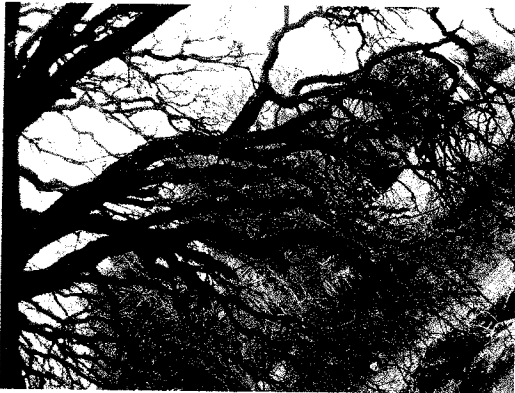
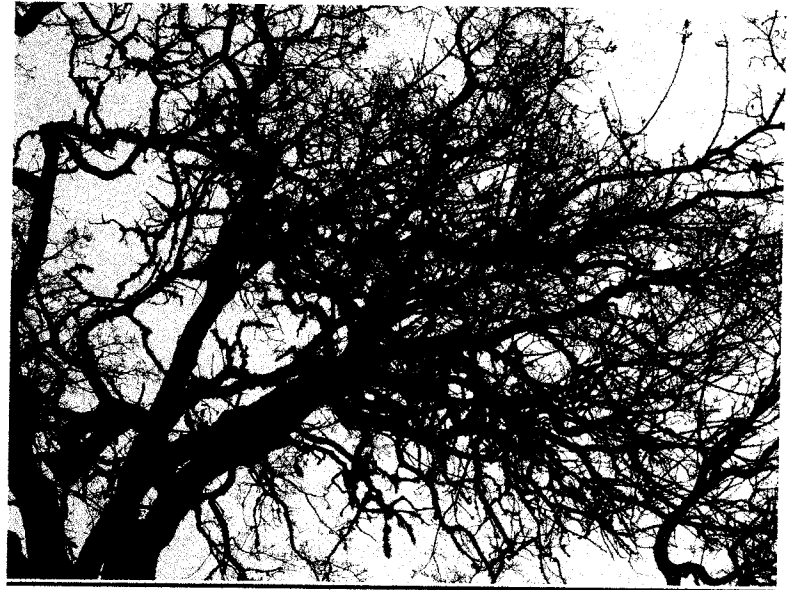
TREE HEALTH, THE CROWN OF "A"

Specifically assessing tree "A", based on ISA criteria regarding the percent of live portions of the crown of tree "A" compared to the live portions of the crown of what a healthy tree should be, I estimate that there is approximately 40% live portion left in this tree when compared to that of a healthy tree of the same size and species.

Most of the live portions of the crown can be seen in the very upper portion of the tree. In the picture to the right, the very fine, long, thin stems in the upper crown are the stems still producing vegetative buds. In the lower portion of the crown, the thicker branches are not producing much in the way of vegetative buds. In many of these thicker branches, one can see where the rot and decay has set in. In a normally healthy tree, these branches should be producing vegetative buds, these are not. A major scaffolding branch was removed 2-3 yrs ago, it shows no signs of sealing itself. Signs of sealing should be seen within the first year.

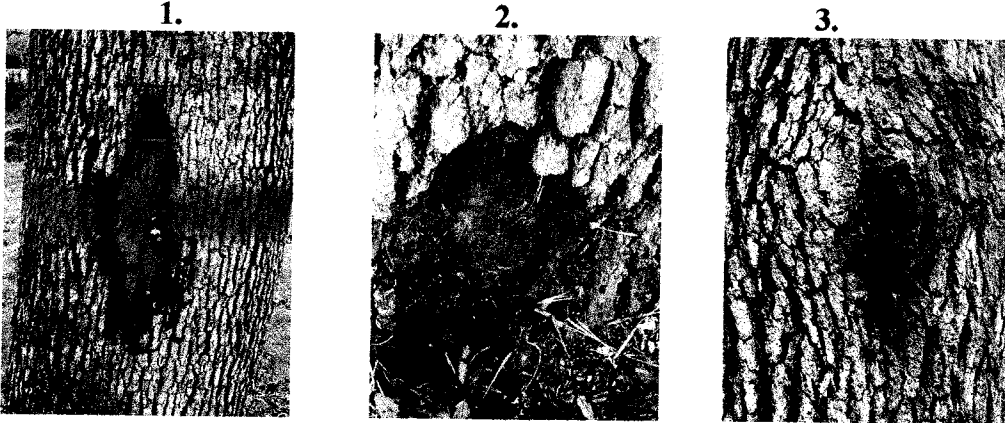
TREE HEALTH, THE TRUNK OF "A"

As mentioned earlier, a tree has the ability to seal itself in response to some injuries. From a distance the trunk of tree "A" appears to be sound and healthy. Taking a closer look, it becomes evident that there are serious problems associated with this tree's vigor. There are two prominent injuries to the bole (trunk) of this tree, pictures 1 & 2. Both appear to have been caused mechanically, something or somebody striking the tree in the past.

The injury in picture number three appears to be a result of the loss of a branch. The important issue regarding all three injuries is that none of them have been able to seal themselves. The wound in picture 1 is to a greater extent than meets the eye. Upon examining the wound, I found that the bark has separated from the tree several inches in all directions beyond what is visible to the eye. There is evidence of rodent activity, nesting in the separated portion of the bark. With the tree unable to seal this wound, the damage will only worsen. The wound seen in picture two is similar to that of picture 1. This wound is at ground level, probably mechanical in nature. Again, the tree has not been able to seal itself. The damage will only increase with time. There is evidence of insect activity associated with this wound. In picture three, there is a small wound, which is not sealing; there is evidence of weeping with fluid oozing from the break in the bark. This is another entry point for pathogens.

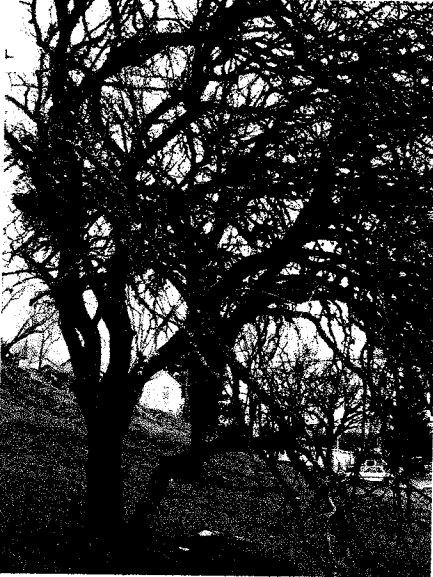
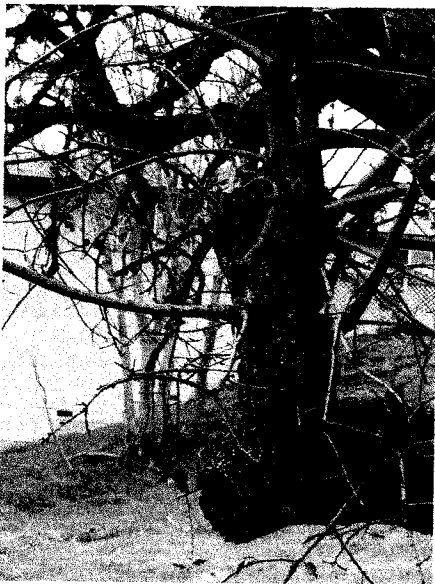
TREE HEALTH, THE CROWN OF "B"

The crown of this tree is producing less vegetative material than that of tree "A". Comparing the live portion of the crown in this tree to what a healthy tree of same size and species should have, I estimate that this crown is approximately 30% live.

This tree is in a much Further stage of decline than tree "A".

Most of the live portions of the crown can be seen in the very upper portion of the tree, the very fine, long, thin stems in the upper crown are the stems still producing vegetative buds. In the lower portion of the crown, the thicker branches are not producing much in the way of vegetative buds. In many of these thicker branches, one can see where the rot and decay has set in. In a normally healthy tree these branches should be producing vegetative buds; again, as with tree "A", these are not. It was also noted that in the lower portion of the crown there is evidence of improper pruning. The end result of this pruning is shown in the picture below. There are two pruning locations in this

picture. The upper cut shows signs of the tree attempting to seal itself, evidenced by

the tan colored callous material surrounding the pruning cut. It almost sealed it completely. The lower cut seen in the picture did not seal at all. Both of these wounds are entry points for pathogens. Another issue to consider with the upper pruning cut is the response by the tree. Though the wound began to seal itself, it also produced "water sprouts". Those small branches emanating from around the pruning cut will eventually increase in size but because of the nature of water sprouts, they will produce attachment to the parent limb. They will be more susceptible to failure at the attachment point.

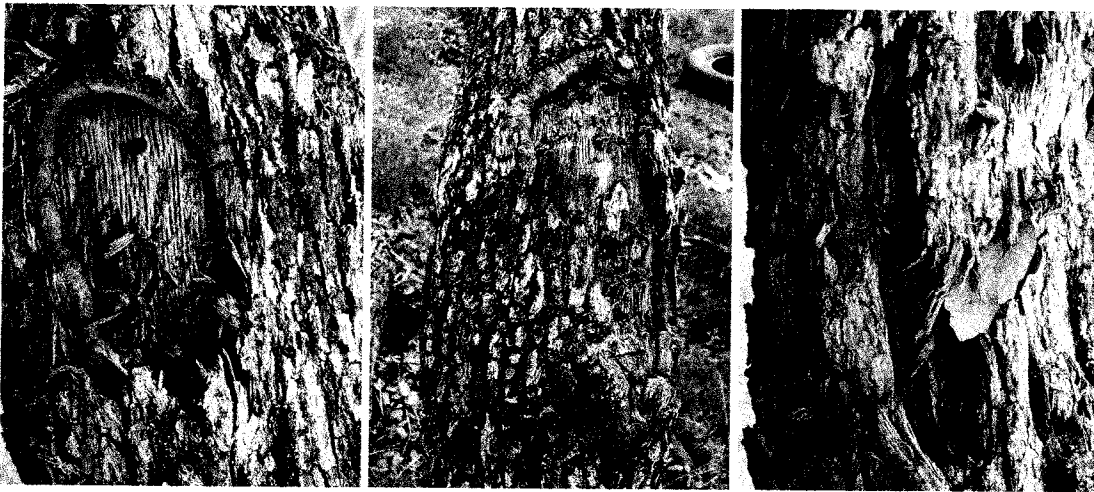
TREE HEALTH, THE TRUNK OF "B"

Based on previous discussions regarding wounds to a tree, it is obvious at first glance that there are issues with this tree. There are several locations on the trunk of this tree that show evidence of previous mechanical damage and the inability of the tree to completely seal itself because of the nature of the wounds.

In all three of these cases above, the tree was able to seal itself to some degree. Picture no. 1 shows the greatest amount of sealing, 100%, picture no. 2 about 75 %, and picture no.3 approximately 50%. There appears to be some secondary wounding in pictures 1 and 2. Someone had pounded a nail into the tree at these locations. Again these are entry points for pathogens to enter and do affect the long term health of the tree. Again nails pounded into the trees as shown in the pictures Below.

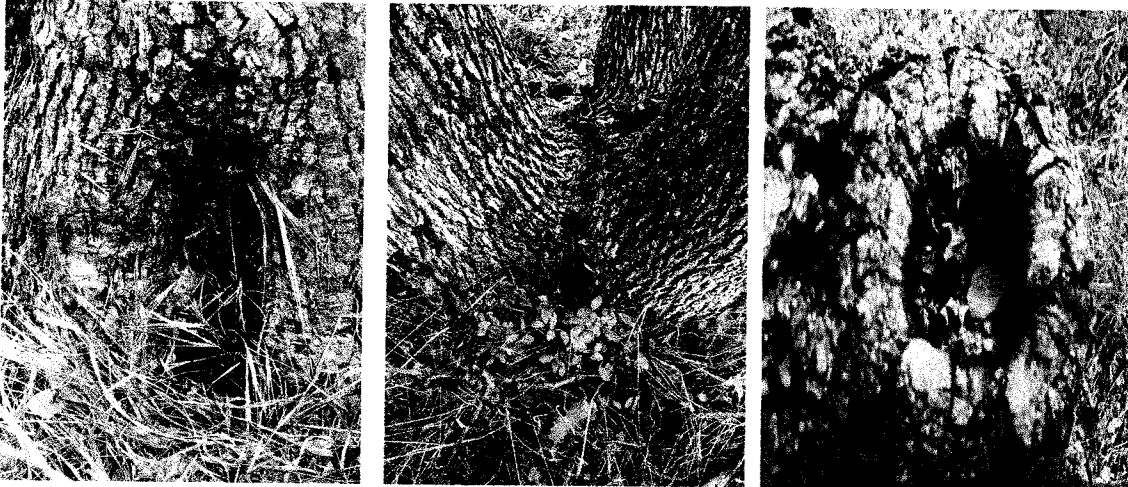
TREE HEALTH, THE TRUNK OF "B"

Other wounds found on the trunk of this tree are shown in the pictures below. These pictures further illustrate the abuse and damage done to this particular tree.

Picture 2 above is showing “included bark” between the three major stems of the tree. Included bark is a situation where bark is actually imbedded into the woody material where the two stems meet. This causes a weak point in the tree at the juncture and is prone to failure.

Picture 3 is showing a location where a limb was pruned and had sealed, however, because the pruning cut was made parallel to the horizon, water was able to accumulate in the wound and do further damage. Again this provides one more entry point for the various pathogens.

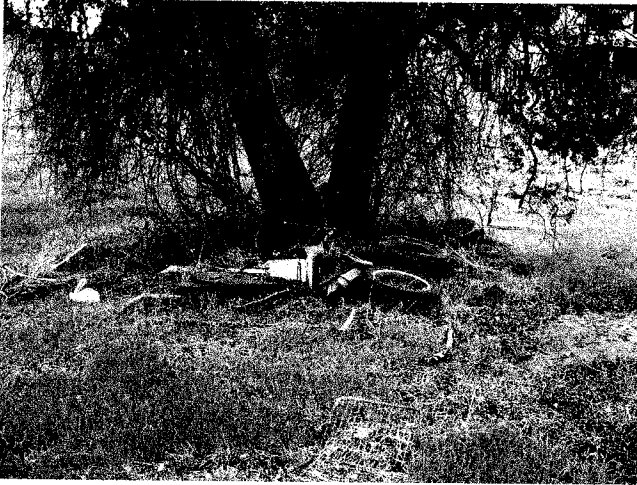
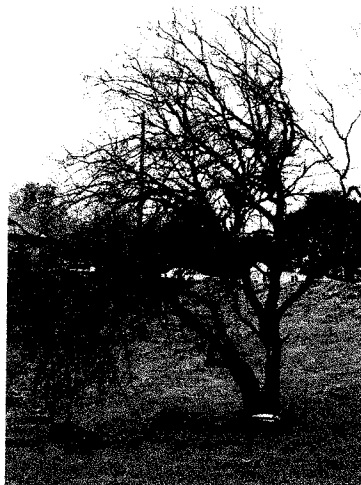
TREE HEALTH, LAND USE

The following are pictures illustrating how this parcel has been abused in the past.

The whole area is scattered with various types of debris, old tires, shopping carts, auto parts, household items all dumped near or around the base of these trees. Judging by the debris dumped in and around the trees on this parcel indicates to me that there is little concern shown for the condition of these trees.
