SUBJECT: OTR 08-001 - REQUEST TO REMOVE ONE OAK TREE (Paso Robles Inn)

DATE: FEBRUARY 5, 2008

December 3, 2007

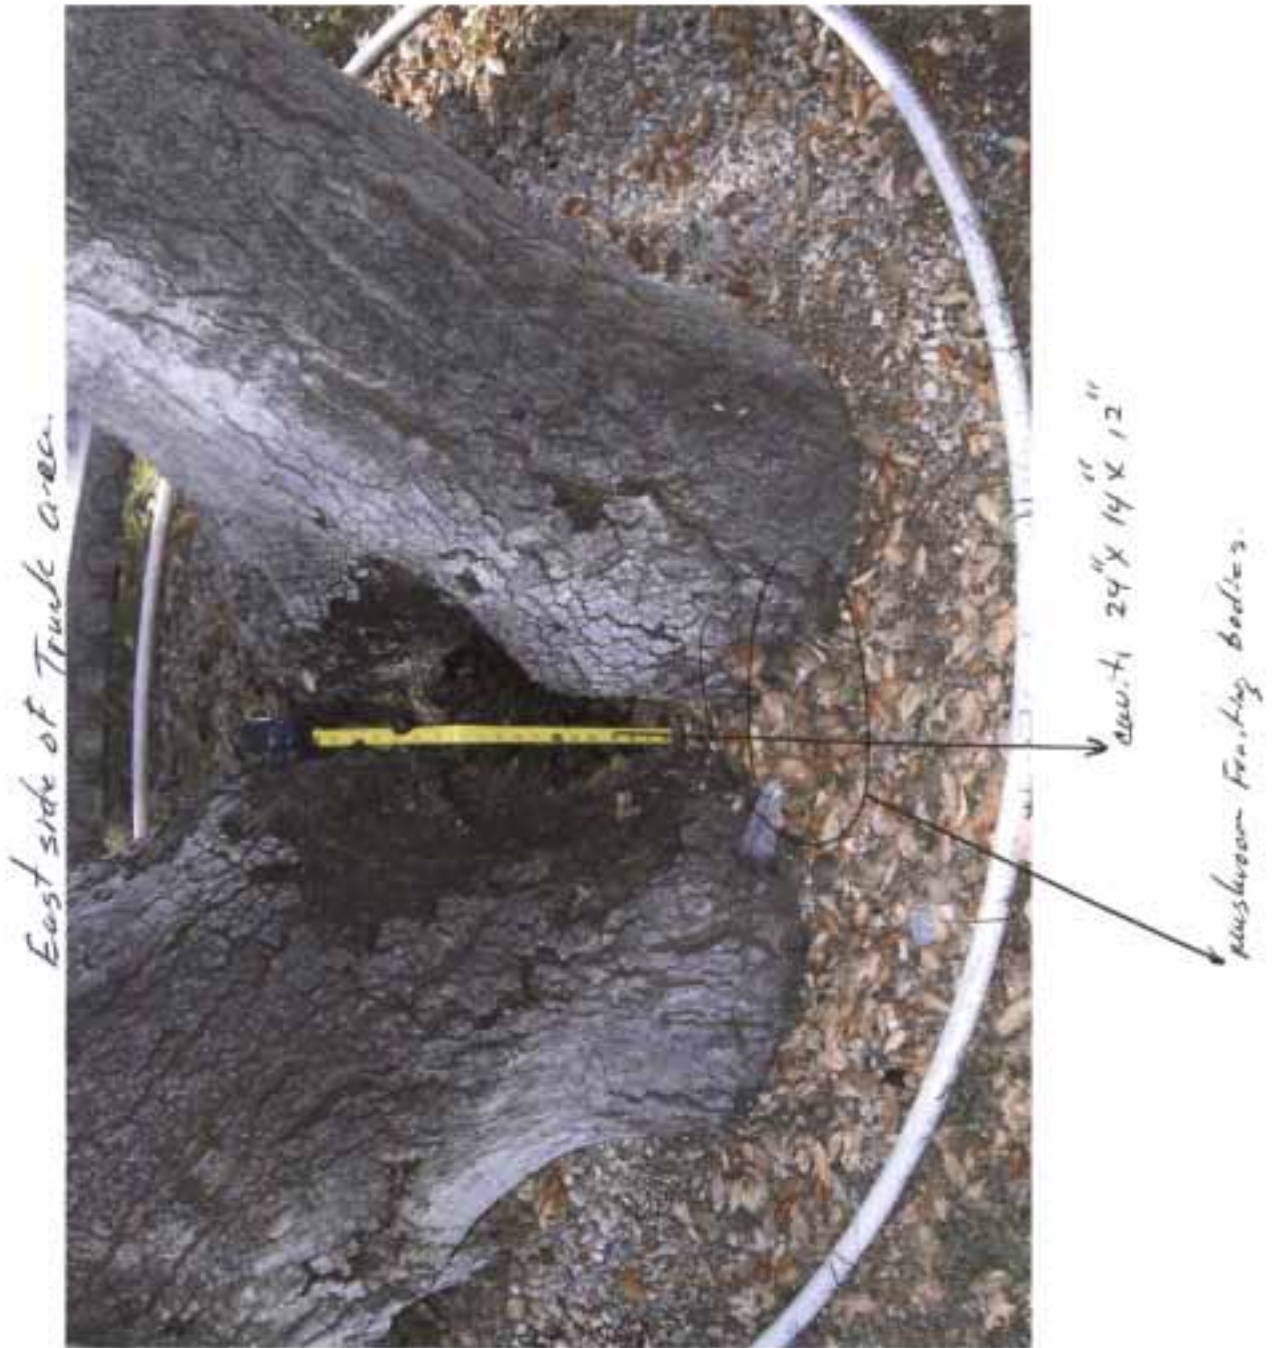
- 1.) East side trunk @ crown cavity & mushrooms
- 2.) West side trunk @ crown cavity & mushrooms

West side of Trunk

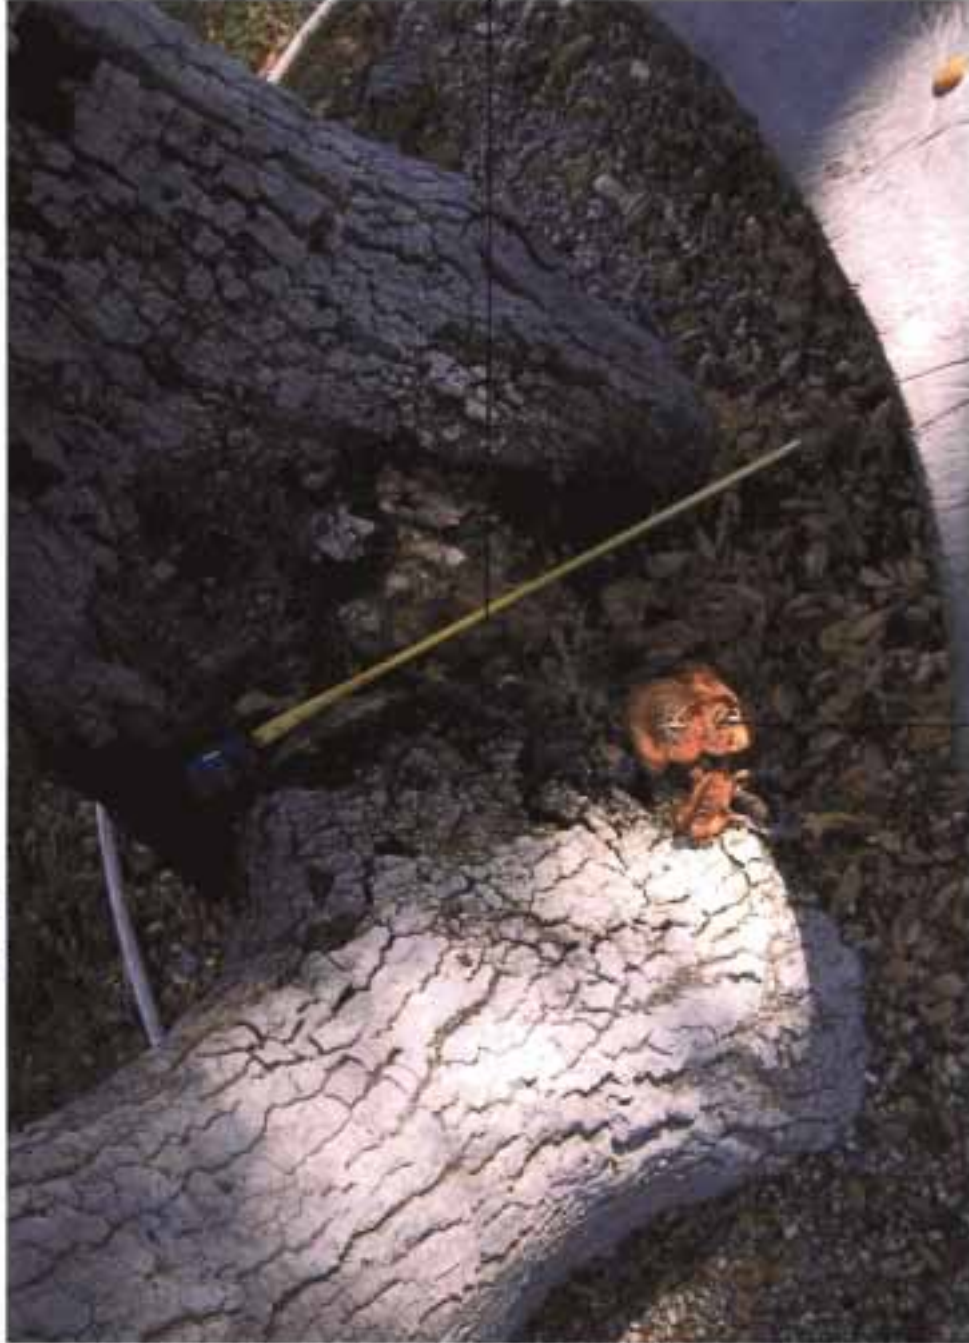
opening 12"
note trunk area

Mushroom Fruiting bodies from oak root fungus

"South side of tree"

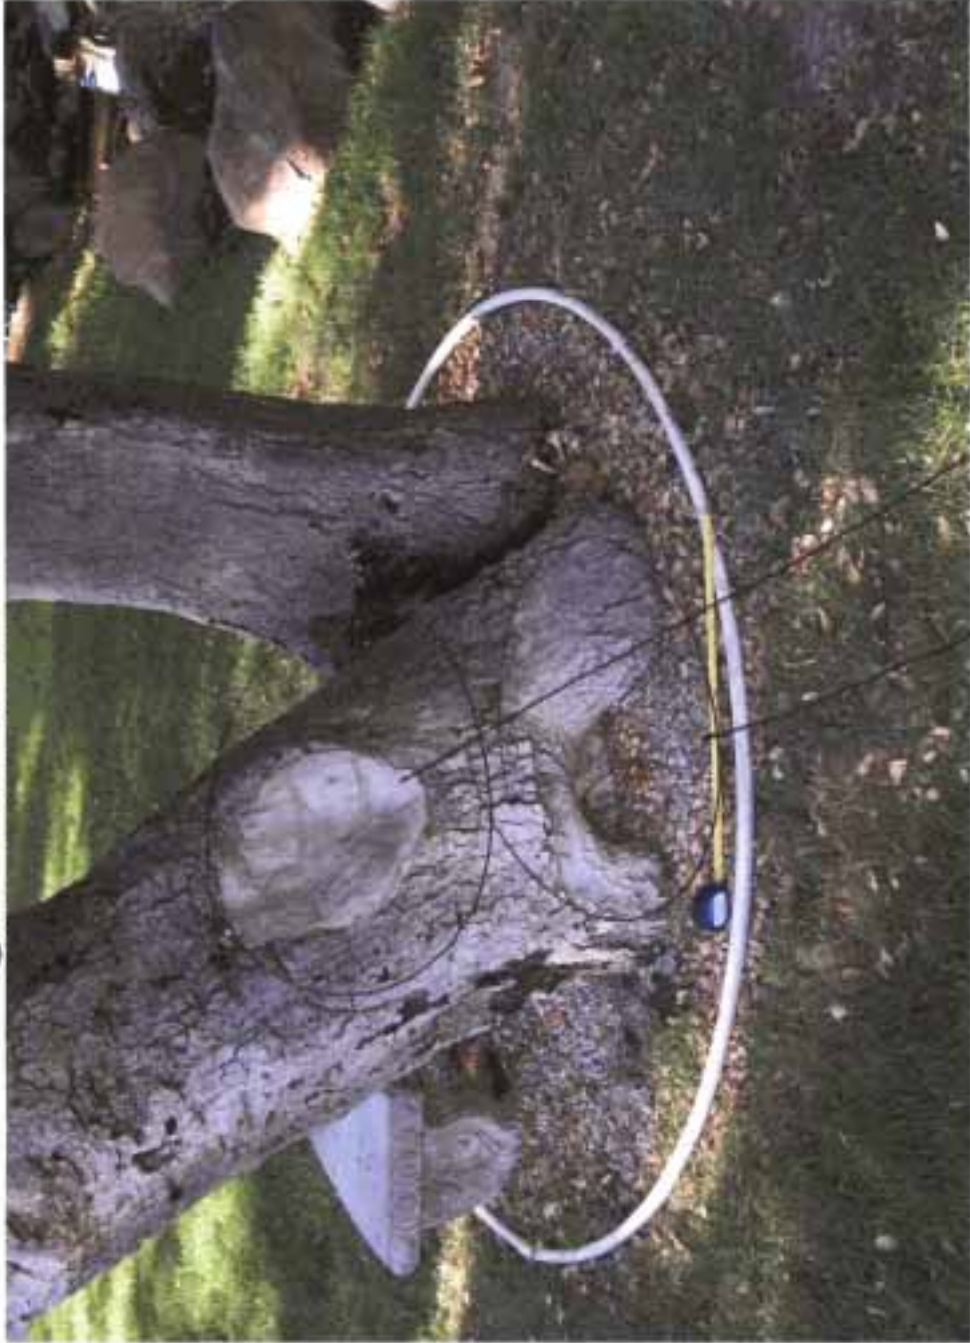
(3)

- 3.) South side trunk @ crown cavity & cement (i)
- 4.) West side trunk & cement in cavity (i)
- 5.) West side cavity
- 6.) Shows scaffolds near from vertical 20° on both scaffolds aerial 1 & 4
- 7.) Shows chlorotic foliage on subj.

old cut by Filbert w/ the cement (A)

old wound from oak root fungus.

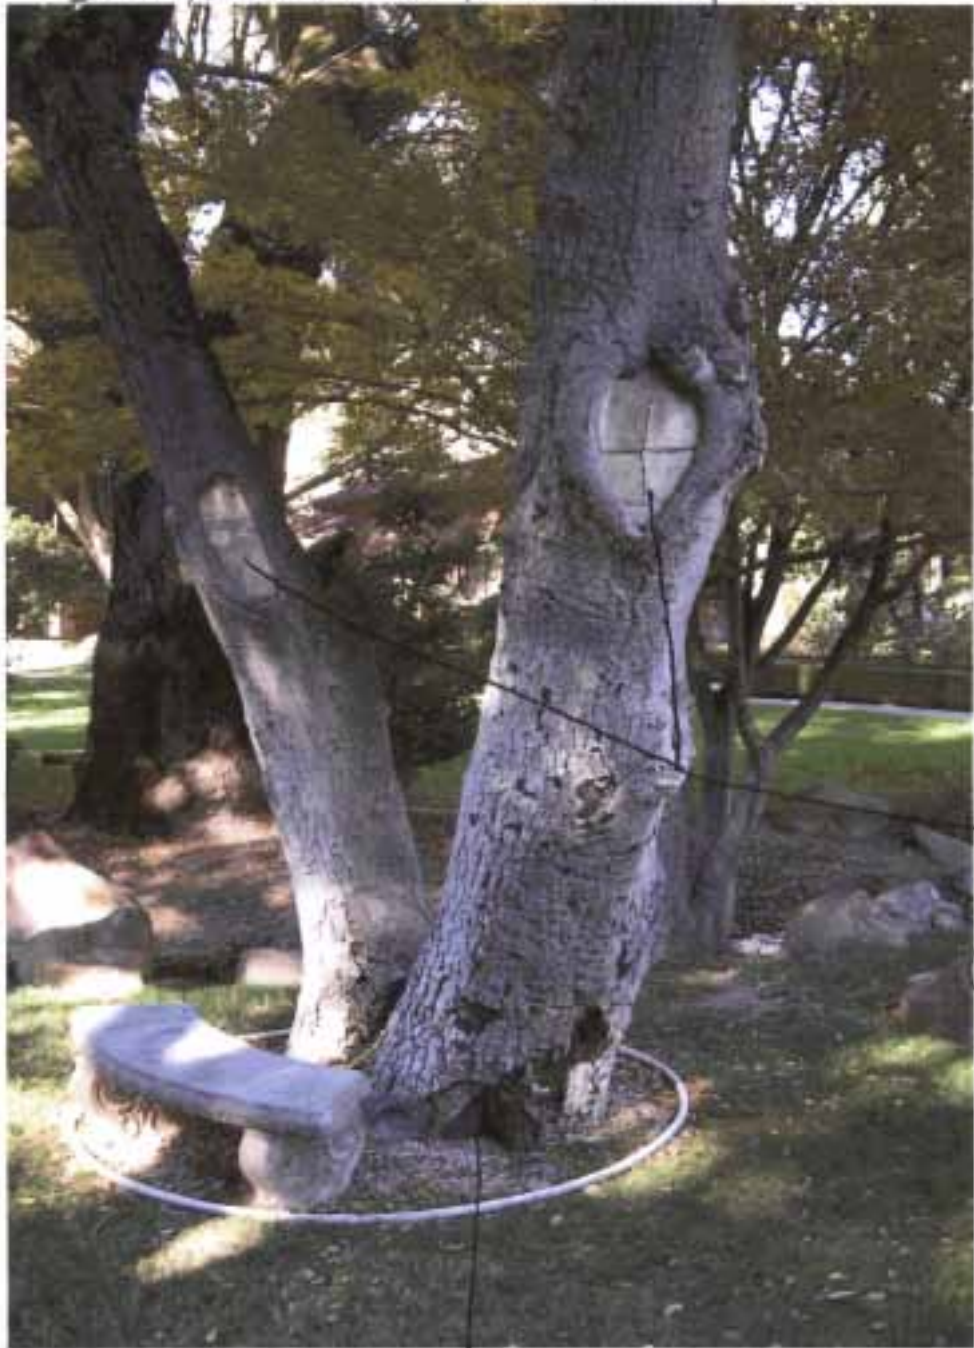
4

South/West side of tree Viewing North

old cavity
Filled w/ cement
(4) poor practice
that creates
decay.

old cavity

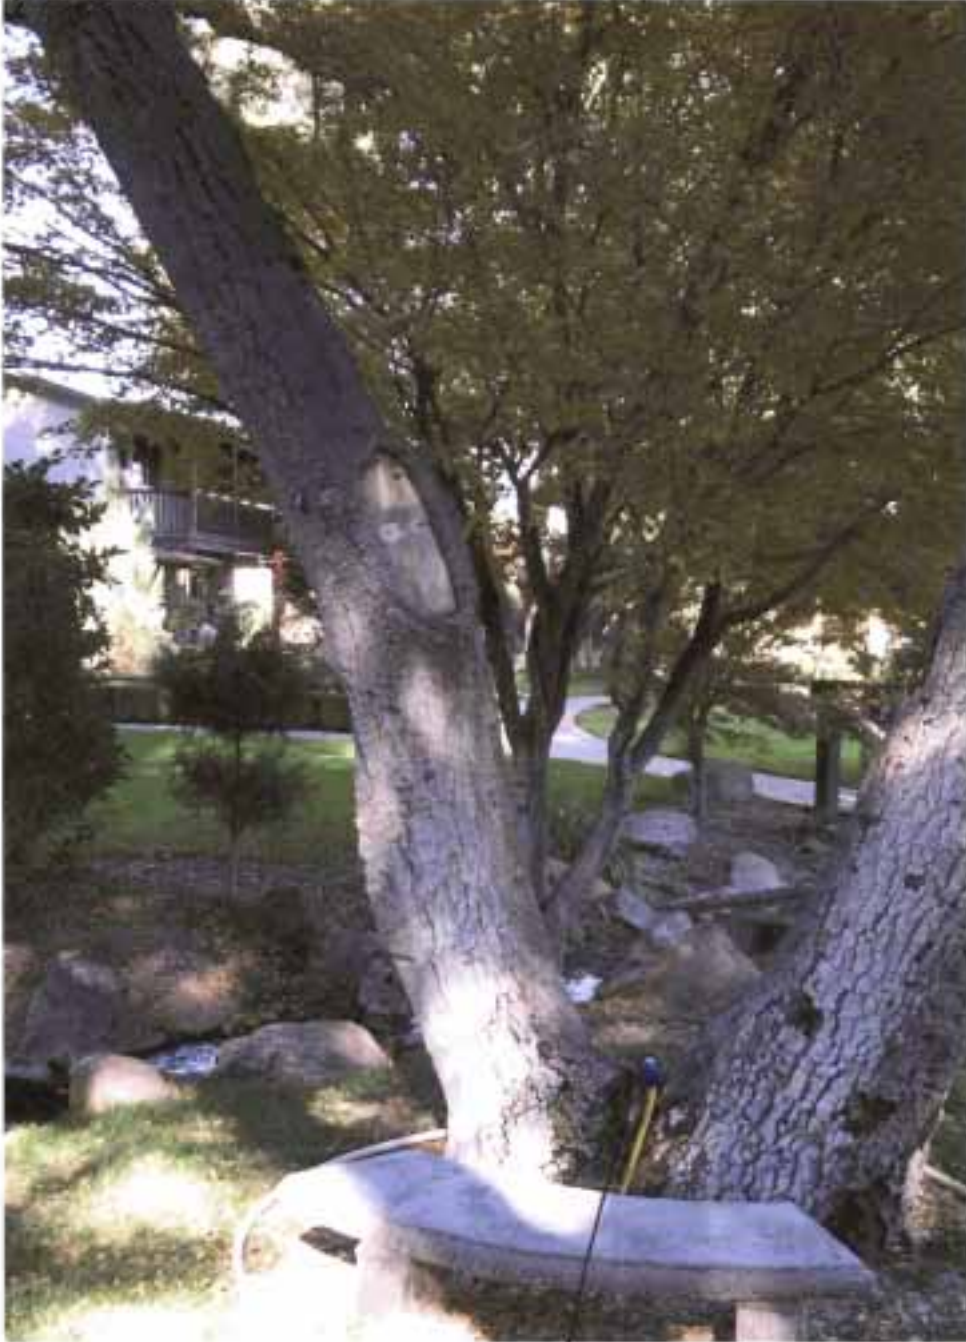
5

West side of tree

↓ cavity @ base of trunk 24" x 12" x 12"

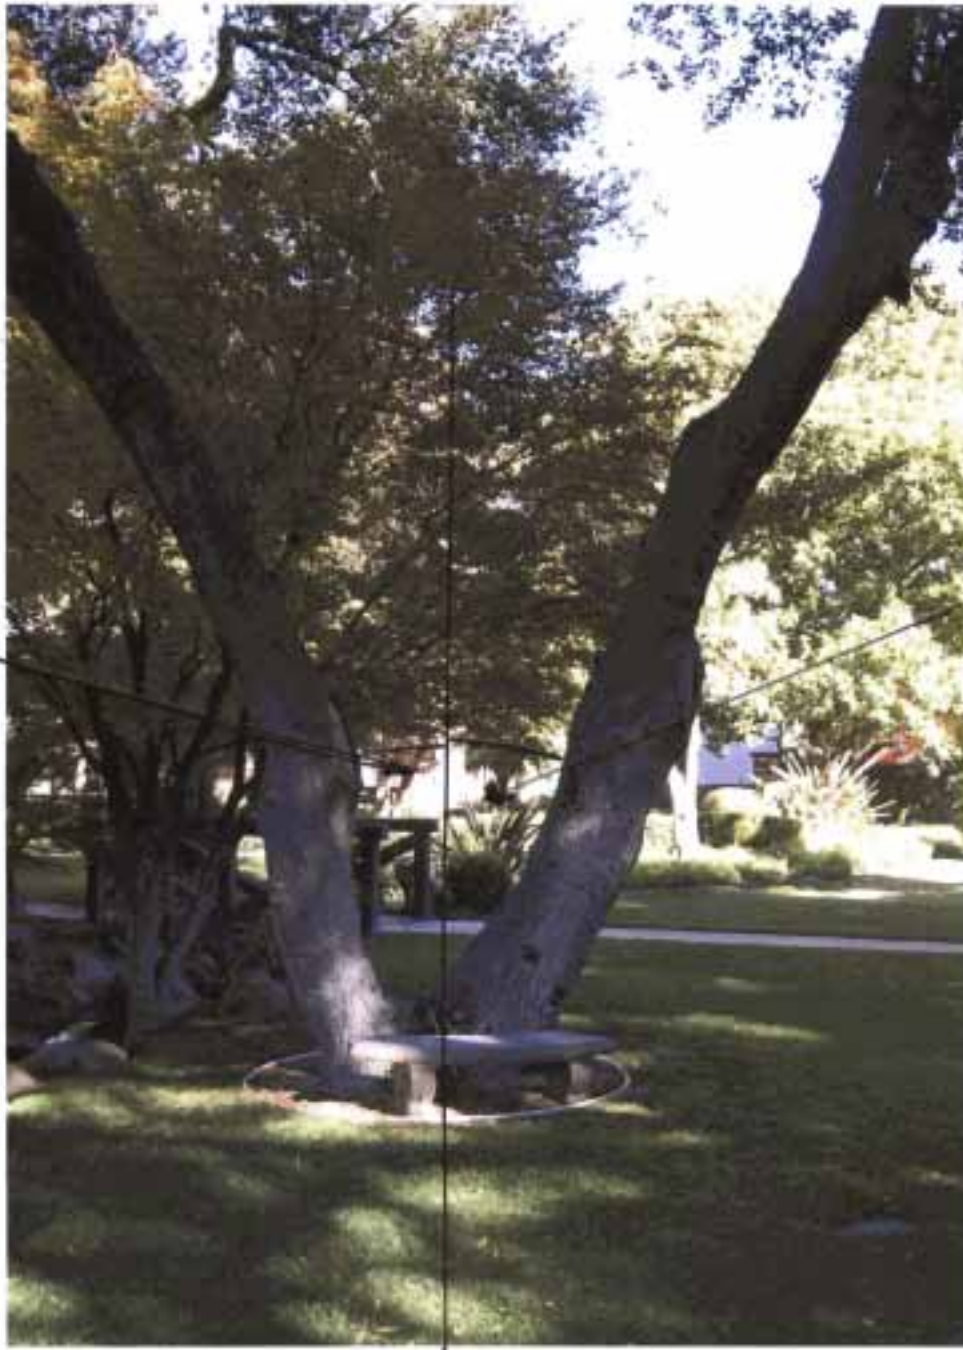
6

The subject tree will most certainly circum to the fungus. Due to the scaffolds and trunk configuration having a 20 degree lean form vertical and the decay is in the plane of the lean makes the subject tree prone to failure at the trunk crown. This situation will definitely have the tree fall across the nearby walkway creating a very hazard situation for anyone walking on the walkway.

Lean From vertical
20°

20°
Lean From vertical

Viewing West overall view of subject tree

After examination and review of the subject tree we have rated the hazard as 12, out of 12. We recognize the subject tree as a hazard that cannot be abated. Due to the above examination we feel the subject tree is an immediate action needed and should be removed as per the City of Paso Robles emergency removal clause 10.01.065-A before the tree falls on an unsuspecting guest of the Paso Robles Inn.

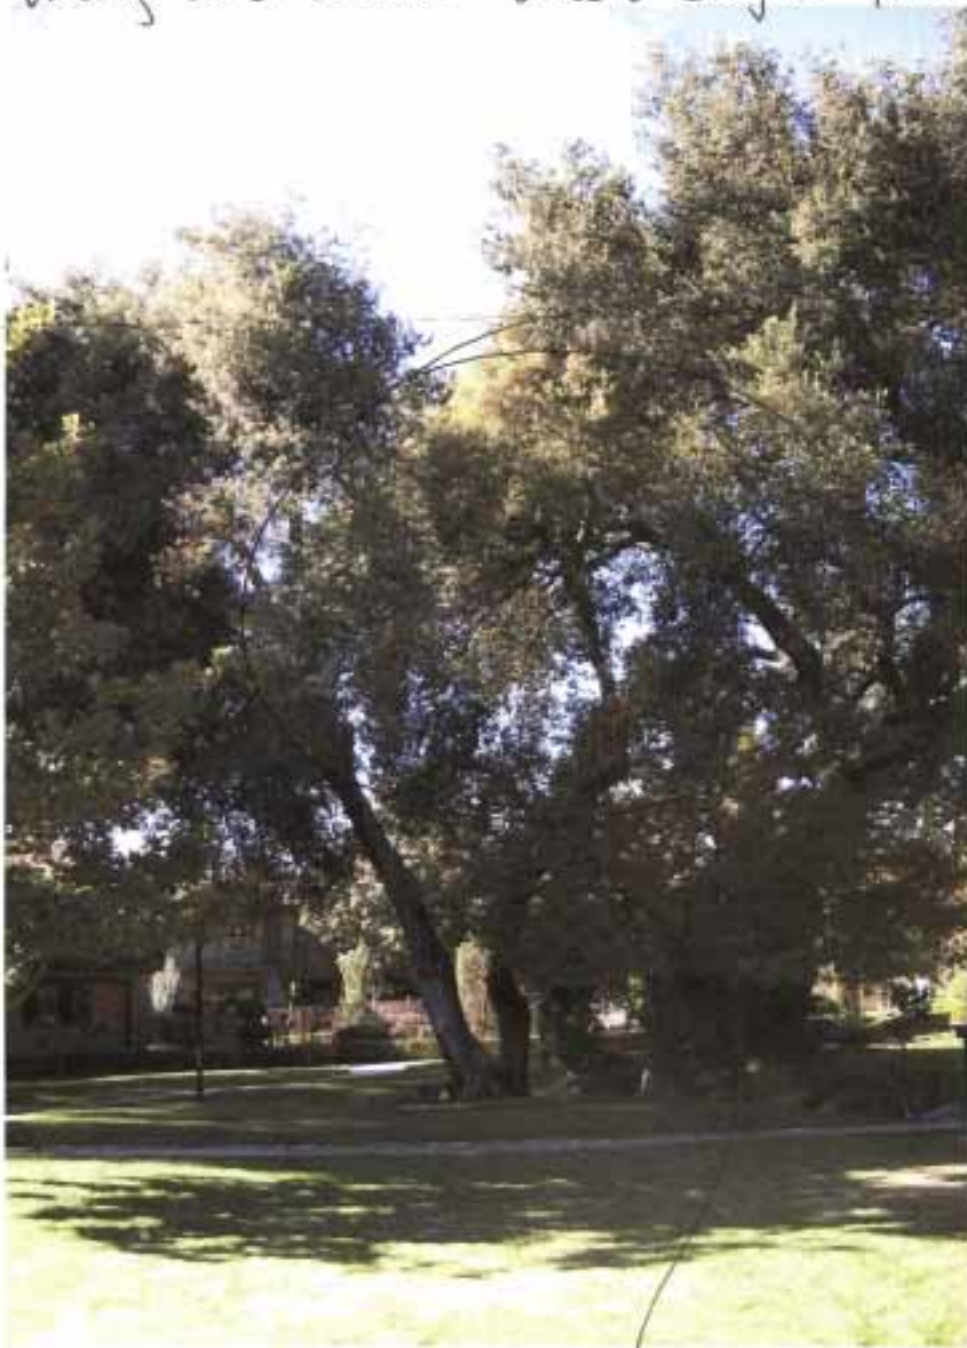
chlorotic foliage symptom
of oak root fungus
infestation.
