SUBJECT: OTR 08-011 - REQUEST TO REMOVE ONE OAK TREE AT 801 28th STREET (PASO ROBLES HOUSING AUTHORITY)

DATE: FEBRUARY 3, 2009

2008 A&T Arborist Report
OTR 08-011
(Housing Authority)

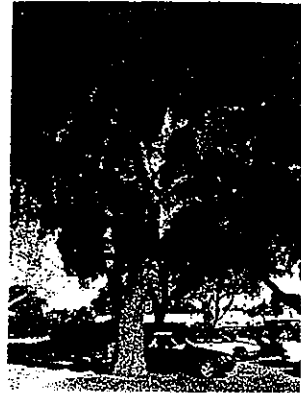
#3 Live Oak

Trunk diameter 36"

Location: Mid Eastern edge of survey map.

Description: Rating "A" good condition. Tree has heavy foliage and well shaped crown. Recommended 25% crown reduction to reduce the weight and overall canopy size. This tree is suitable for preservation. Also pavers should be placed under drip-line to reduce parking impact.
