TO: Jim App, City Manager

SUBJECT: Oak Tree Removal Intersection of River and Creston Roads

DATE: October 19, 2010

A & T ARBORISTS

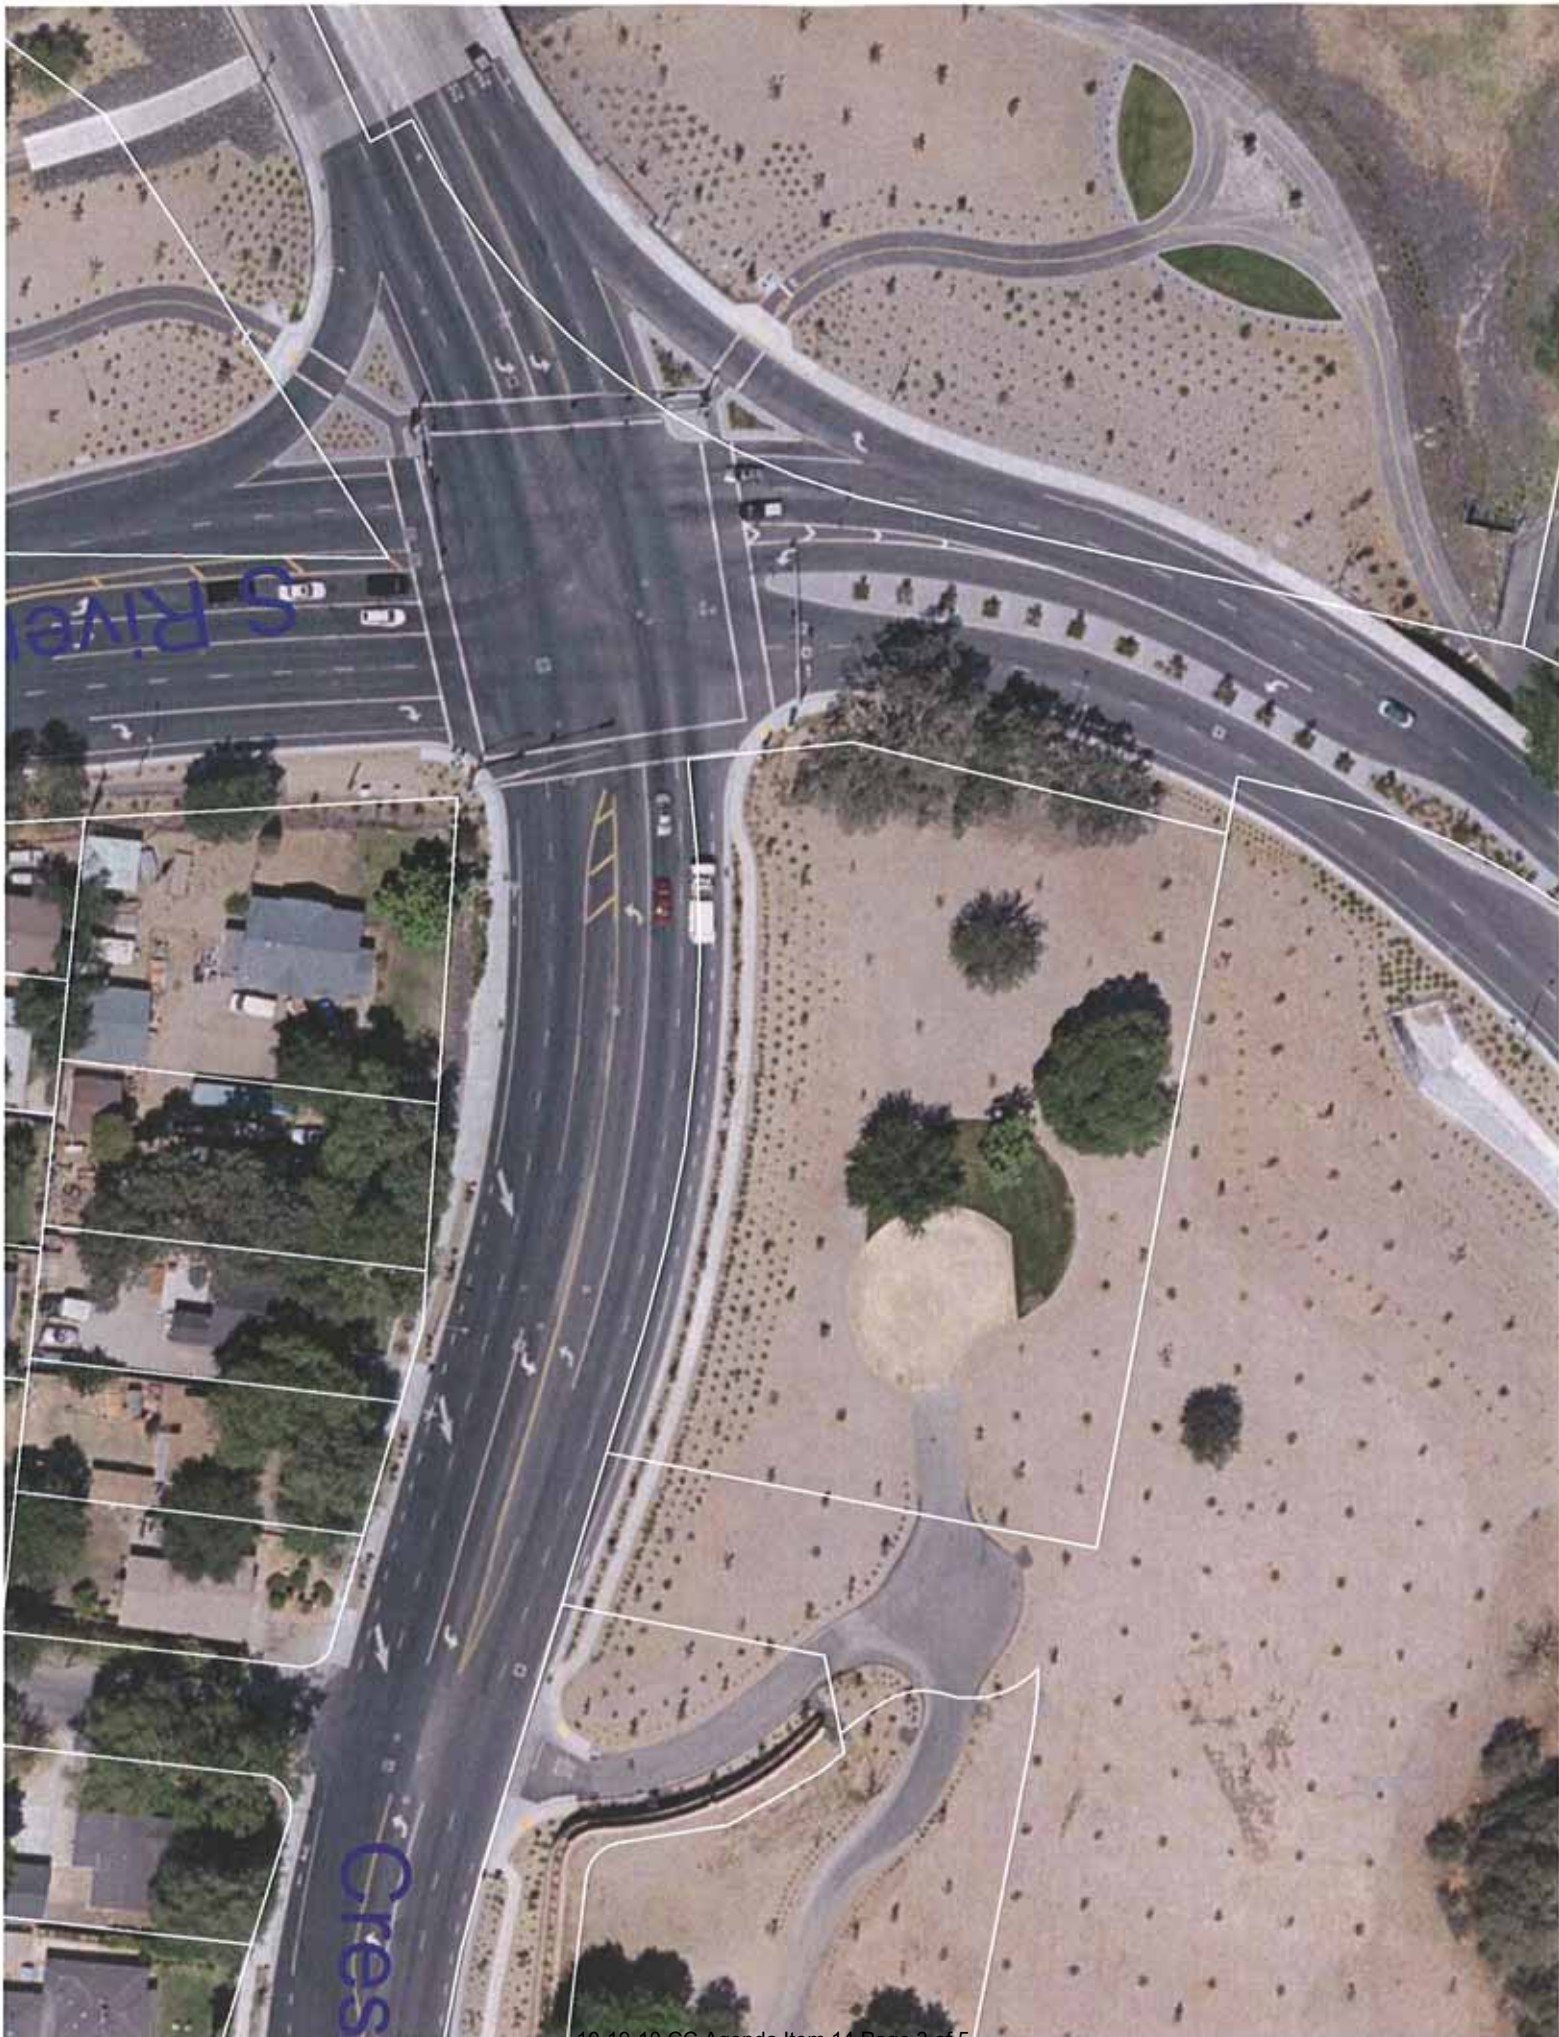
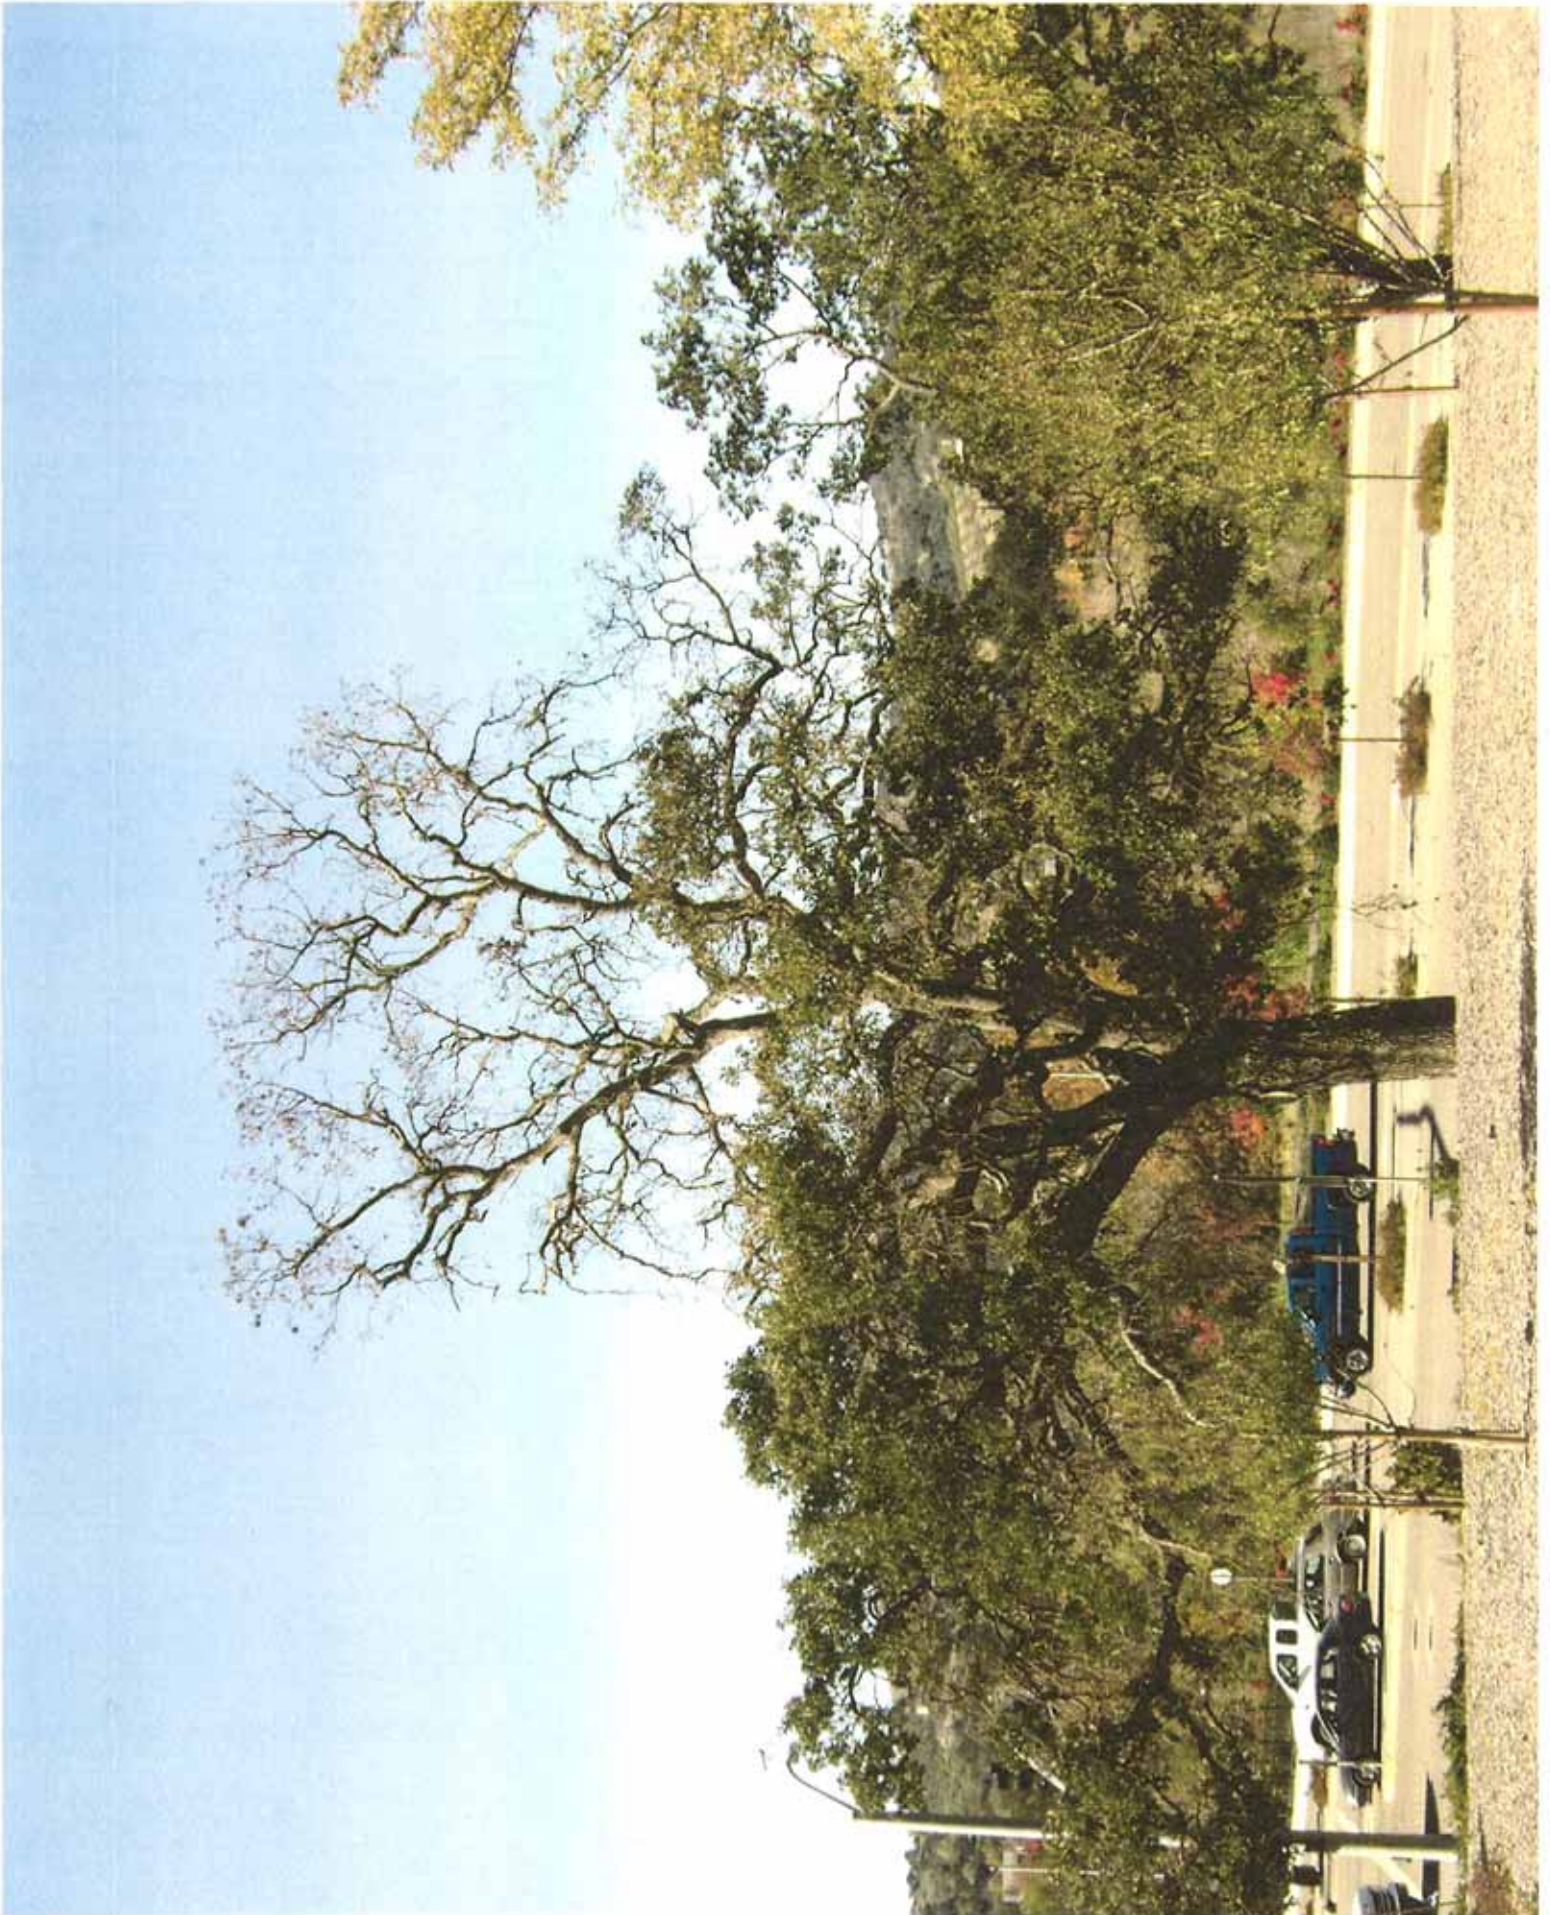
This report is in regard to the dying 30" diameter valley oak tree (*Quercus lobata*) owned by the City of Paso Robles that is located at the corner of North River Road and Creston Roads. The tree has been in decline for several years and currently retains approximately 10% live canopy. As the main scaffold limbs continue to decay, there is a strong possibility of failure onto North River Road. This could be a hazard to both pedestrians and vehicular traffic. Failures may range from small branches up to half of the entire tree.

Included is a photograph that was taken from the east side of the tree that illustrates the dead portion.

There are two options regarding this tree. First would be to remove the dead portion and leave the remaining live portion. Due to the fact the tree has continued to decline, the remaining portion that would be left may soon die let alone the fact the tree will appear severely disfigured. Second option is to remove the entire tree. We prefer this alternative as the tree will most likely be completely dead in the future.

We strongly recommend immediate action before a failure happens. Please feel free to contact us if there are any questions.
