SUBJECT: Repairs – Golden Hill Road Water Tank & Merry Hill Water Tank

DATE: May 17, 2011

PROJECT: Supplemental Inspection Tank #1

LOCATION: Golden Hills Tank #1

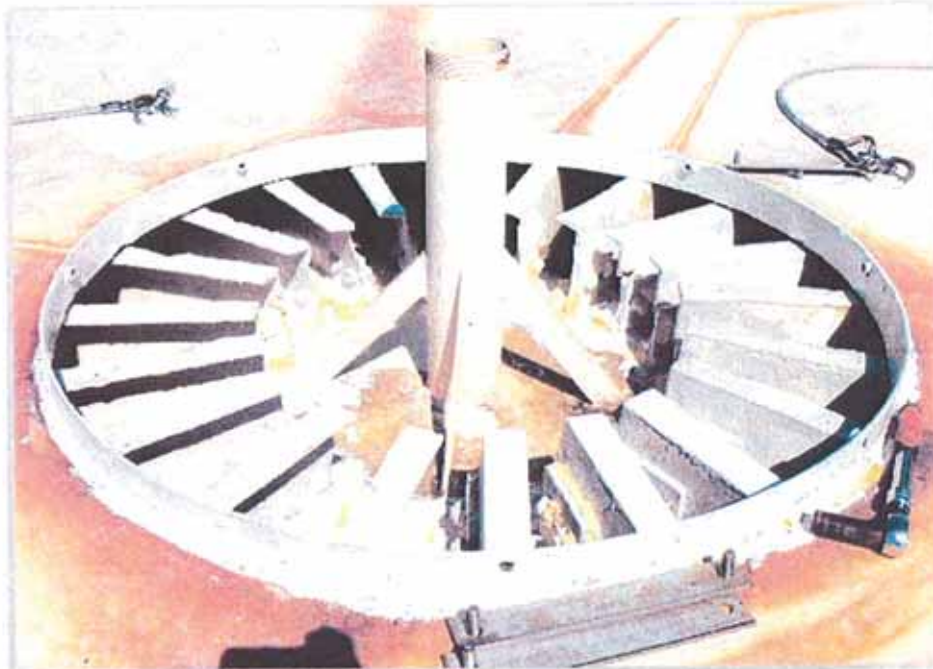
Roof vent area overall view.

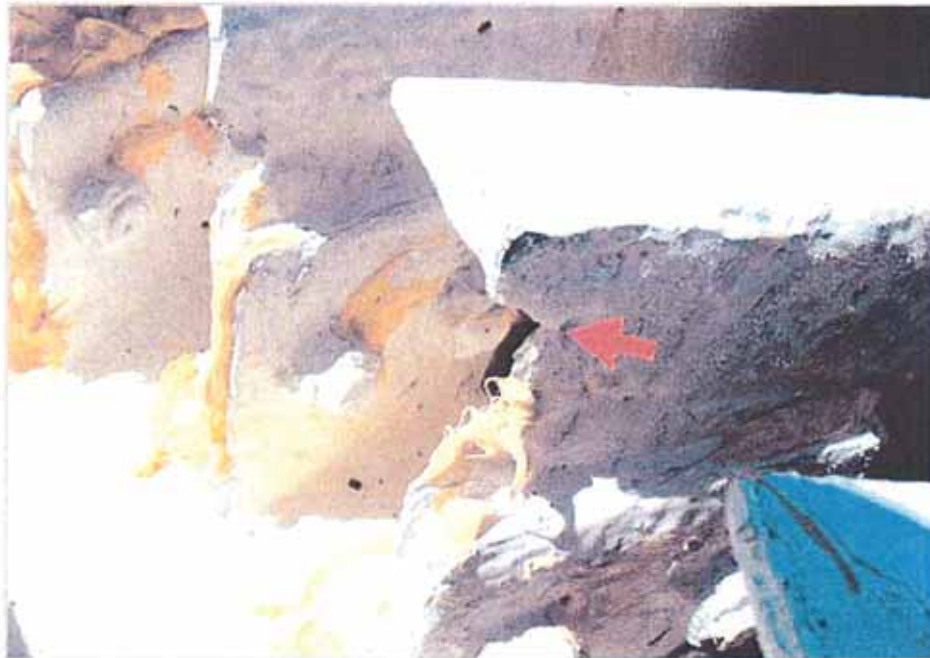
Severe metal loss due to corrosion at rafter ends has significantly reduced edge distance of structural bolting.

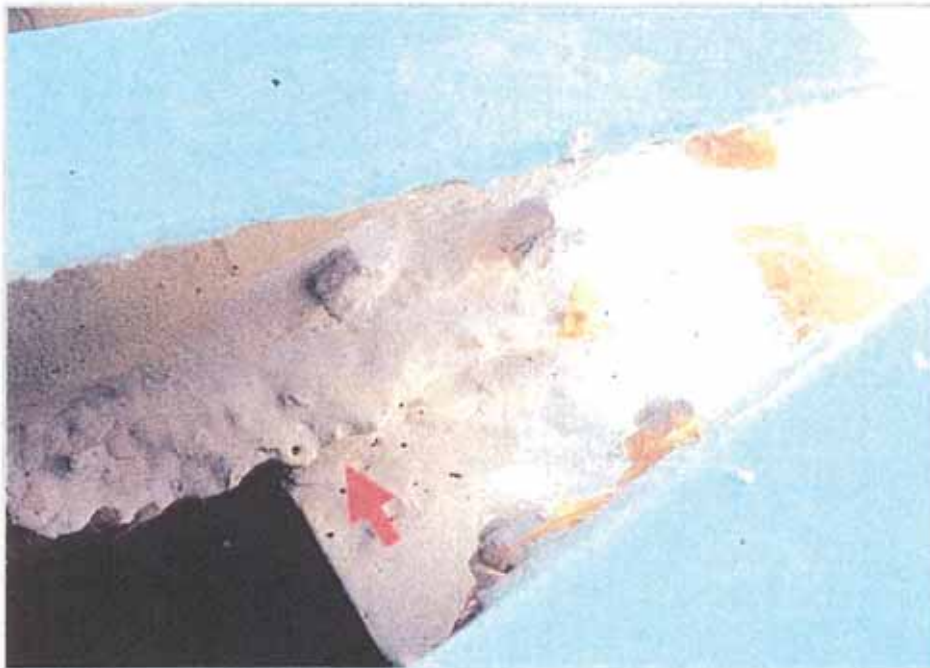
Severe metal loss due to corrosion at area of high shear load has significantly reduced the strength of the roof structure.

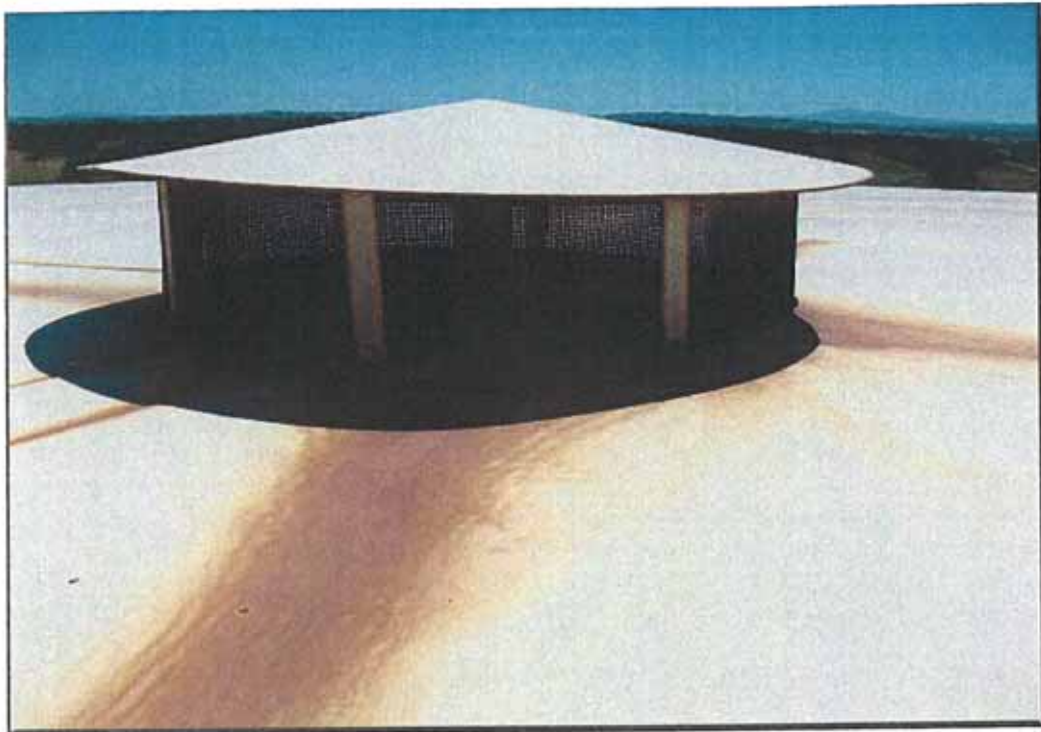
The roof vent consists of a steel cover over a steel riser pipe. Rust stains are evident from the substantial amount of rust on the screen and other surfaces of the vent.

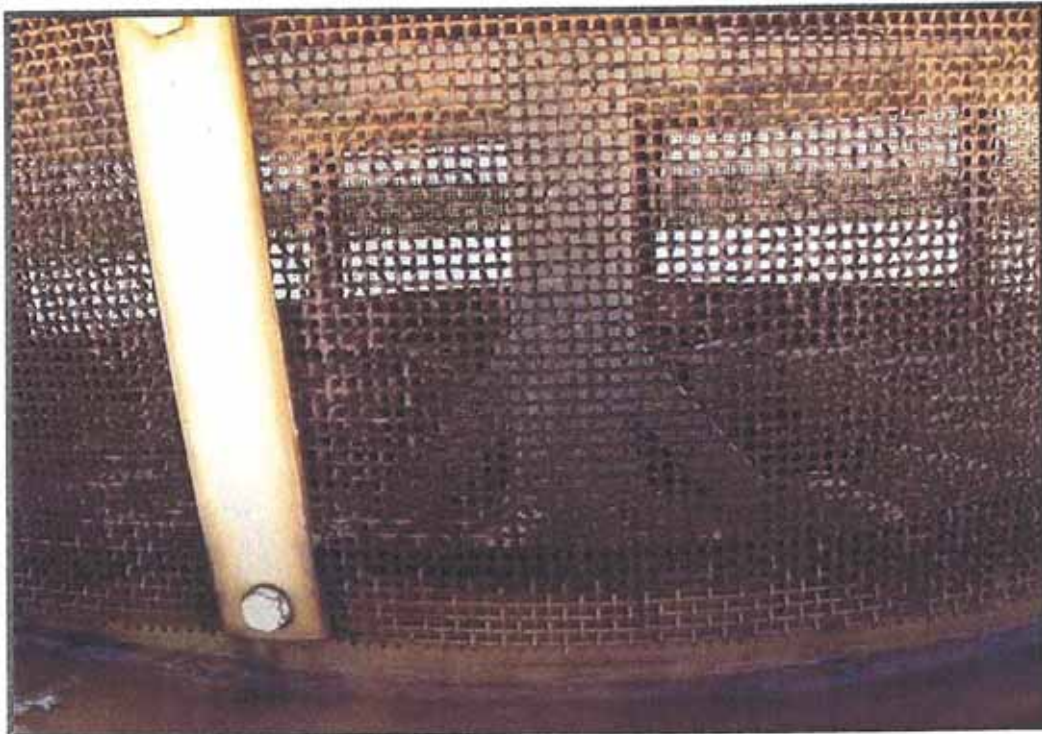
This view of the underside of the vent hood shows that the screen is in poor condition. Coatings are starting to fail in spots within this area with significant corrosion on most surfaces.

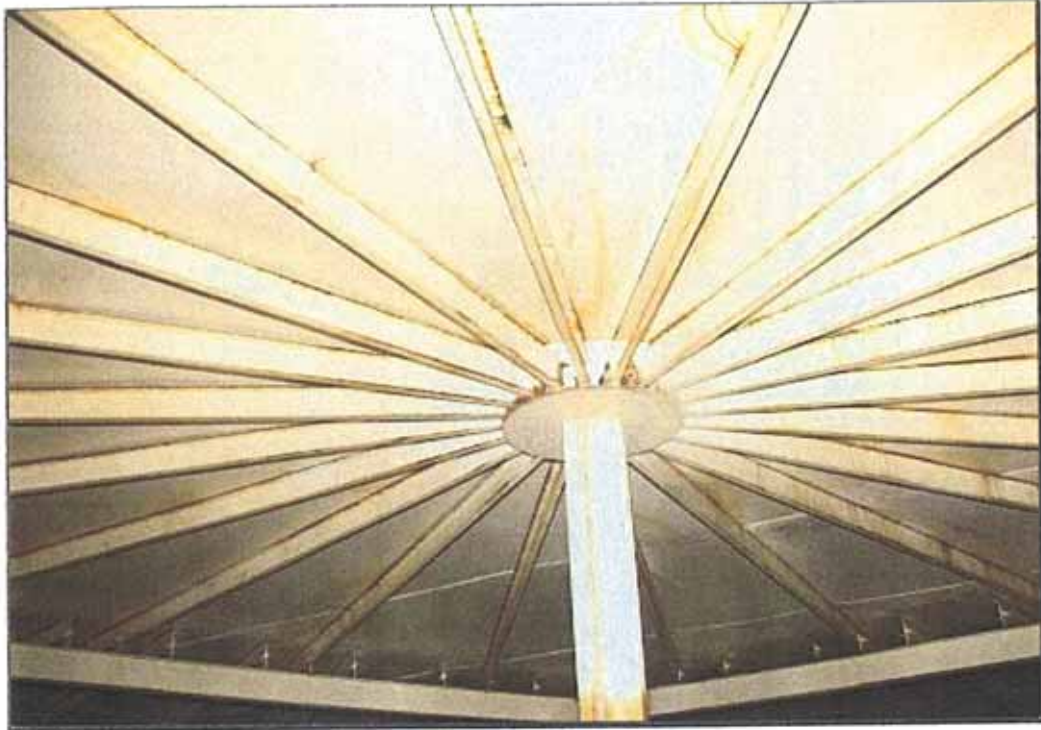
Upper center column, rafters and roof plate. Significant corrosion was present on edges of much of the structure but staining from inaccessible areas above the rafters is the source of much of the rust color.

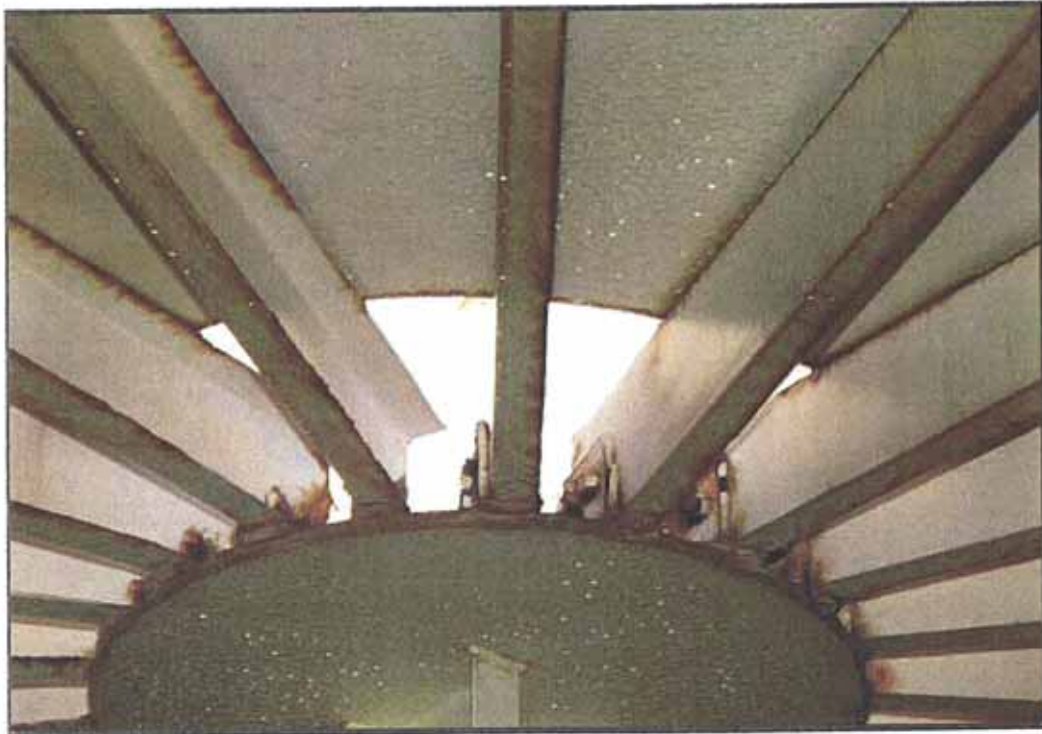
Close view of the area shown in the top photo. Significant corrosion is present around the bolts and attachment clips.

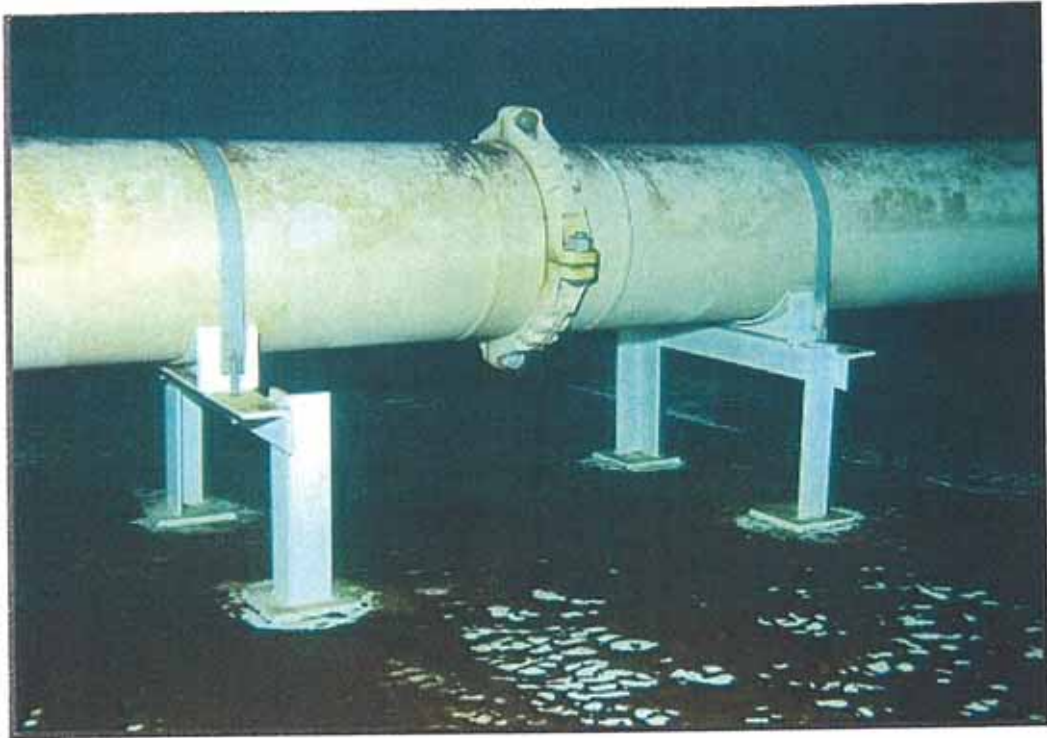
The outlet piping on the tank interior. This view shows supports and coupler.

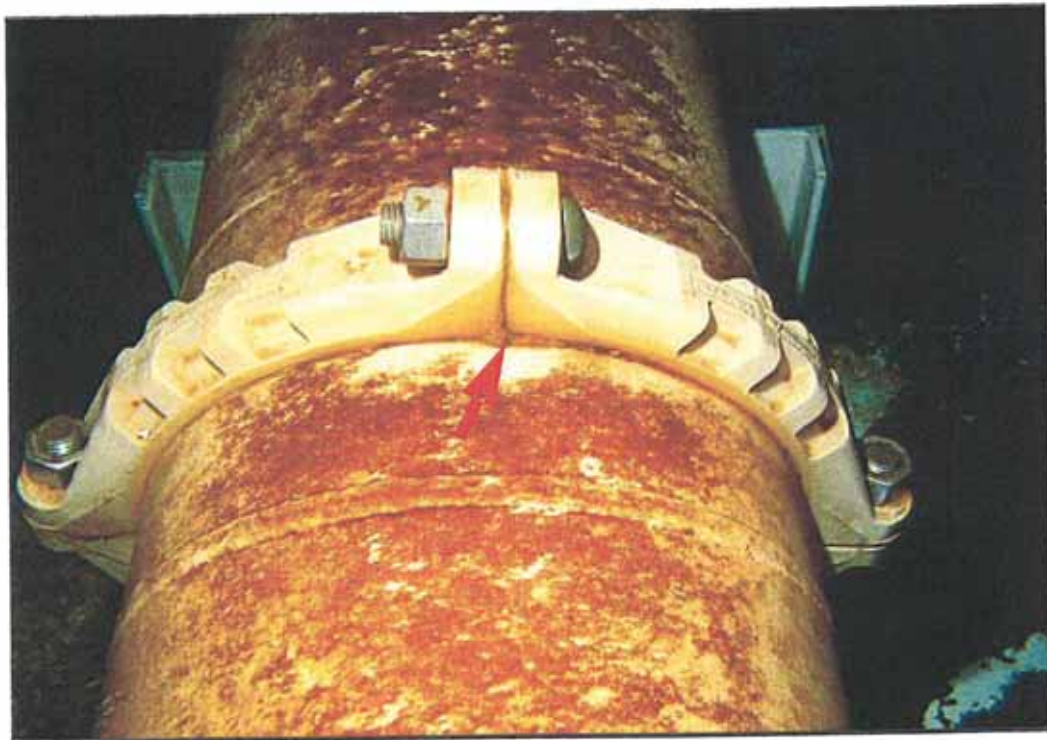
Outlet piping coupler, close view. Numerous corrosion points are present around the difficult access areas (arrow) including saddles, straps and supports.

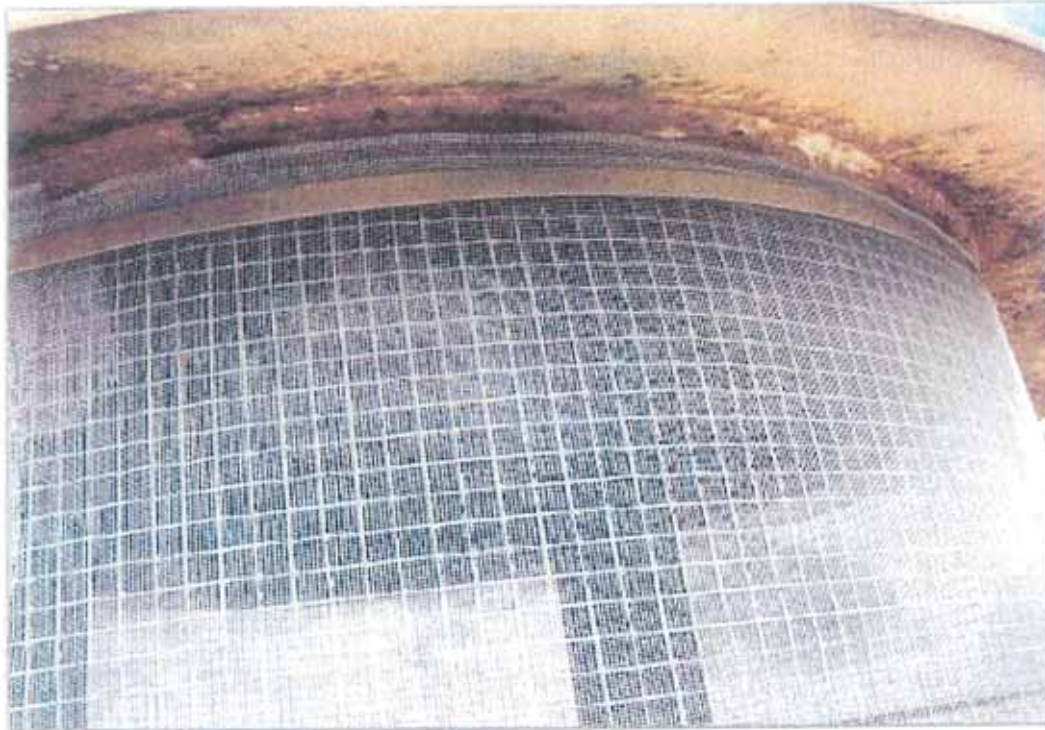
This view of the underside of the vent hood shows that the screen is in good condition and is "bug proof". Coatings are starting to fail in spots in this area with significant corrosion on the underside of the cover.

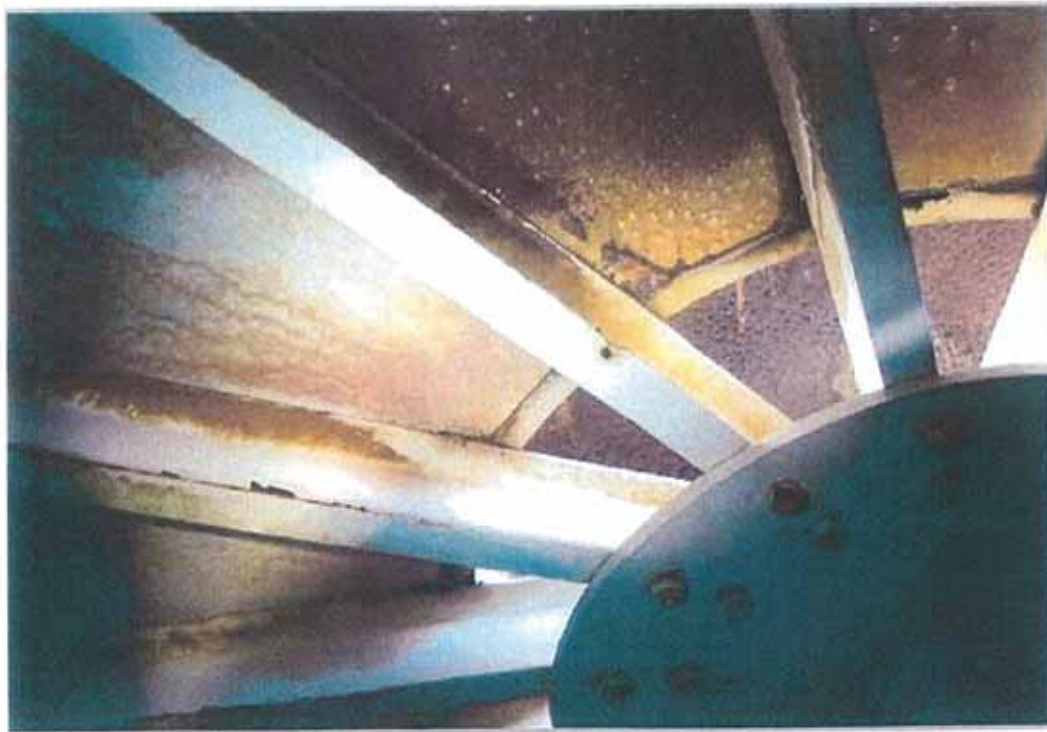
Vent area as viewed from inside the tank. Some concentrated corrosion is present on the rafters and the roof plate.

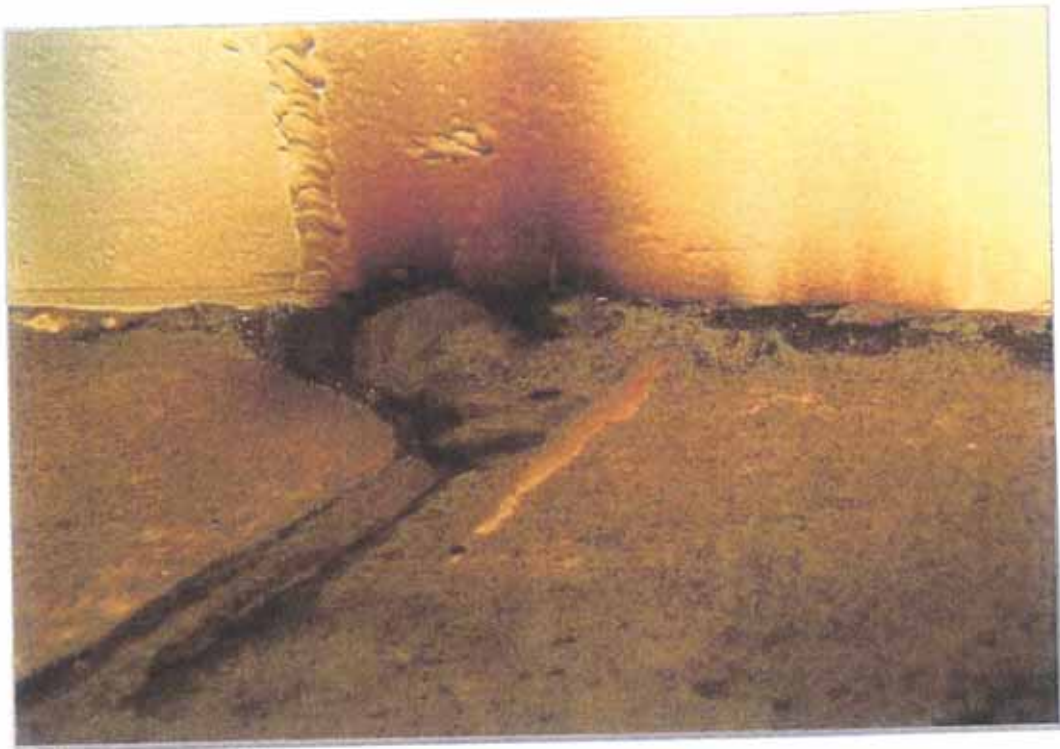
This photo of the interior bottom and shell shows the typical condition found. The coatings are cracked and corrosion is present in this area all around the tank.

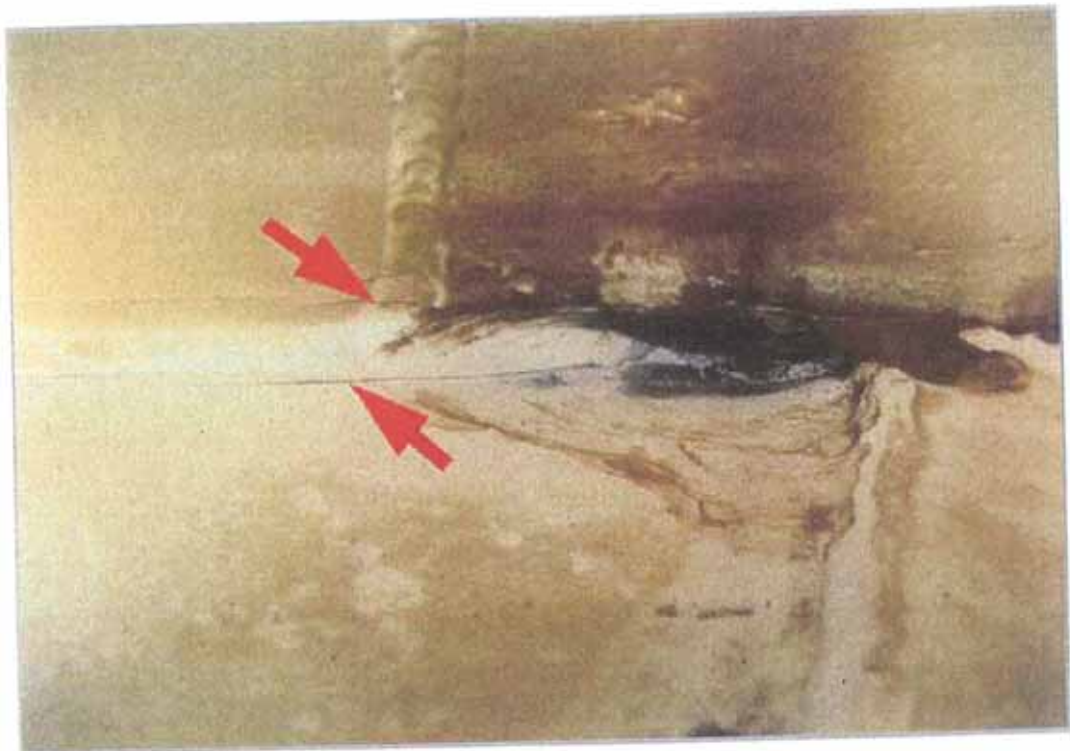
This photo shows the same area as in the top photo with the sediment removed. The rust is propagating from the cracks in the coating (arrows).

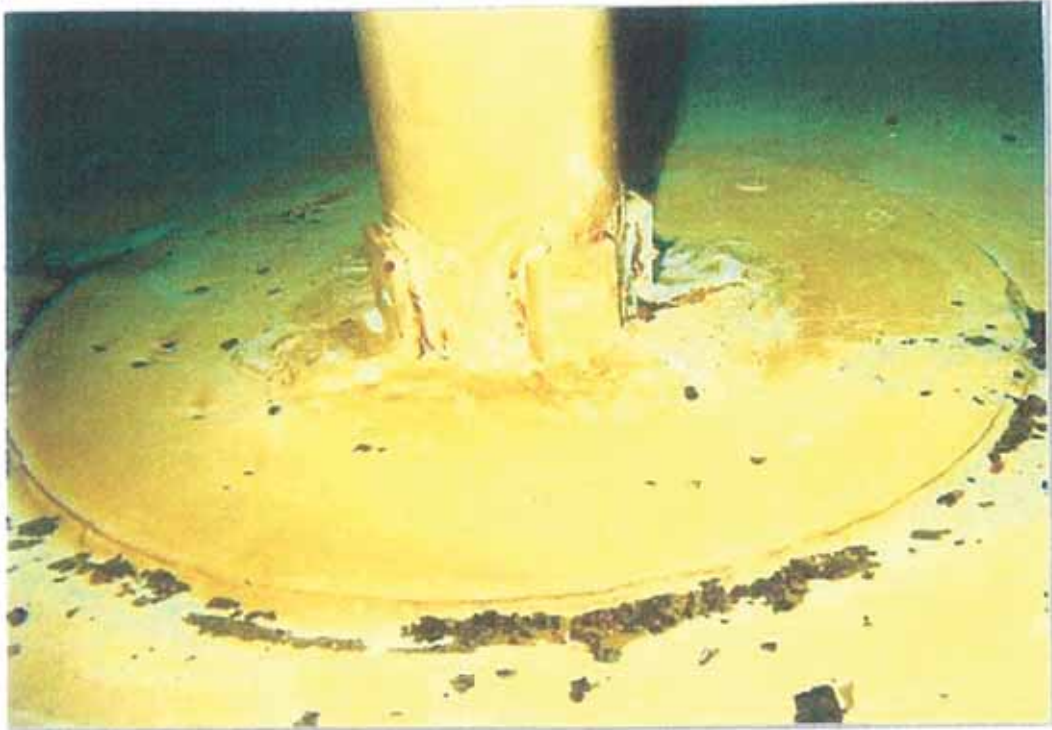
This is a view of the lower portion of the center column and base plate. Some rust points are visible on the column "clips" and sediment is visible on and around the base plate.

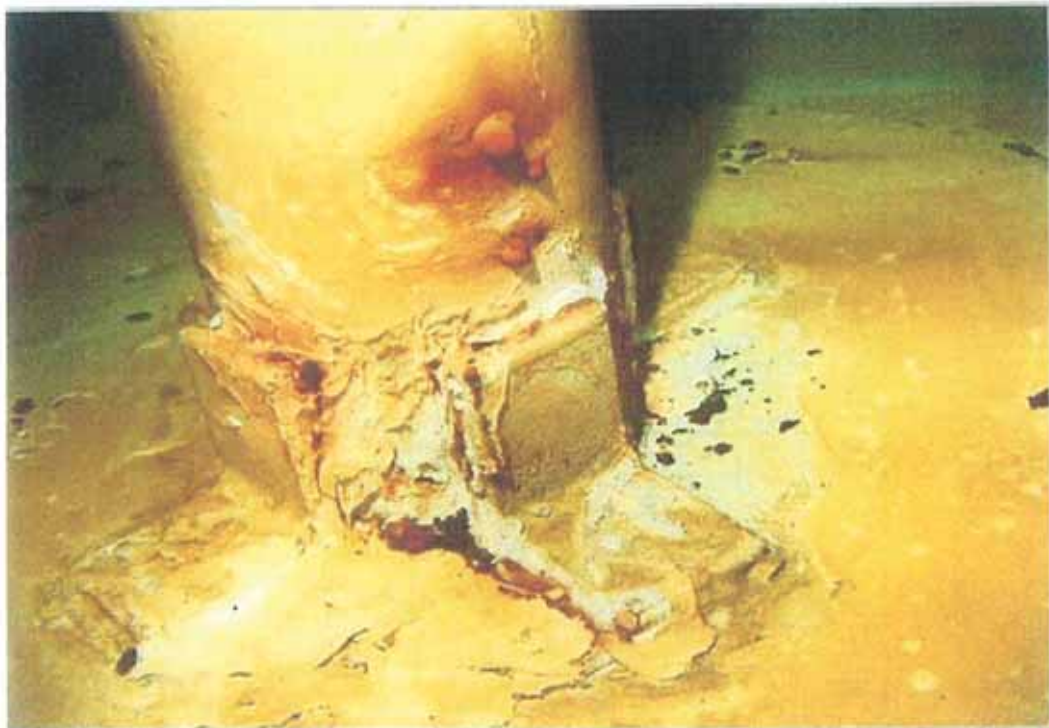
This view of the lower column shows some rust nodules that are present. The column has caulking in place to isolate inaccessible areas at the un-welded faying surfaces of the "floating" support.

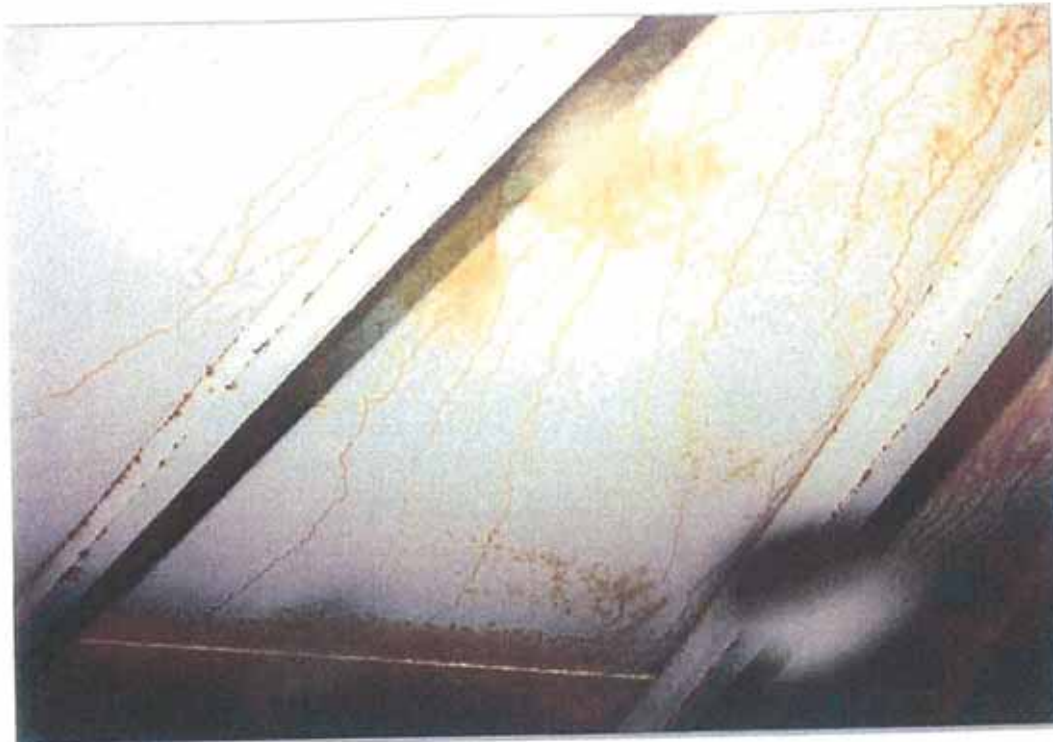
Roof plate and rafters as viewed from the water surface.
This view is typical of the conditions found with general corrosion and staining
on the roof plate and scattered-concentrated corrosion on the structure.

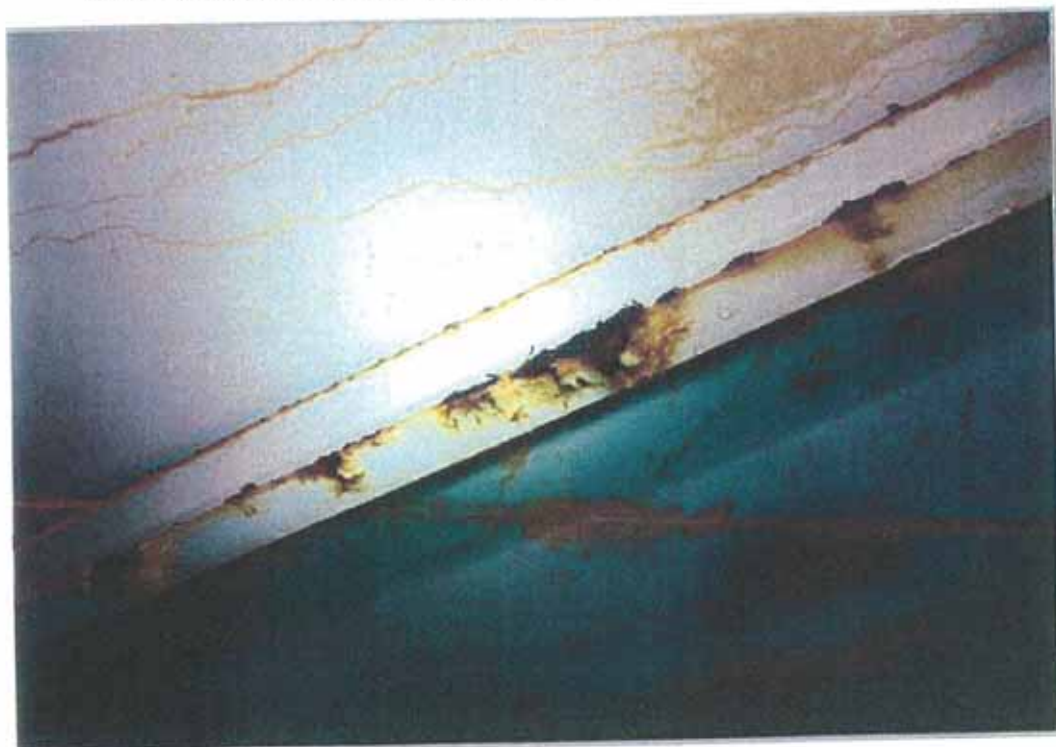
This view shows some of the aggressive corrosion that is present on the
roof structure.

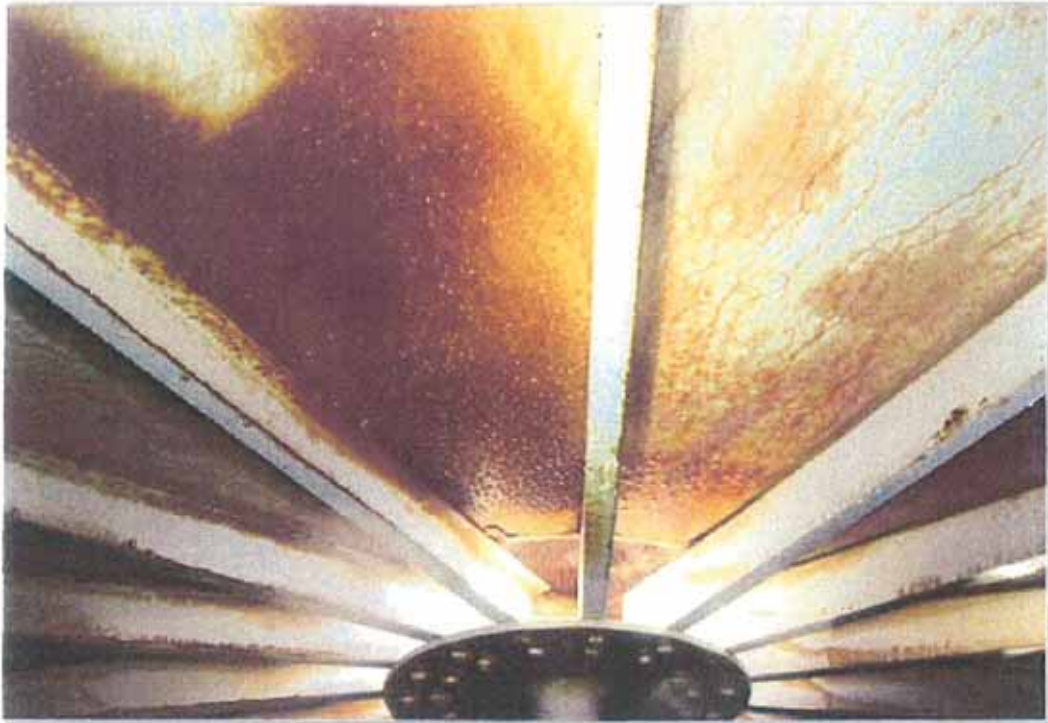
Roof plate, rafters and center support as viewed from the water surface. Serious general corrosion is present on the roof plate along with scattered-concentrated corrosion on the structure.

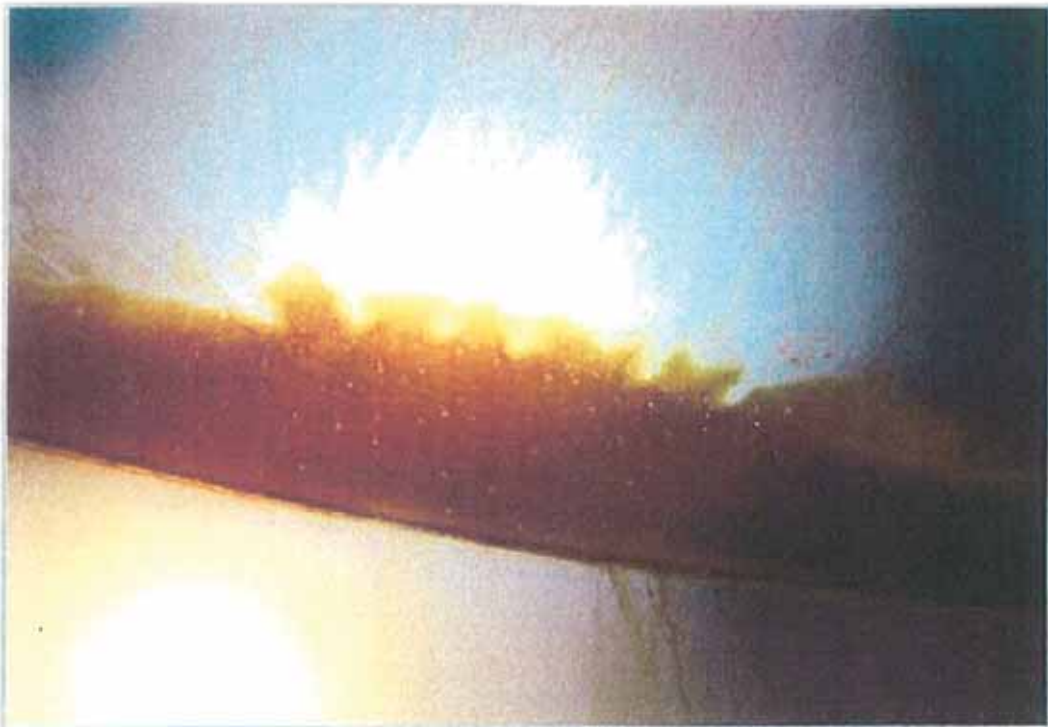
Interior roof plate and shell. Significant general corrosion is present on the roof plate where the coating has aged beyond its useful life.
