Council Agenda Report

Subject: OTR 16-004 - A request by Bruce Eisengart (property owner / applicant) to approve the removal of one 44-inch Valley Oak tree at 1803 Spring Street.

Date: October 4, 2016

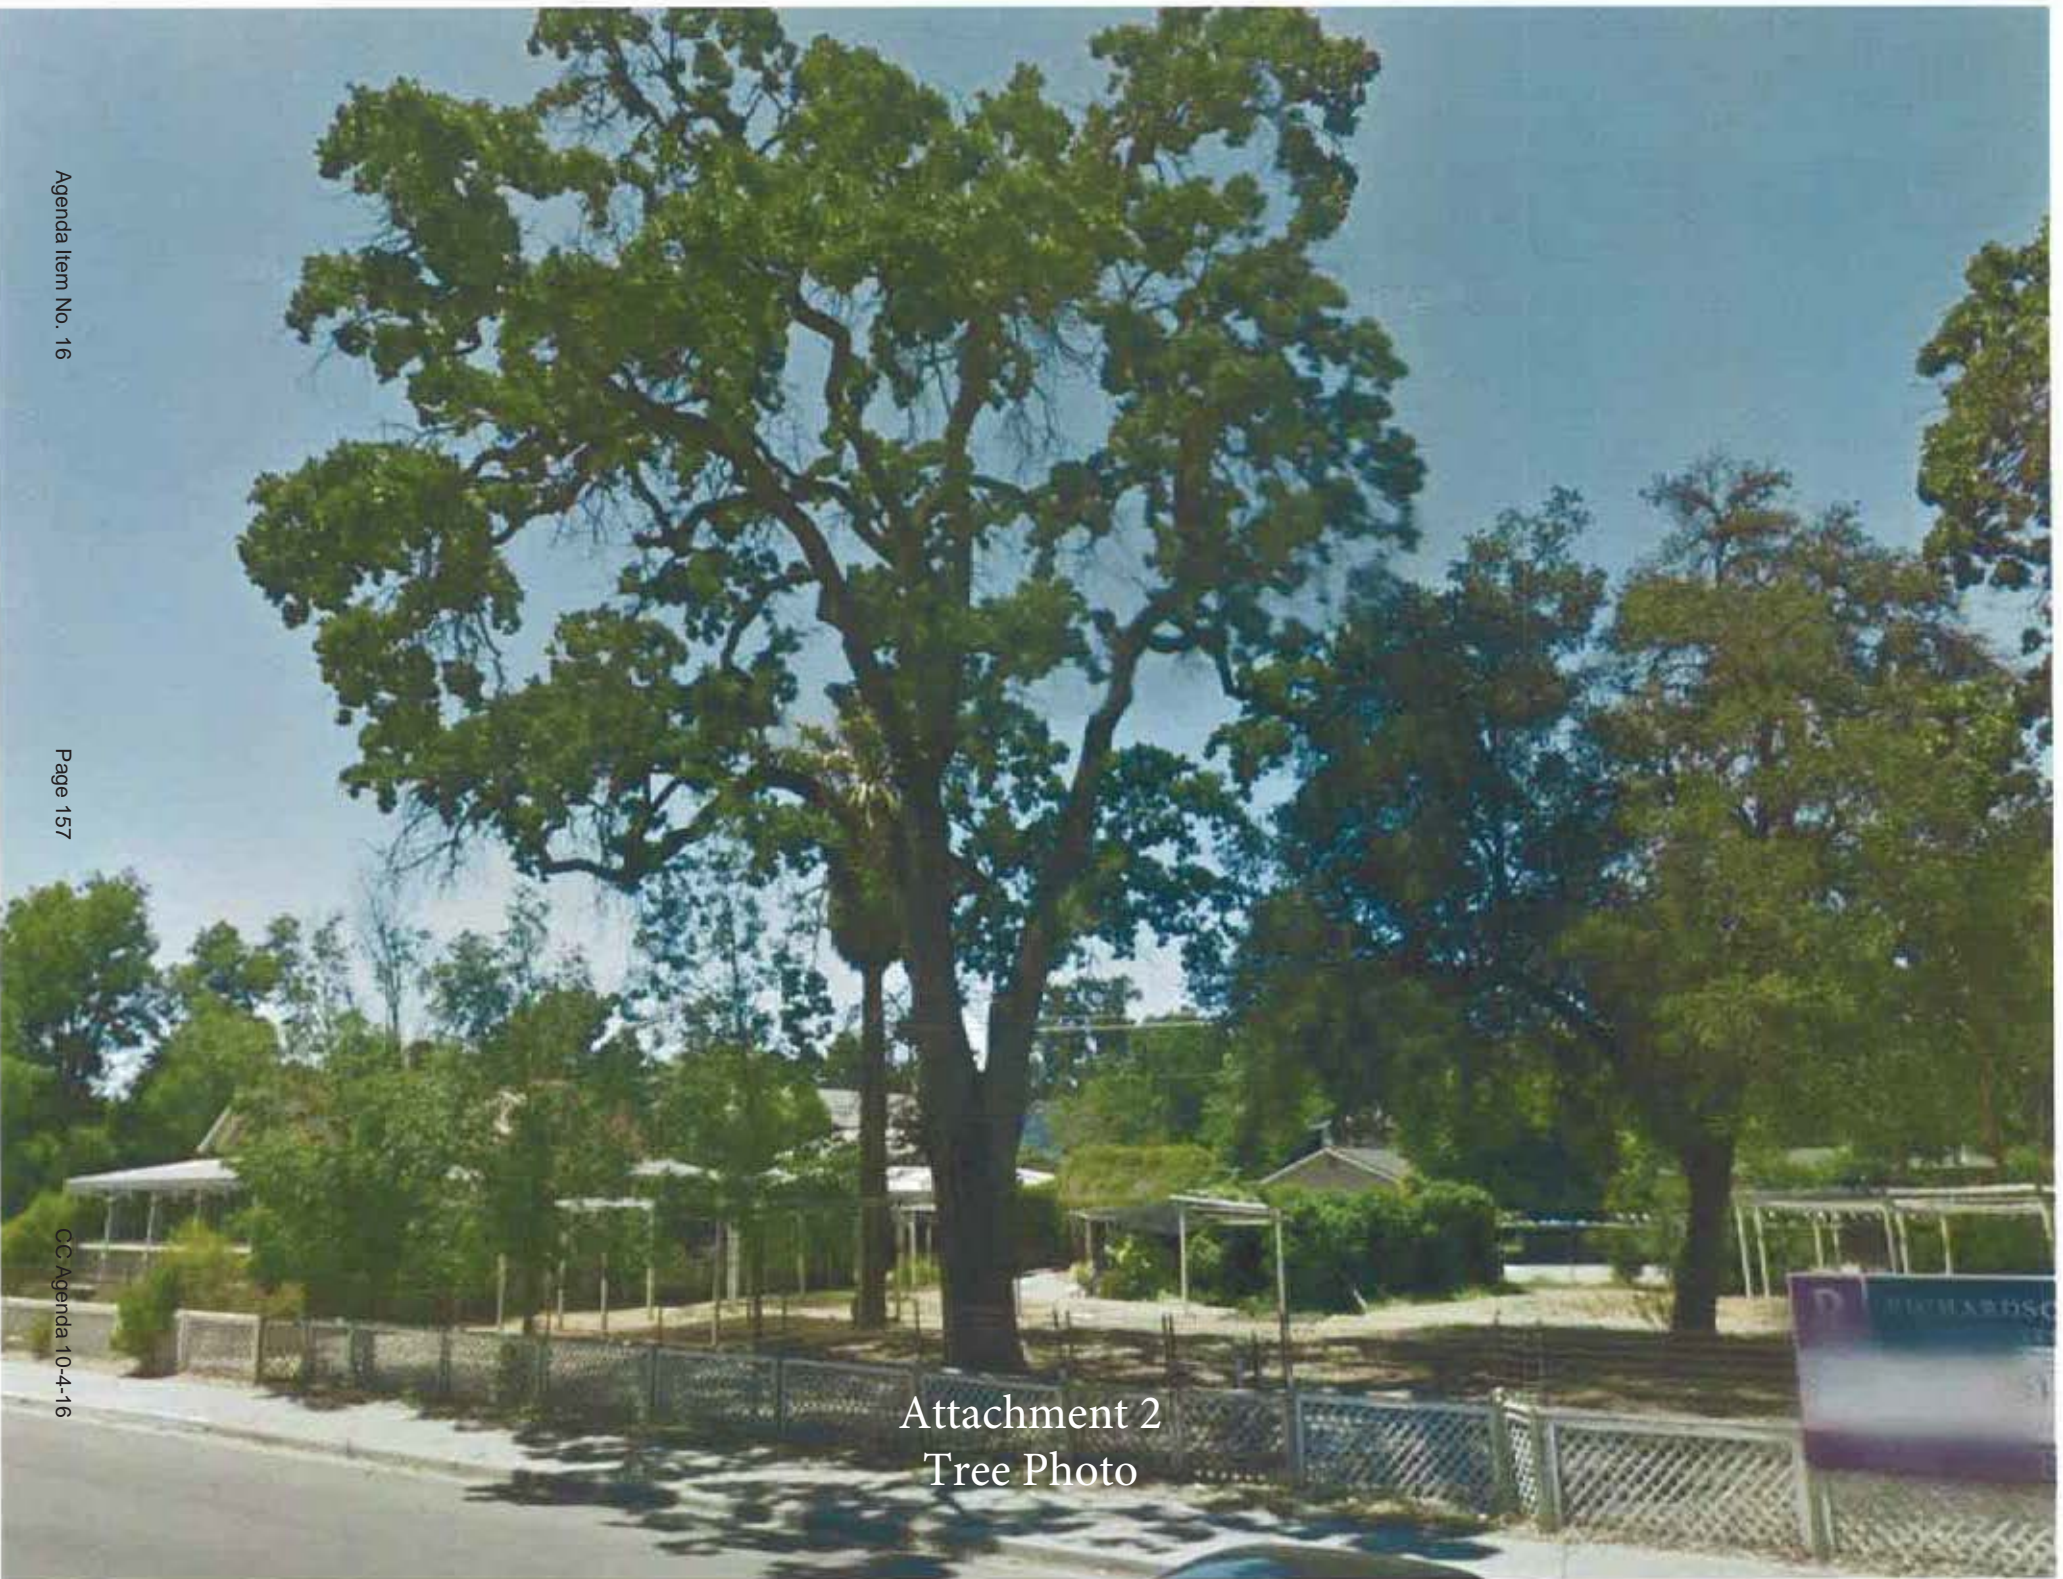
Attachment 2
Tree Photo

7. Planning Staff inspected the site to review the trees. Since the trees has a full canopy and health leaf growth the Director could not make the determination that the tree is "clearly dead or diseased beyond correction," and therefore, Section 10.01.050.C of the Oak Tree Ordinance would consider the tree "healthy" and require that the City Council make the determination of whether the tree should be removed or not, after consideration of the factors listed in Section 10.01.050.D.

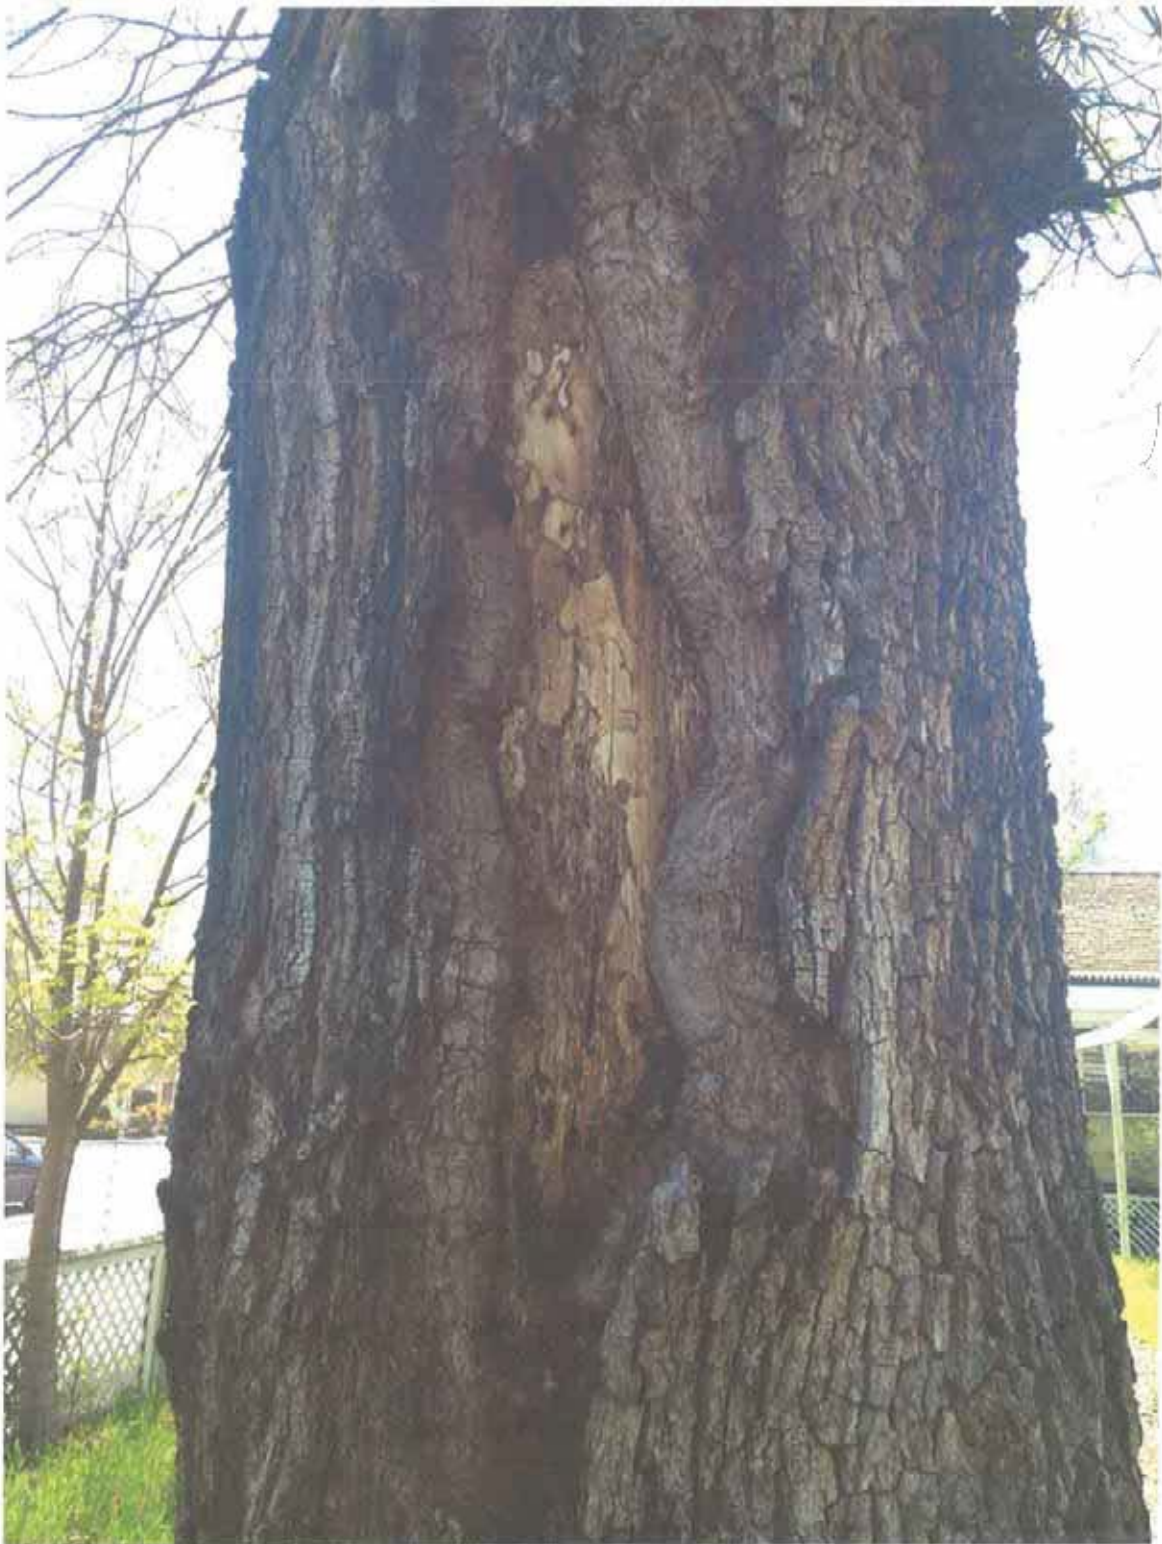
This report is in regard to the diseased 44" valley oak (*Quercus lobata*) located at the old hometown nursery site in the 18th block of Spring Street. We inspected the trees on this property many years ago for potential development and this tree concerned us back then as far as safety is concerned. The tree has a significant cavity that encompasses well over the 30% cross sectional threshold that would dictate it as a hazard tree. The cavity is located at about four feet above the ground as seen in the photograph. There are two nesting holes that extend deep into the cavity. Concern is that this tree may fail at this location which would result in entire tree failure. This consequences could be catastrophic as a large portion of this tree extends over Spring Street. We strongly recommend removal at this point in time. Pruning at this point in time will not sufficiently reduce the hazard.

Notice the nesting holes at the upper left and top of the cavity.

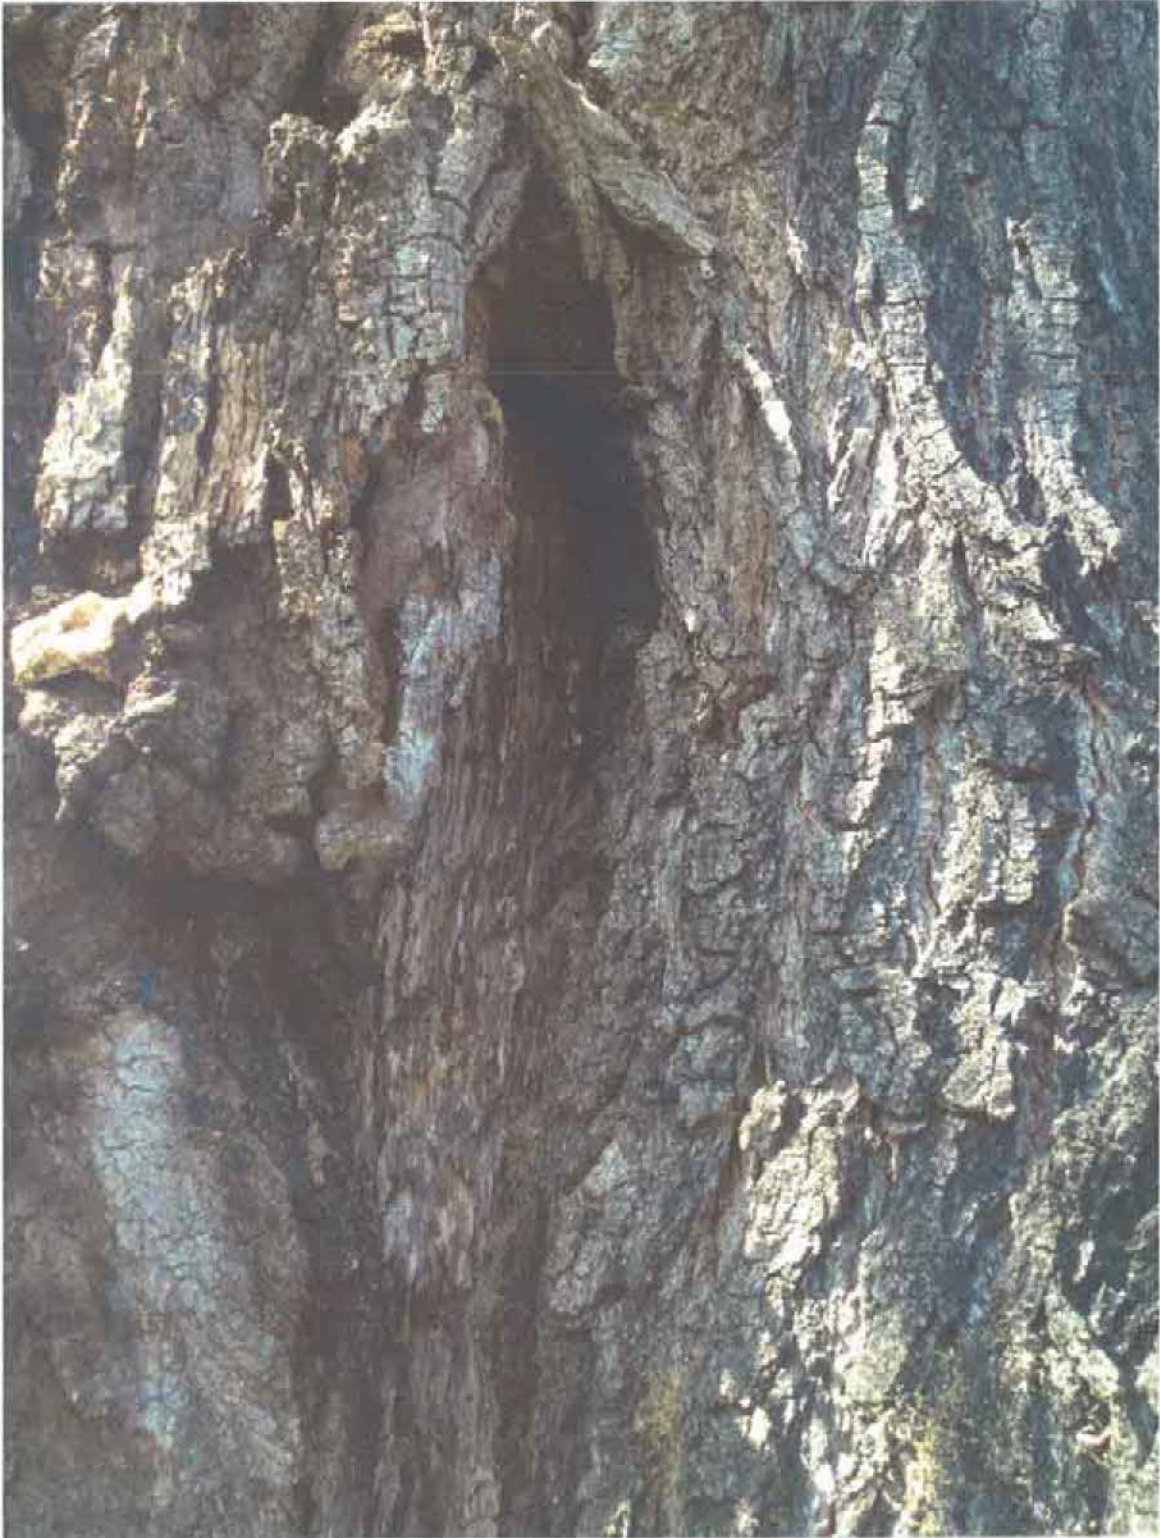
This view is from the backside of the tree illustrating the cavity extends through the entire trunk.

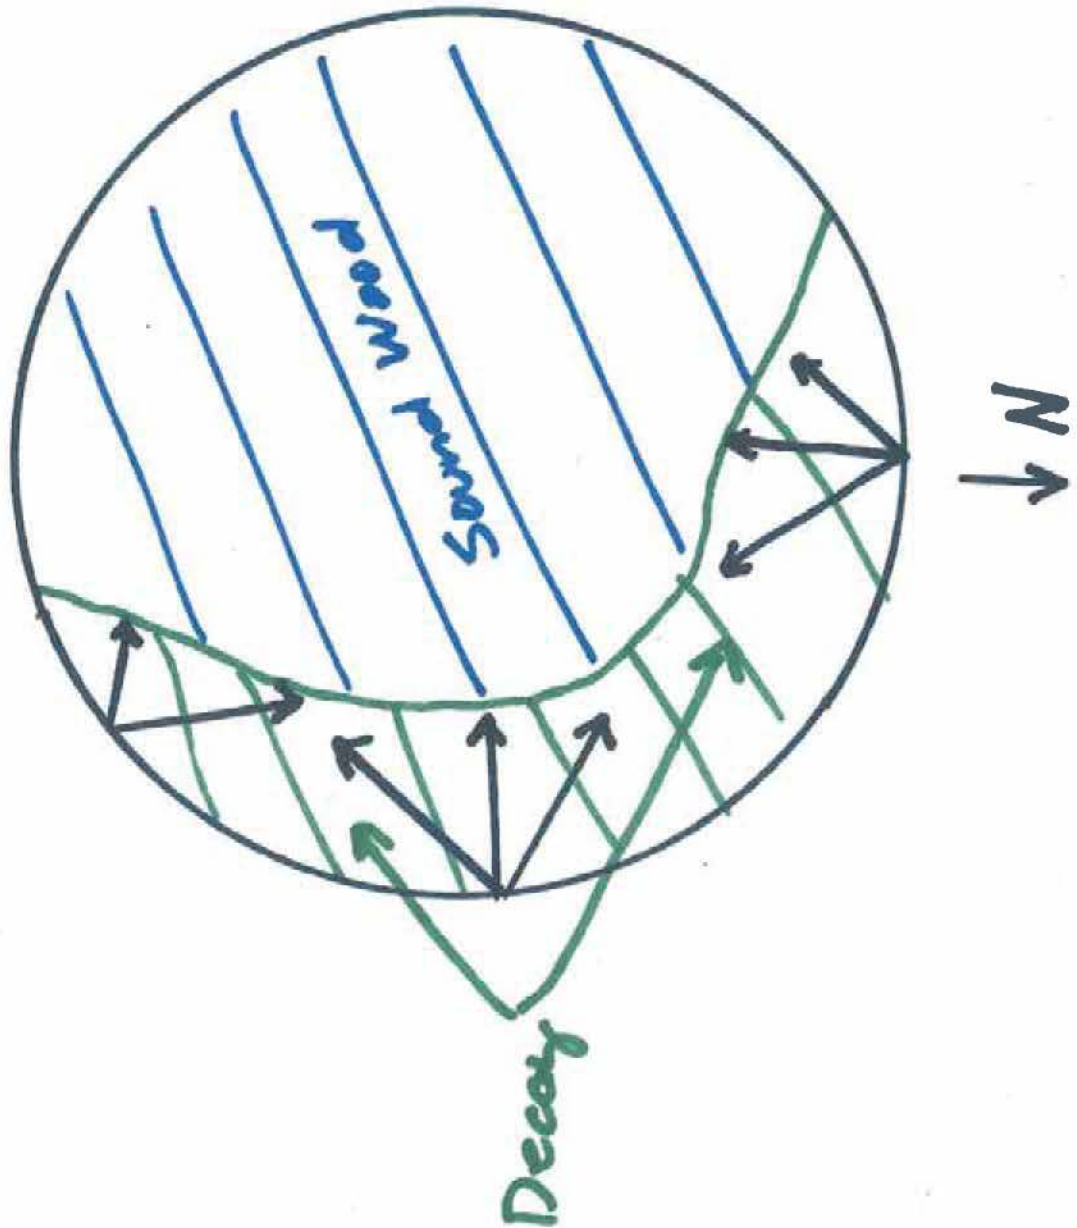
Old Hometown Nursery Valley Oak

- When drilling from the north facing cavity, sound wood was reached at 8" drilling to the southwest, 9 inches to the south and I buried the 12" drill and hit no sound wood when drilling to the south/southeast.
- When drilling from the eastern cavity, sound wood was reached at 8" when drilling due west, no sound wood was reached when drilling to the northwest, and no sound wood was found when drilling to the south west.

From the diagram, it appears that there is at least 25-30% decay across the plane of the tree. Most likely, the decay extends to at least 30% which is the ISA threshold for action to the tree. That action could be trimming to reduce weight which may prevent failure at this time, however, that may be "kicking the can down the road" if the tree continues to decay. Furthermore, the test drilling was done in one plane at approximately 4.5 feet above the ground. There most likely are additional pockets of decay either above or below the testing area. The tree appears to be trying very hard to compartmentalize this decay by trying to close up the wounds which could have been a result of excess water throughout the years when the nursery was in operation.

Included is a diagram illustrating the approximate locations of the decay at the 4.5 foot level. We feel this tree is potentially hazardous and consideration should be given to removing this tree before it collapses onto Spring Street.

While this tree is an aesthetically important tree, it appears to be in a hazardous condition from the testing that we performed. Granted, it is a difficult decision to remove it, however, public safety has to take precedence in this situation.
