Council Agenda Report

Subject: Oak Tree Removal Permit 17-004 (1600 Country Club Dr.) – Request to remove one hazard oak tree within Fairway No. 5 of the Paso Robles Golf Club.

Date: March 21, 2017

Exhibit A: Arborist Report

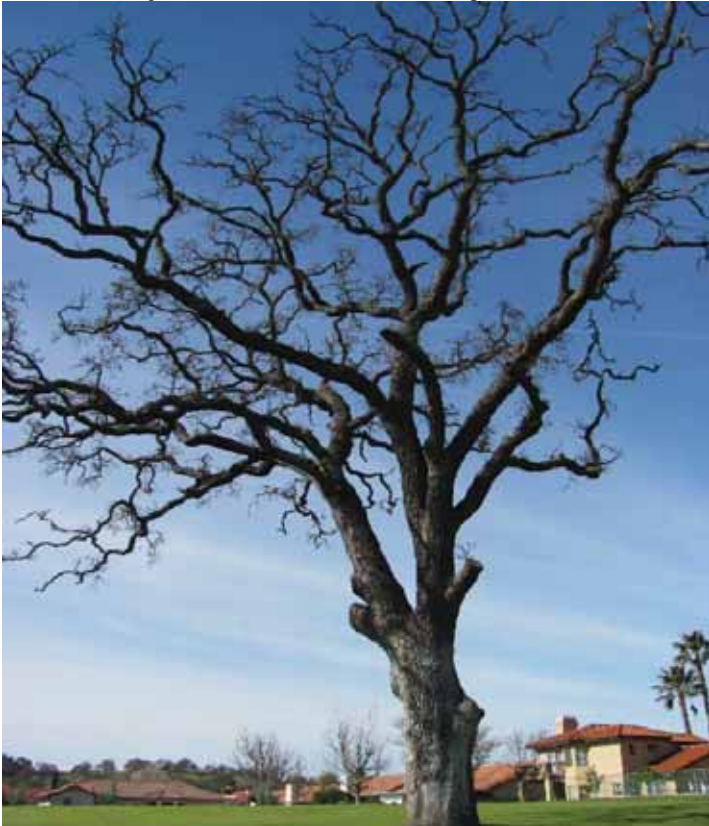
3. The Arborist indicates that tree is located in the middle of the fairway in a location where many golfers stop to hit their second shot. The report concludes that as a result of visible cavities, root crown stability, and other trunk and branch issues, the tree is in "imminent risk of sudden failure".

54-inch Valley Oak Tree (deciduous during winter) within Fairway No. 5

Approve Draft Resolution 17-xxxx, approving OTR 17-004, authorizing the removal of the 54-inch Valley Oak based on the trees being in poor condition with the potential for sudden failure as indicated in the Arborist Report; and require that ten 1.5-inch diameter Oak replacement trees (or a reduced number of larger diameter replacement trees adding up to 13.5-inches) be planted on site at the direction of the Arborist.

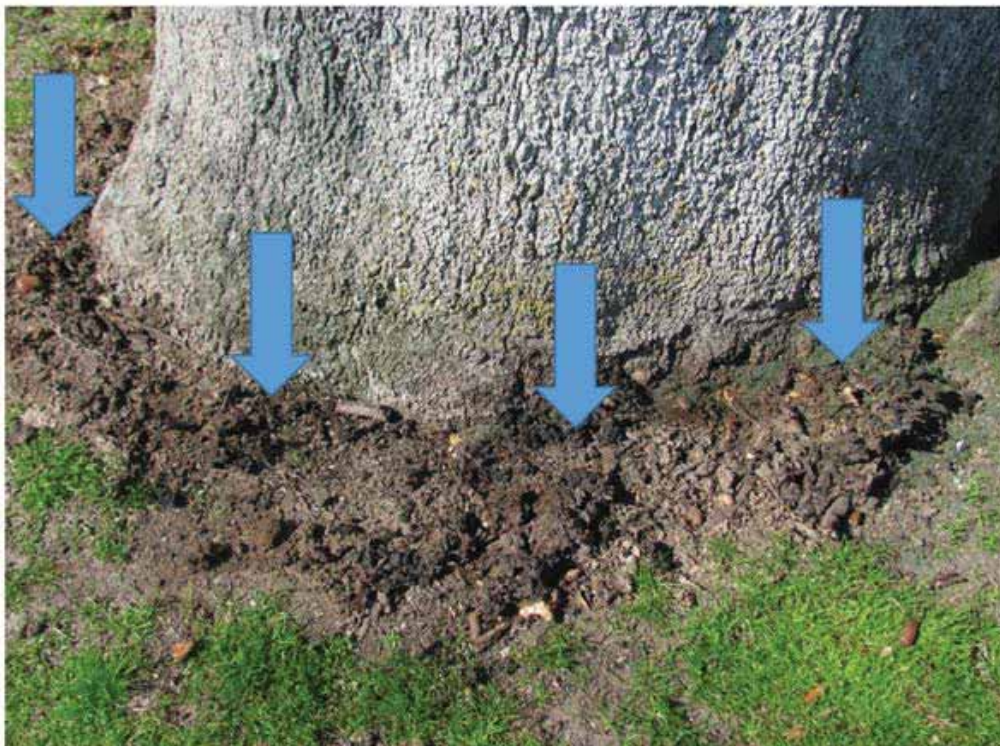
Photo of tree indicating rot at base of trunk

As shown in the photos and described by the Arborist, the tree shows signs of disease and is in danger of failing. Allowing the removal of the tree would seem to be consistent with finding D.1 below, based on the trees being in poor condition, and danger of the trees falling into the golf fairway where many golfers are present throughout the day.

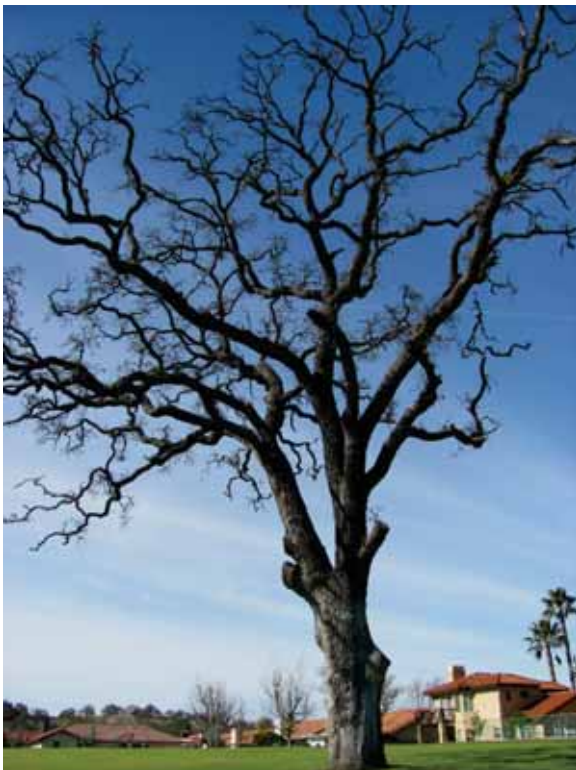
Of the 13 trees, I found one tree in particular that alarmed me with its severe degree of structural deterioration. This tree is located on hole #5, and is the subject of my 3/7/17 letter to Mr. Mike Rawitser, a copy of which I am attaching to this letter. It is also pictured in the photo here.

The tree is a Valley oak with a 54" trunk diameter. It is located in the middle of the fairway just where the hole turns to the right. This location is where most golfers first shot lands from the #5 tee, so is frequently occupied by golfers all day long. Additionally, employees are frequently passing below the tree.

My recommendation to the property owners is to remove the tree as soon as possible.

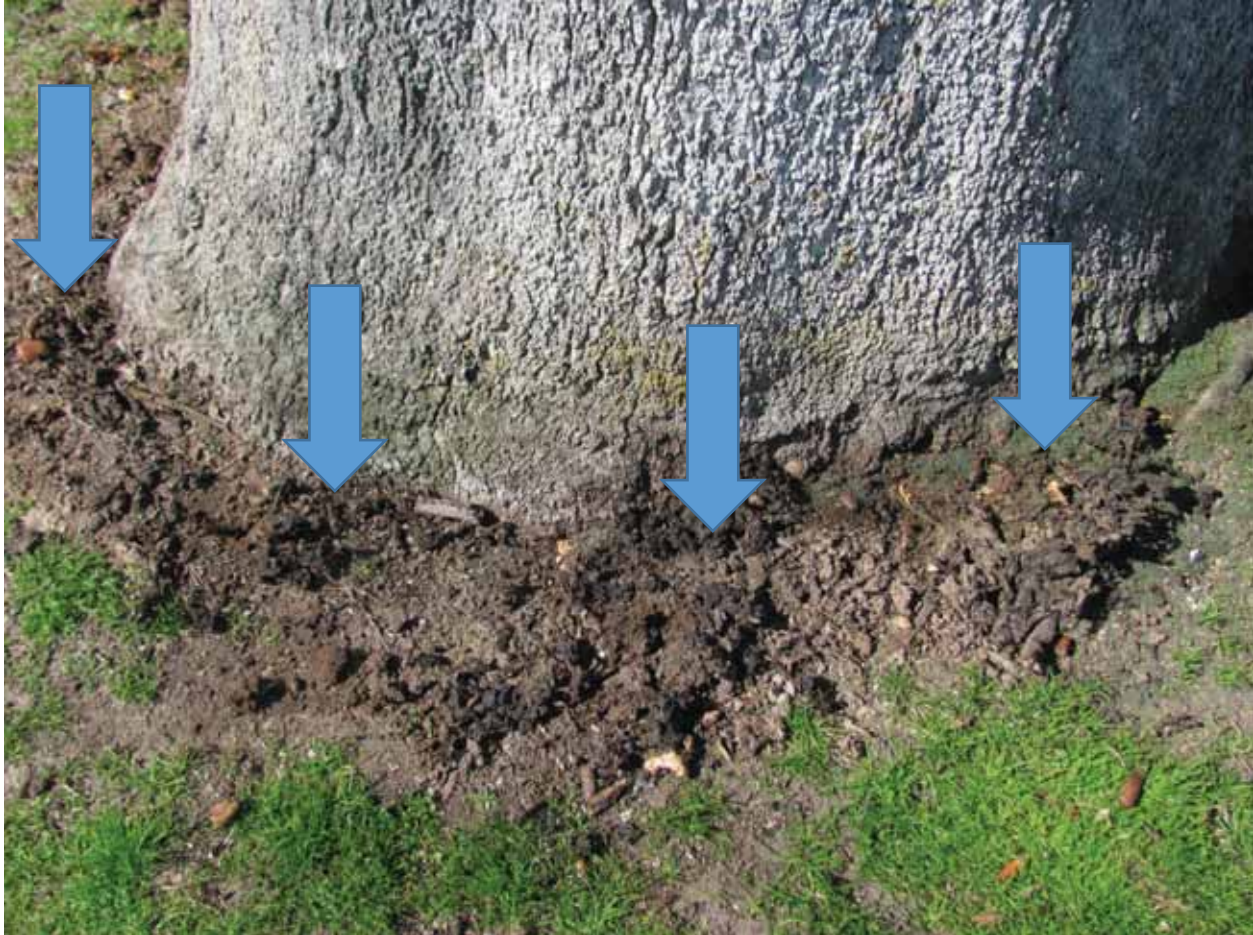
I found at least four clusters of dried mushrooms that are most likely Oak root rot disease, *Armillaria mellea*. The photo above of the base of the tree above with the dried mushrooms indicated by the arrows.

The clusters were located on about 75% of the trunk circumference. When I chipped into the bark at the trunk base, I found the entire bark and inner sapwood to be rotted by the disease.

From the little amount of twigs developed in the canopy last year, the tree has been suffering from this disease for some time now.

This tree will die from this amount of infection.

In the meanwhile, the tree is in extremely high likelihood of falling over. The disease is rotting away all of the structural root support. It is highly hazardous.

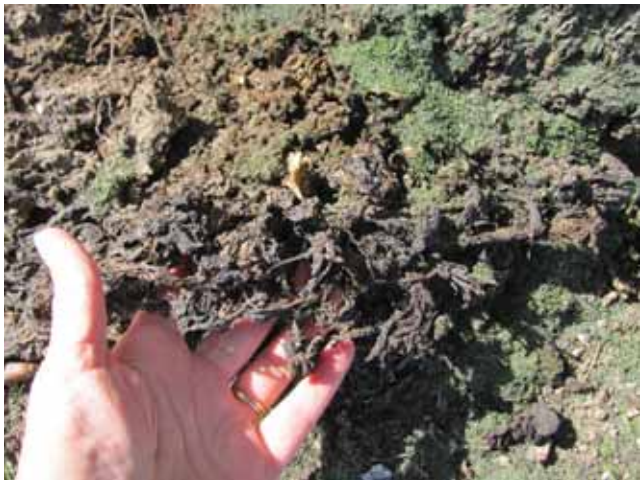
Here is a photo of me holding one of the mushroom clusters.

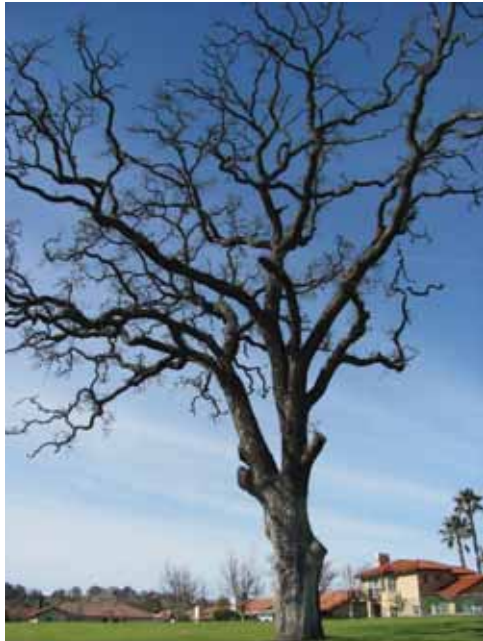
During my inspection, I found a tree in such poor condition that I immediately gave you my verbal opinion that it is in **imminent risk of sudden failure**. This tree, shown in this photo, is in the middle of the #5 fairway. It is a *Quercus lobate* with a 54" trunk diameter. The entire circumference of the root crown area, where the trunk meets the ground, is decayed.

I dug down below soil level all around the tree base and found it entirely rotted. Additionally, I saw the remains of 4 clusters of mushrooms which appeared to be *Armillaria mellea*, also known as oak root fungus. This decaying disease infects the woody roots as well as the root crown area, leaving behind pulpy textured wood with no holding capacity.

I am shocked that the tree is still standing with that vast amount of decay.

Please remove this tree as soon as possible.

Until the tree is removed, I suggest roping off the area with caution tape, to alert the golfers and your employees of the risk.
