Council Agenda Report

Subject: Oak Tree Removal Permit 17-014 (Dallons Drive – Leo Tidwell III)
Council consideration of OTR 17-014 a request to remove two oak trees (Tree Nos. 2 and 3) located west of the intersection of Dallons Drive and Golden Hill Road (APN 025-423-003).

Date: September 7, 2017

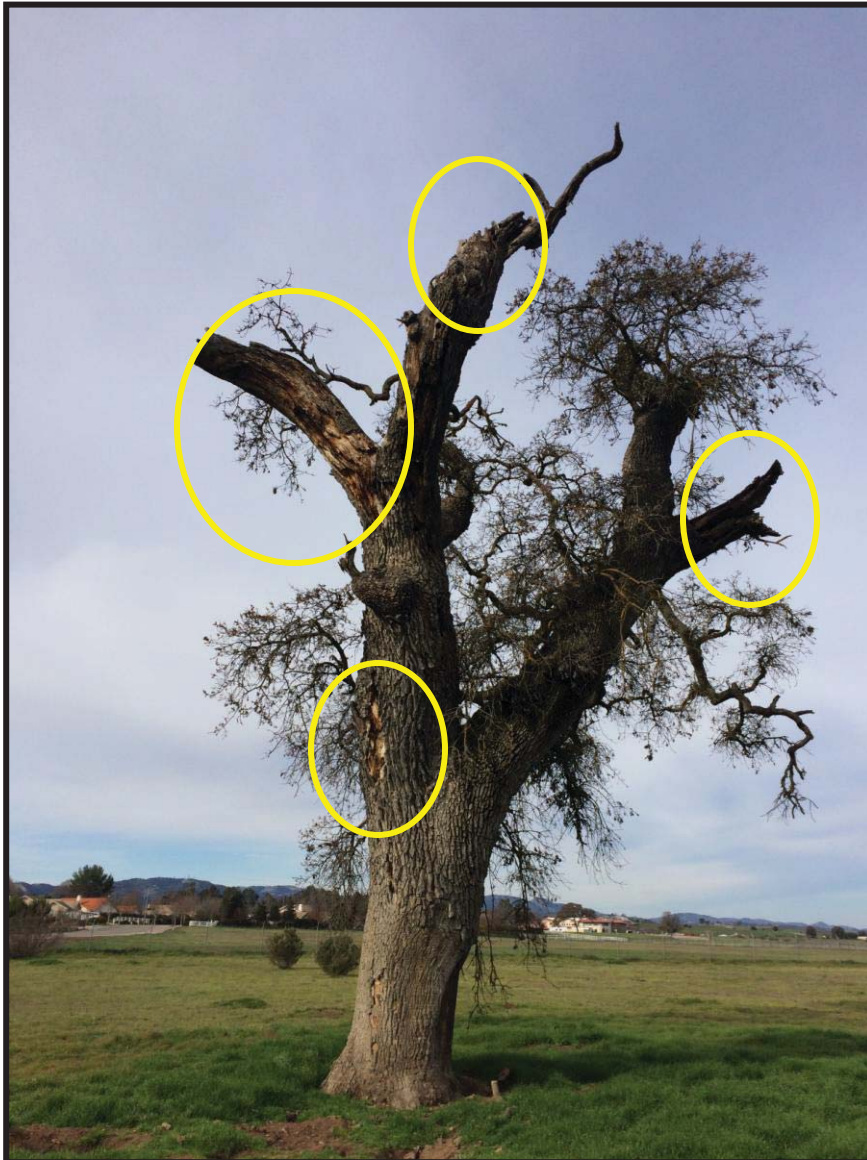
Tree # 1 has a rating of very poor. This tree is growing in what was once agricultural land used for farming and grazing. Because of these uses this trees' root zone was likely damaged by vehicle activity, plowing and or animal activity. It does not appear that any damage that would have caused these trees to decline was caused by the current owner.

Injuries to the roots allowed decay fungus to enter the root. Over a period of years the decay fungus has advanced and caused a large decay cavity in the lower trunk and root flare on its north side. The decay extends 64 inches up from the ground and has a width of 42 inches. The total circumference of the trunk is 170 inches, which means approximately 25% of the exterior of the trunk is compromised. The actual internal decay is typically advanced at least 1/3 greater than the visible decay area.

At this point the structural integrity of the anchor roots and the lower stem of the tree have been compromised. Drought conditions over the last 5 years have also contributed to this trees' decline. This is indicated by twig dieback on the extremities of the tree branches as well as loss of entire branches in the upper canopy. Approximately 25 percent of less of the trees original canopy remains.

Photo 2- Tree #1 Areas of major decay and scaffold failure

There is no way to mitigate hazards through pruning. Cultural improvements in the critical root zone (CRZ) such as aeration, mulching and irrigation are unlikely to revive this tree. If cultural improvements were to work, the structure of the tree is not sound enough to support additional canopy weight.

Trees 1 through 3 are in advanced stages of decline and present safety hazards that cannot be mitigated by pruning. Cultural improvements, could improve the vigor of these trees but the structure of the trees would not support the growth. I recommend removal of these trees.

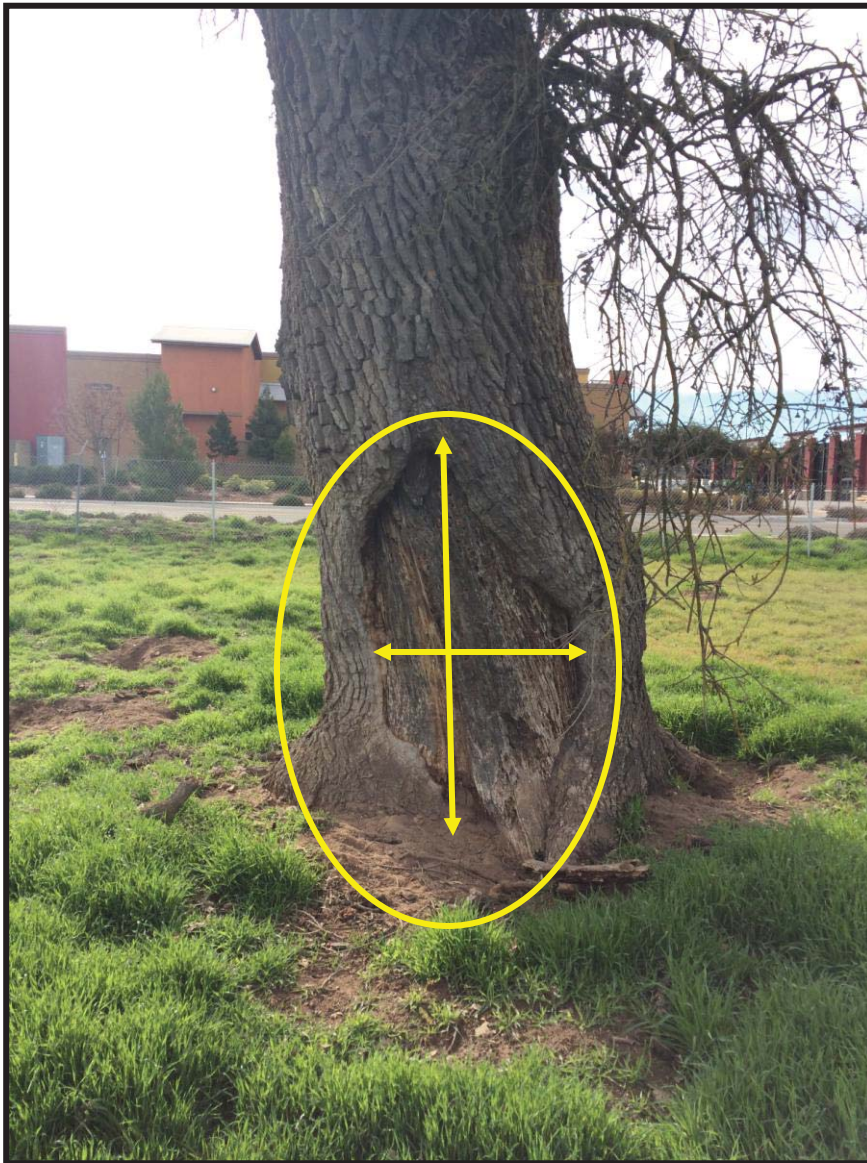
Photo 4- Tree #1- Decay cavity on north side of tree measures 64" x 42"

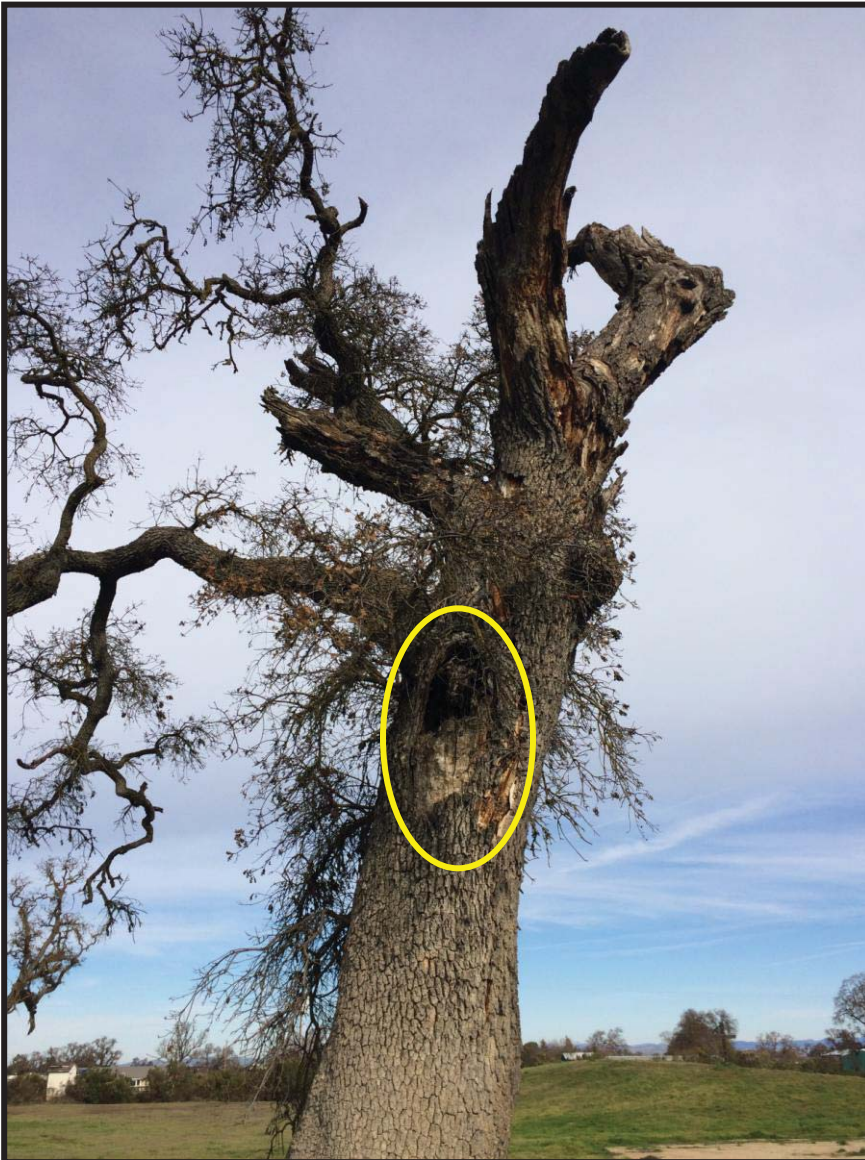
Photo 5- Tree #1- Large area of decay in stem approximately 36" by 18".

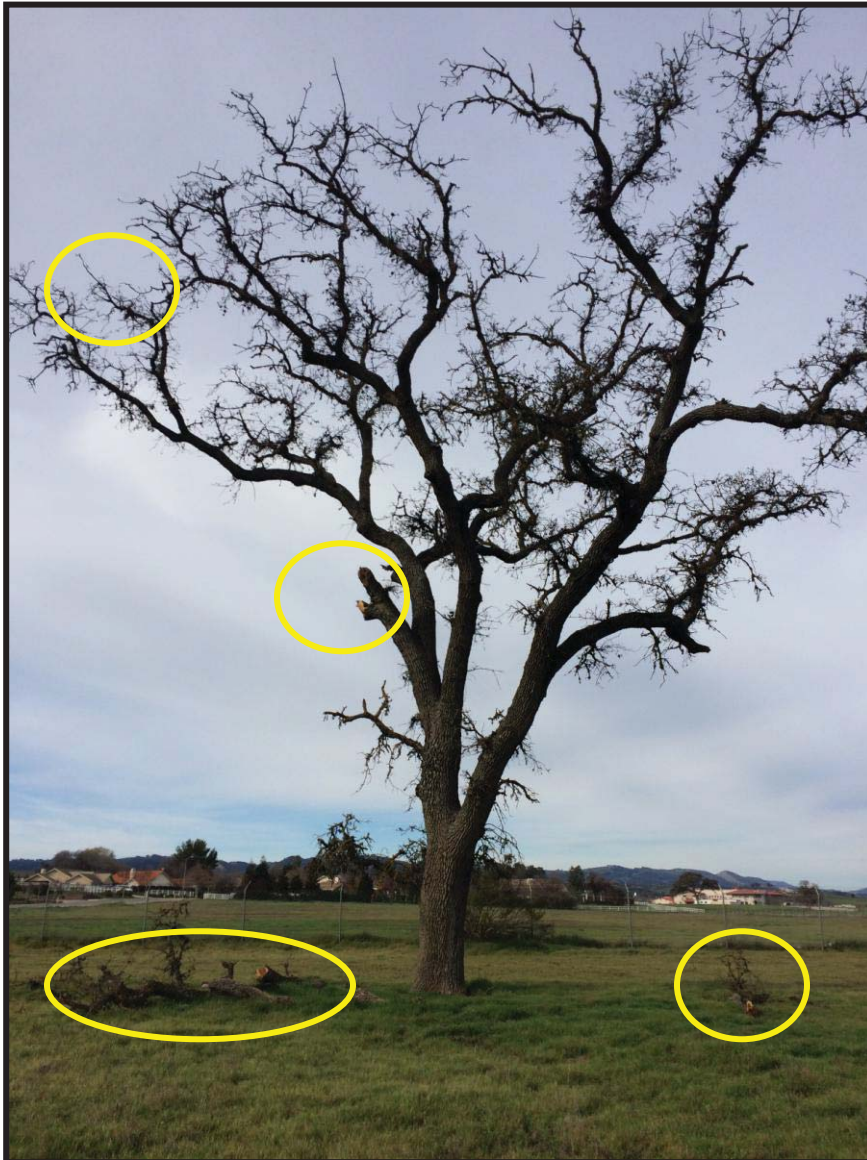
Tree #2 has a rating of very poor. This tree is growing in what was once agricultural land used for farming and grazing. It does not appear that any damage that would have caused these trees to decline was caused by the current owner.

No damage to the structural roots is apparent. The roots in the CRZ although not exposed or visibly damaged, and do not have a favorable environment. No natural mulch from tree debris is present in any significant amount. Without mulch to protect the fine hair roots that transport moisture through the tree, the roots become dehydrated and die.

Due to the reduced feeder roots the canopy has also begun to decline. This is evident in twig, branch and scaffold dehydration and death. Several dead branches have been shed from the tree and are lying on the ground below. Young shoot growth is also poor or dead. The trunk of the tree appears to be in stable condition with no visible defects or decay.

Photo 5- Tree 2. Declining canopy, decreased shoot growth and failed scaffold branches.

There is no way to mitigate hazards through pruning. Cultural improvements in the CRZ such as aeration, mulching and irrigation are unlikely to revive this tree. If cultural improvement were to work, the structure of the tree is not sound enough to support additional canopy weight.

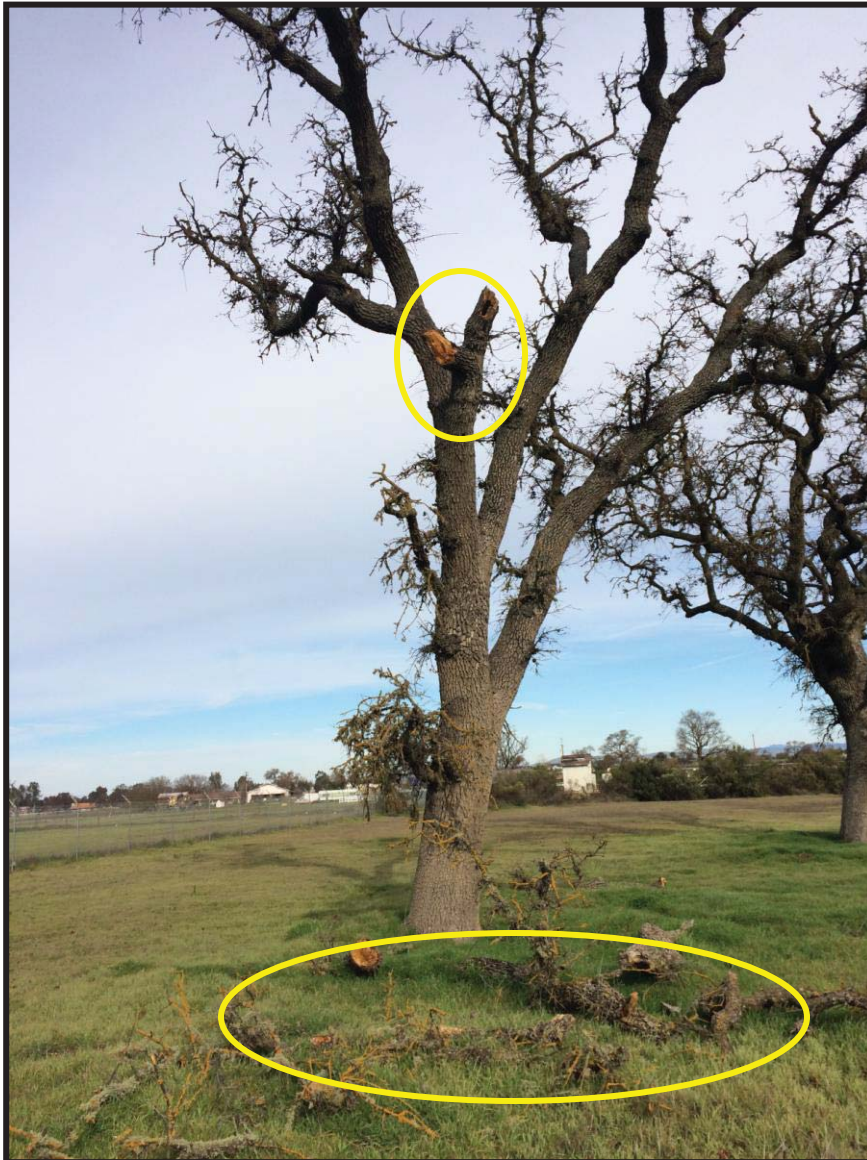
Photo 6- Tree 2. Close up of failed scaffold branches

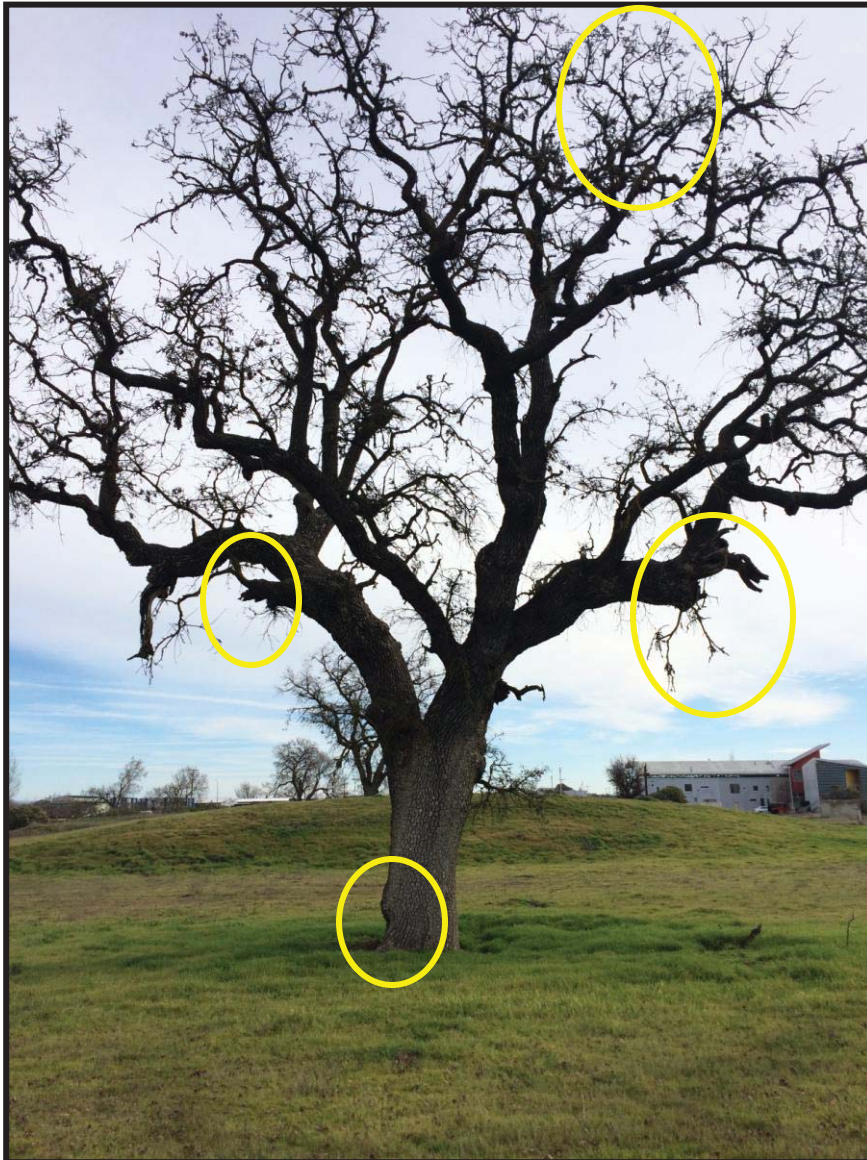
Tree #3 has a rating of very poor. This tree is growing in what was once agricultural land used for farming and grazing. It does not appear that any damage that would have caused these trees to decline was caused by the current owner.

Drought conditions over the last 5 years have also contributed to this trees' decline. This is indicated by twig dieback on the extremities of the tree branches as well as loss large branches in the upper canopy. There is no way to mitigate hazards through pruning. Cultural improvements in the CRZ such as aeration, mulching and irrigation are unlikely to revive this tree. If they did, the structure of the tree is not sound enough to support additional canopy weight.

Photo 7- Tree 3. Declining canopy, decaying and failed scaffold branches, decreased shoot growth, trunk decay.

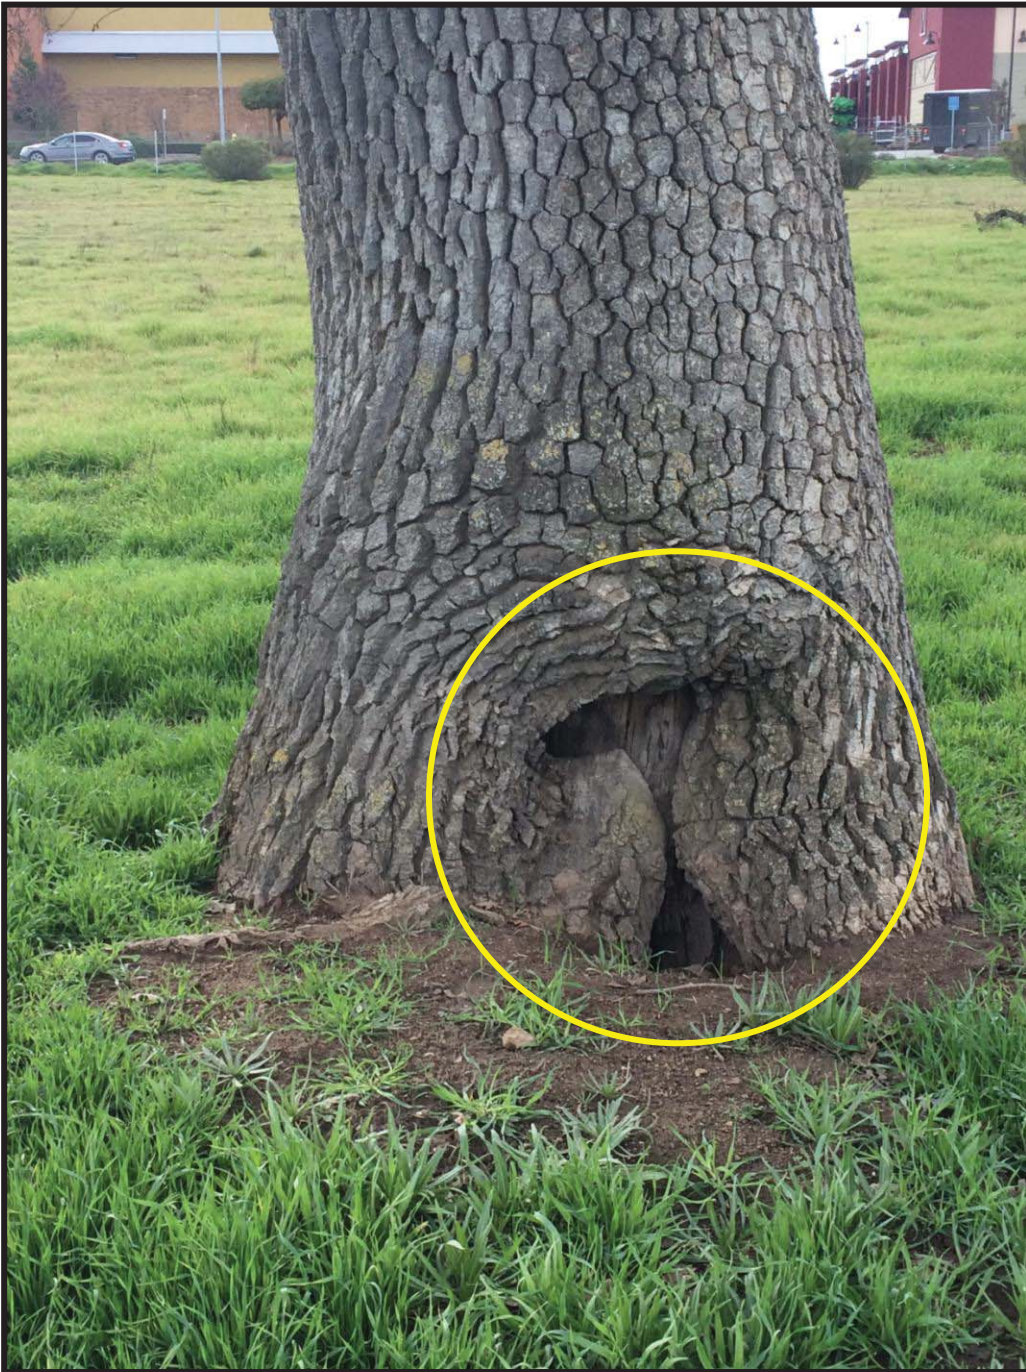
Because of the farming activity, this trees' root zone could have become damaged by vehicle activity, plowing and animal activity. The tree has a large decay cavity in the lower trunk and root flare on its north side. The decay cavity measures 2 foot by 1 foot 3 inches. Decay most likely entered the tree through a root wound that occurred many years ago. At this point the structural integrity of the anchor roots and the lower stem of the tree have been compromised.

Photo 8- Tree #3. Decay cavity on north side of tree. Measures 24" x 15"

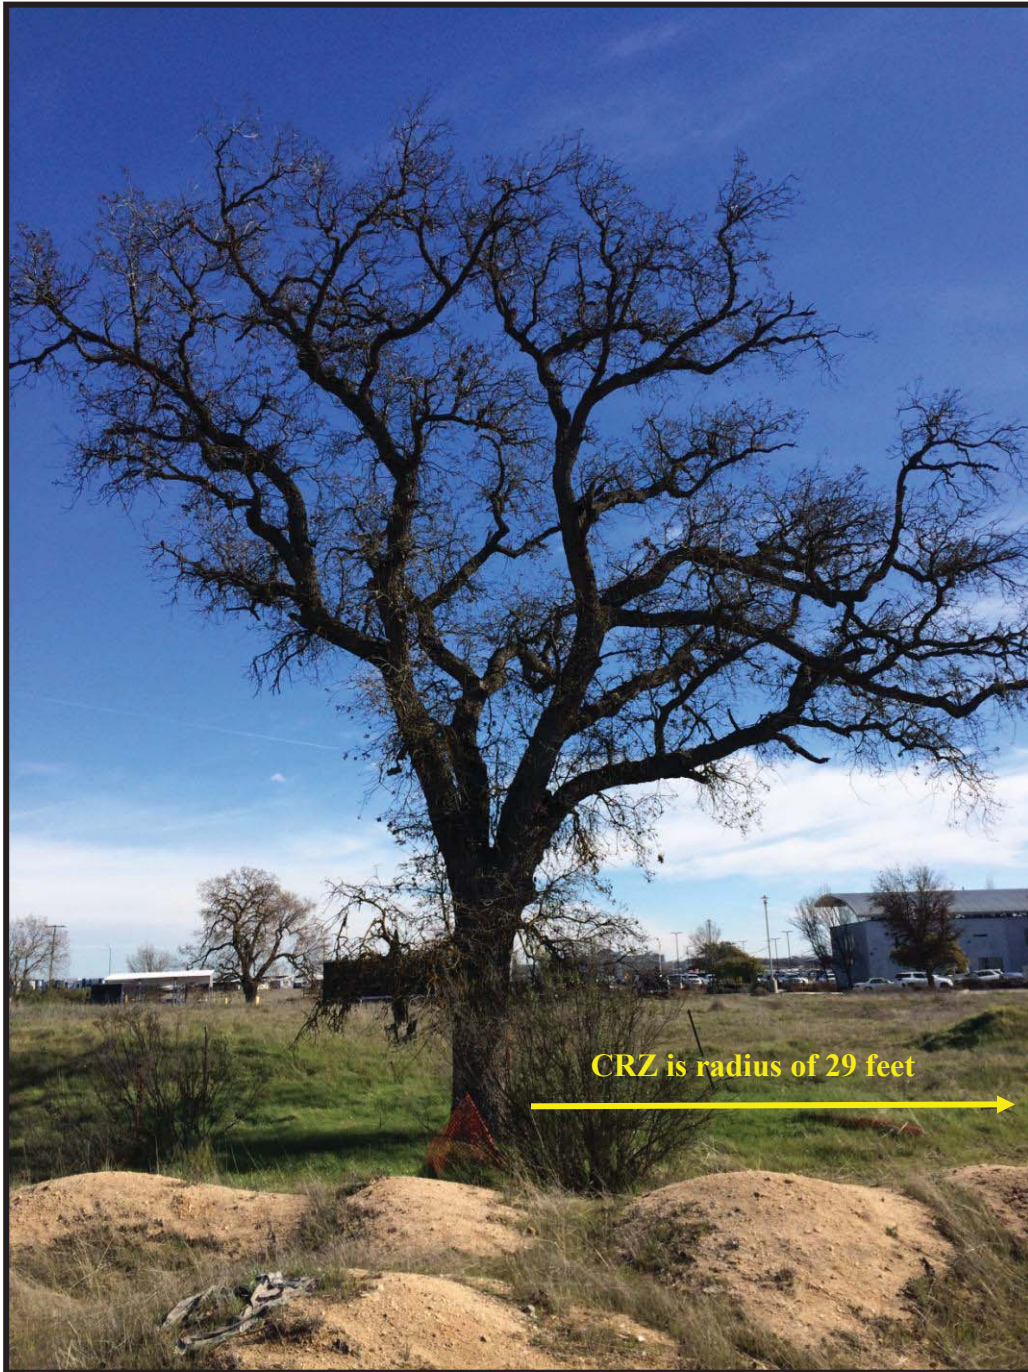
Tree #4 has a rating of fair. This tree is moderately drought stressed. Multiple years of drought has contributed to the moderate decline of this tree, indicated by twig die back in the canopy and decline of smaller diameter branches ranging between 2 and 4 inches. It does not appear that any damage that would have caused these trees to decline was caused by the current owner.

Photo 9- Tree # 4. Declining canopy, decreased shoot growth, small diameter branch die-back.

With proper pruning and cultural improvements to the root zone this tree could be a viable asset to the property. During construction, the tree will need tree protection fencing to ensure no damage occurs in the CRZ. The CRZ for this tree is a radius of 29 feet measured from the trunk outward past the drip-line of the tree.

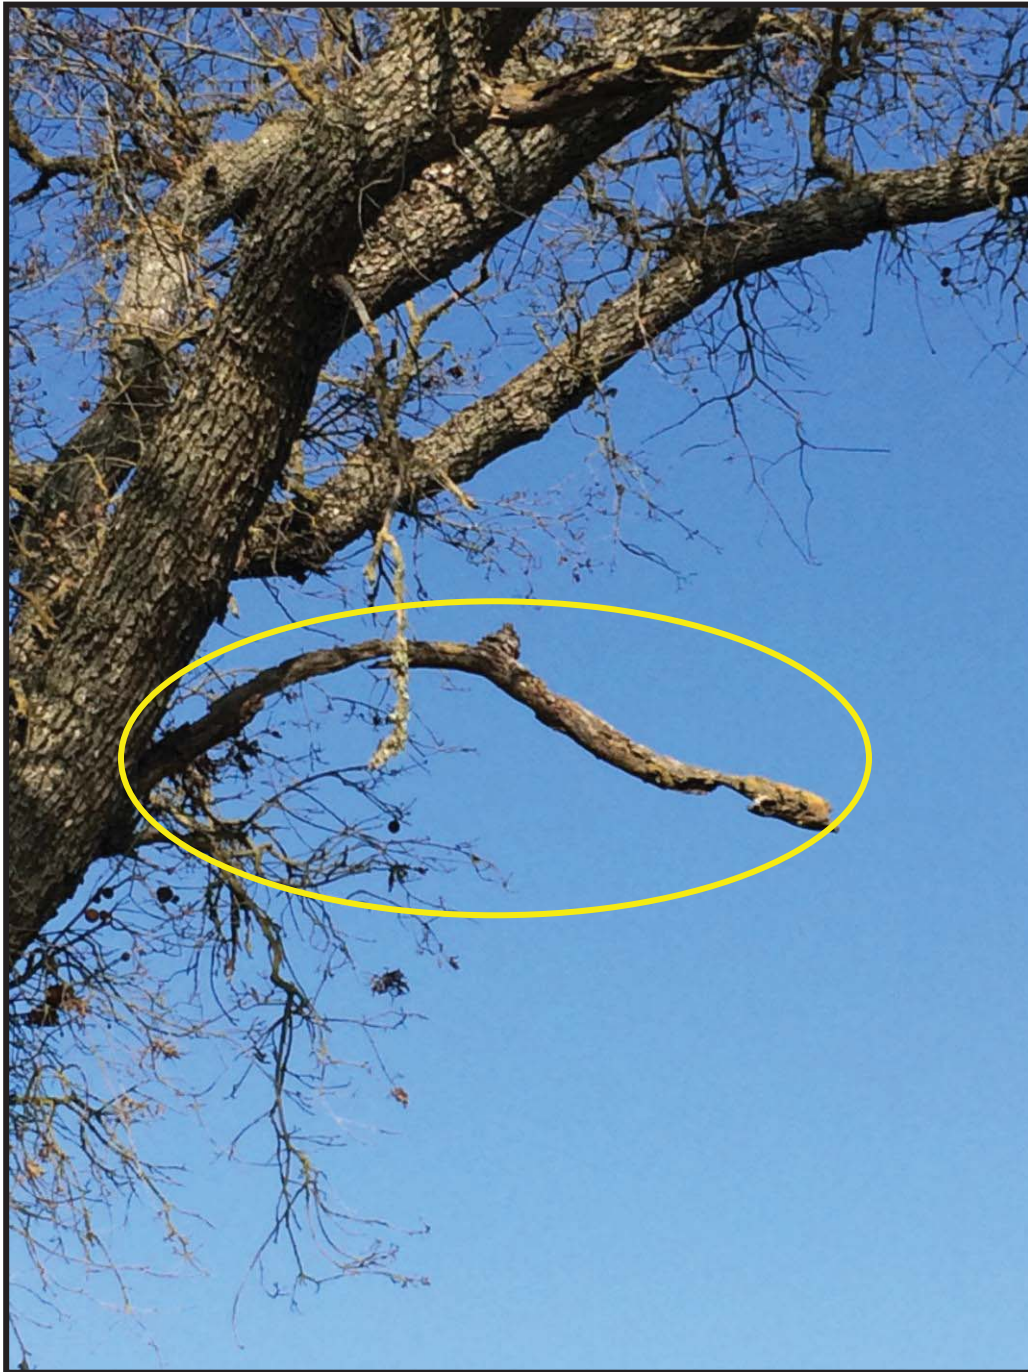
Photo 10 - Tree #4. Small diameter branch die-back.

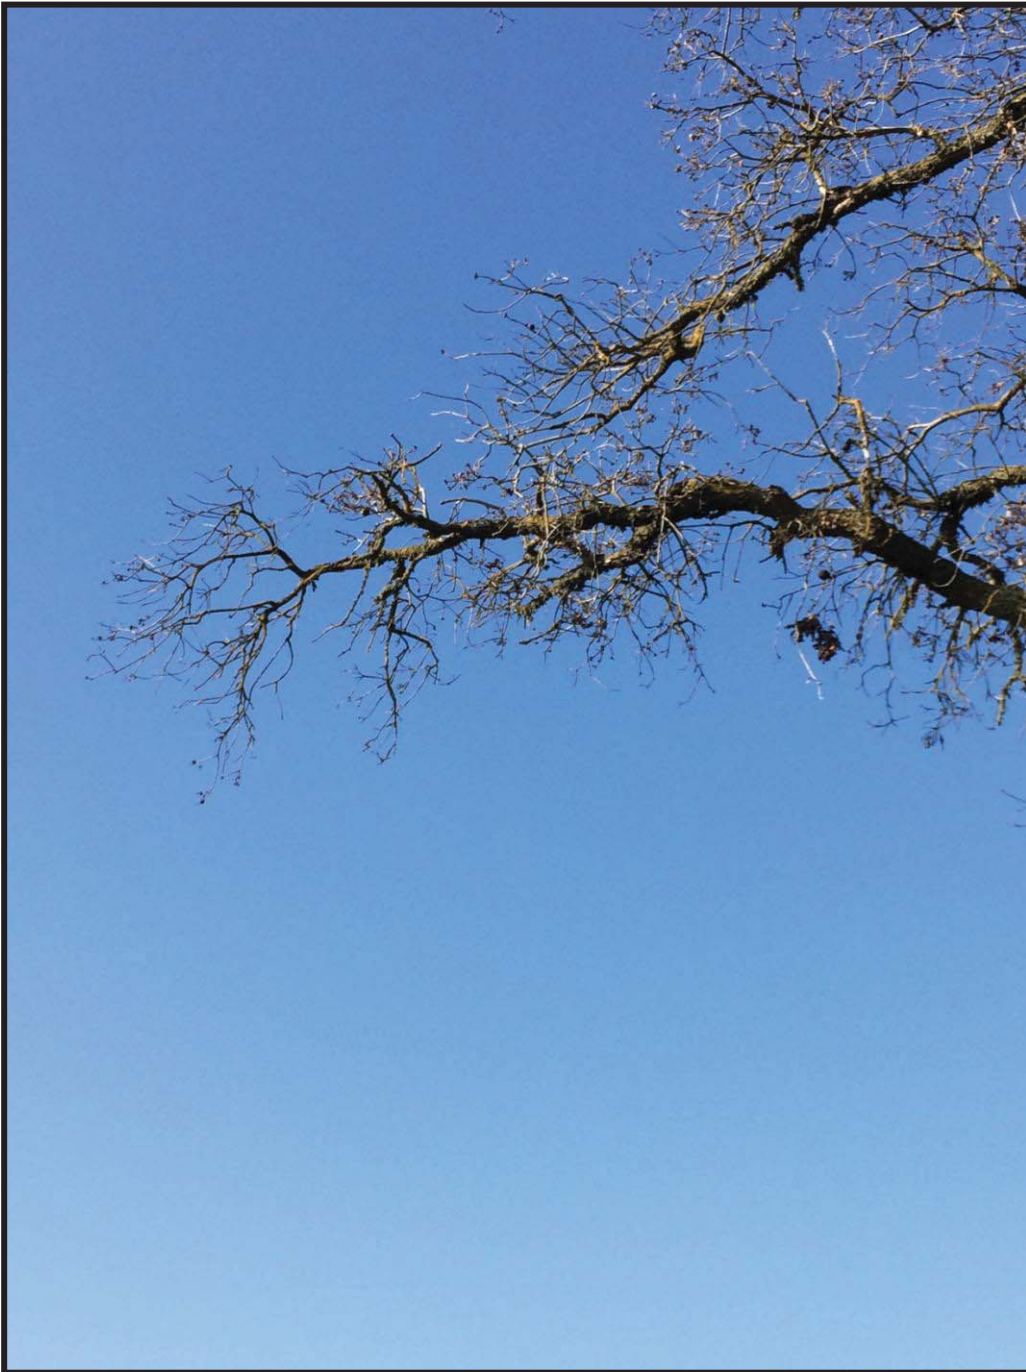
Photo 11- Tree #4. Decreased shoot growth.

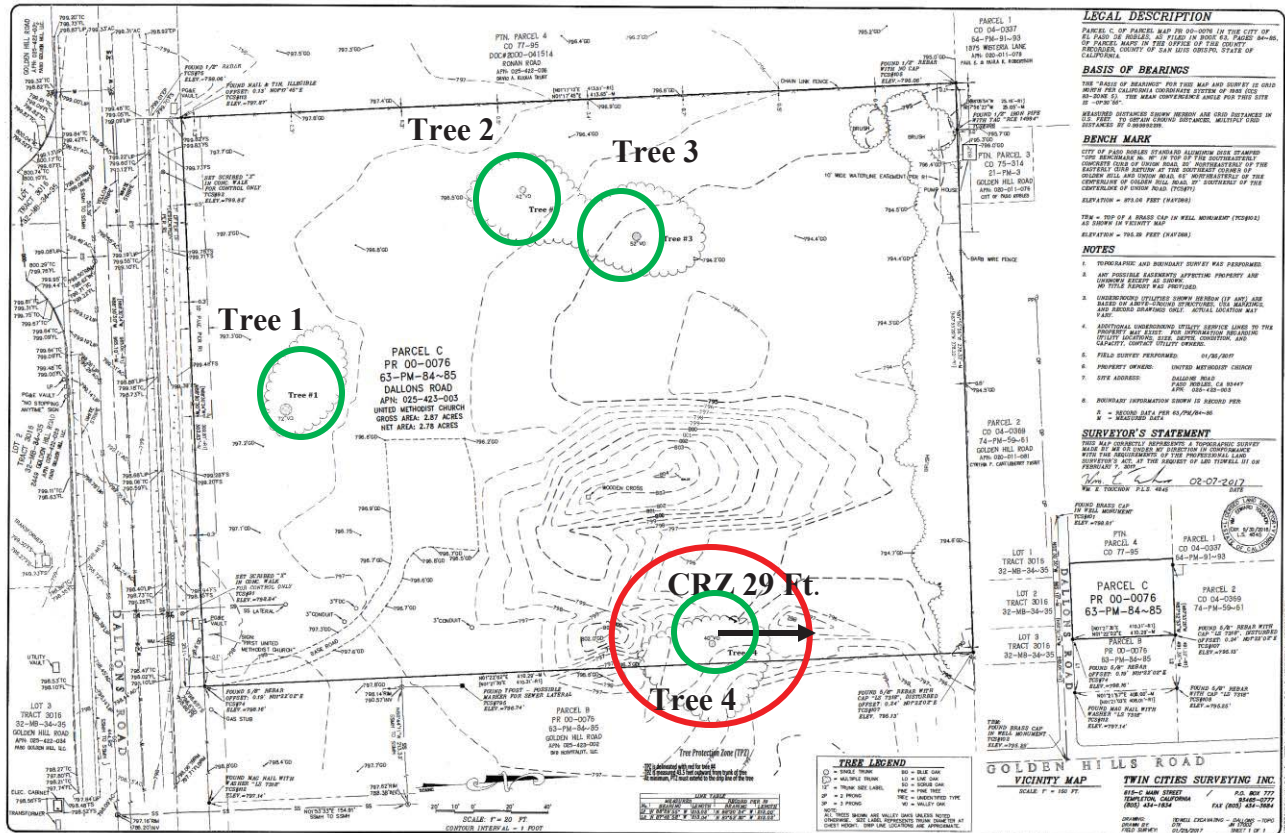
Diagram 2- Topographical Map with Tree Locations and Critical Root Zone delineated for tree #4 highlighted in red.
