## Council Agenda Report

Subject: Oak Tree Removal Permit 17-016 & 17-017 - City of Paso Robles Initiated  
Council consideration of the request to remove multiple oak trees within the Oak Creek Park, the Senior Center, and within the Vine Street right of way, adjacent to Georgia Brown School.

Date: October 3, 2017

**Re:** Tree Health Assessment for Nate Wyatt, 270 Scott Street, Paso Robles, CA

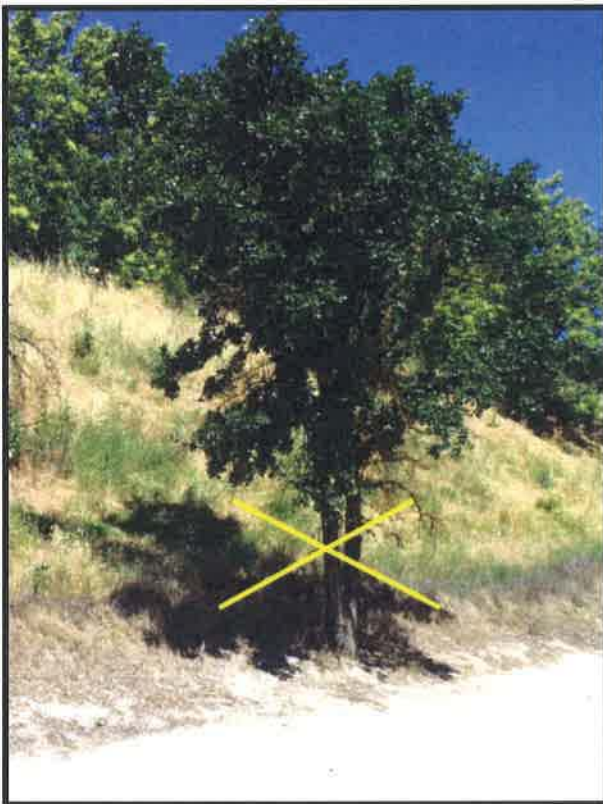
4. Out of the 16 trees, one tree, Tree No. 7, a dual stem, 14-inches in diameter Valley Oak is proposed to be removed. The tree has a major area of included bark in the trunk which makes it prone to failure. It is located within the grading zone of the project and will impede the paving improvements for the Vine Street project.

**Tree 7** is a 14" diameter two-stem valley oak located at the west side of Vine Street approximately ¼ of the way north of 32<sup>nd</sup> street toward Caballo Road. This tree has a major area of included bark in the trunk which makes it prone to failure. It is located within the grading zone of the project and will impede road construction. This tree should be removed.

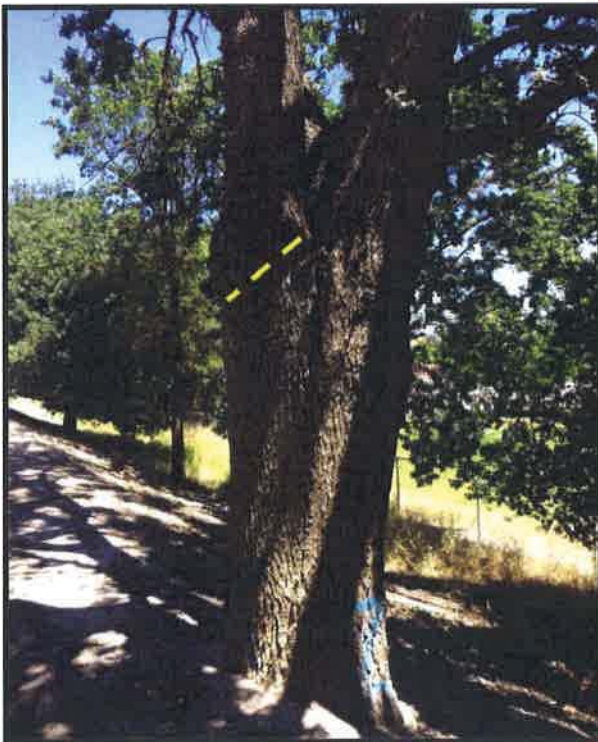
**Tree 10** is a 29" diameter valley oak located on the east side of Vine Street approximately ½ way between 32<sup>nd</sup> street and Caballo Road. This tree has a major area of included bark in the trunk which makes it prone to failure. The stem leaning over the roadway should be removed to eliminate the risk of branch failure. Yellow dashed line indicates branch to be removed. No significant grade cuts are planned for this area of road construction. Exploratory excavations in the critical root zone of the roadbed found no significant roots. This tree can be retained.

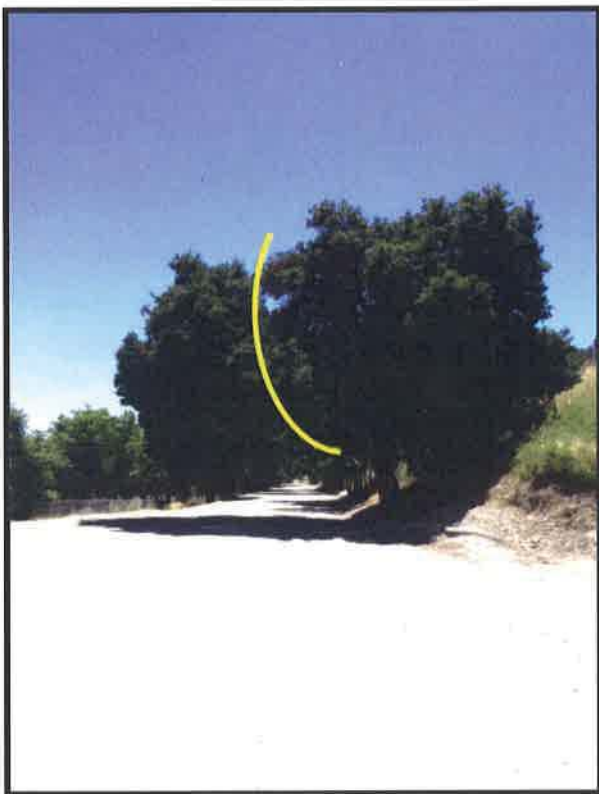
**Tree 24** is a 28" diameter coast live oak located at the northwest corner of Vine Street and Caballo Road. The tree is at the edge of the construction footprint. No significant grade cuts are planned for this area of road construction. Exploratory excavations in the critical root zone of the roadbed found no significant roots. This tree can be retained. The tree creates a visual barrier down Vine Street for drivers turning south off Caballo Road. Pruning for 15 feet of clearance above the roadway to allow for fire trucks and other large vehicles to pass beneath will be needed. Yellow line in picture below indicates approximate reduction of canopy.

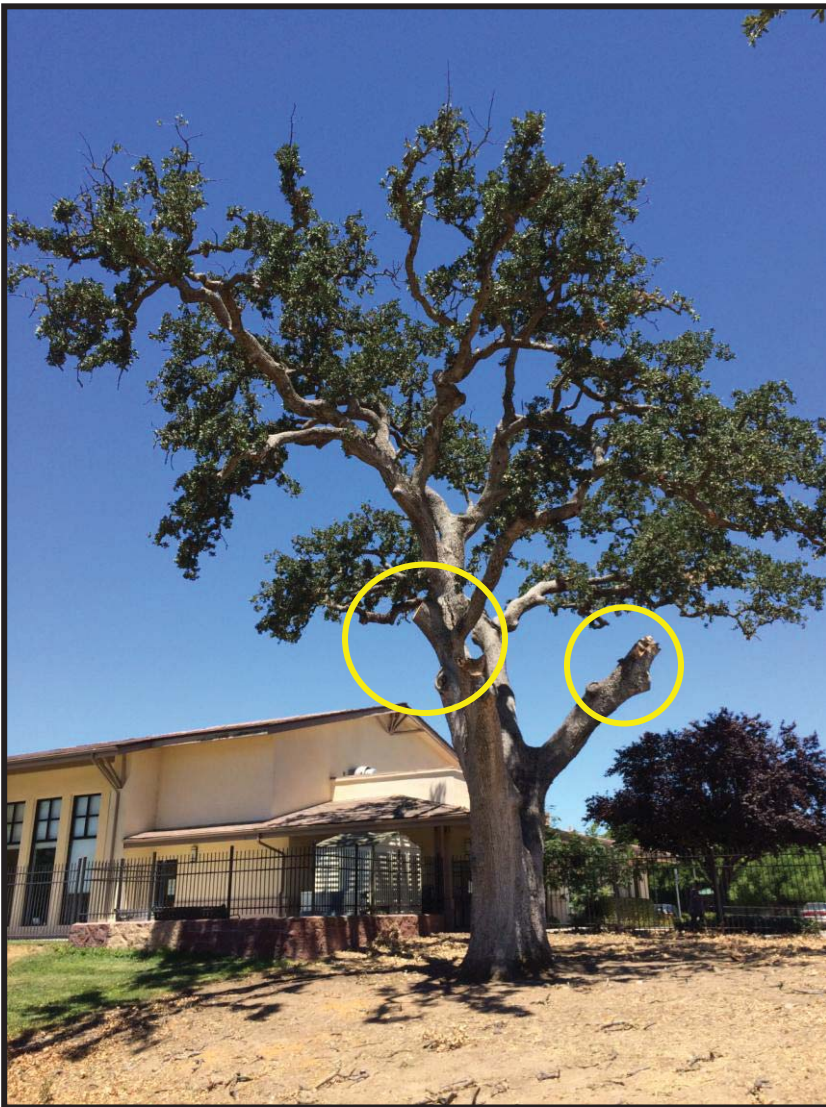
- The tree was a single stem with a **\*diameter at standard height (DSH)**, measured at 4.5 feet above ground level, of 50 inches. The tree height was approximately 60 feet with a **\*crown** spread of approximately 60 feet. See Appendix A- Photo1.

- The **\*canopy** was declining, indicated by some branches not being fully leafed-out and live crown at approximately 50% of normal. See Appendix A- Photo1.

- I observed recent and past large **\*scaffold** branch failures due to large areas decay. See Appendix A- Photos1-3.
- There was root decay indicated by white fungus at the **\*root-crown** on the west side of the tree. See Appendix A- Photo 4.

**Photo 1-** View of tree from southeast. Scaffold failures indicated by yellow circles.

**Recommendation:** This tree is diseased beyond correction and should be removed as soon as possible.

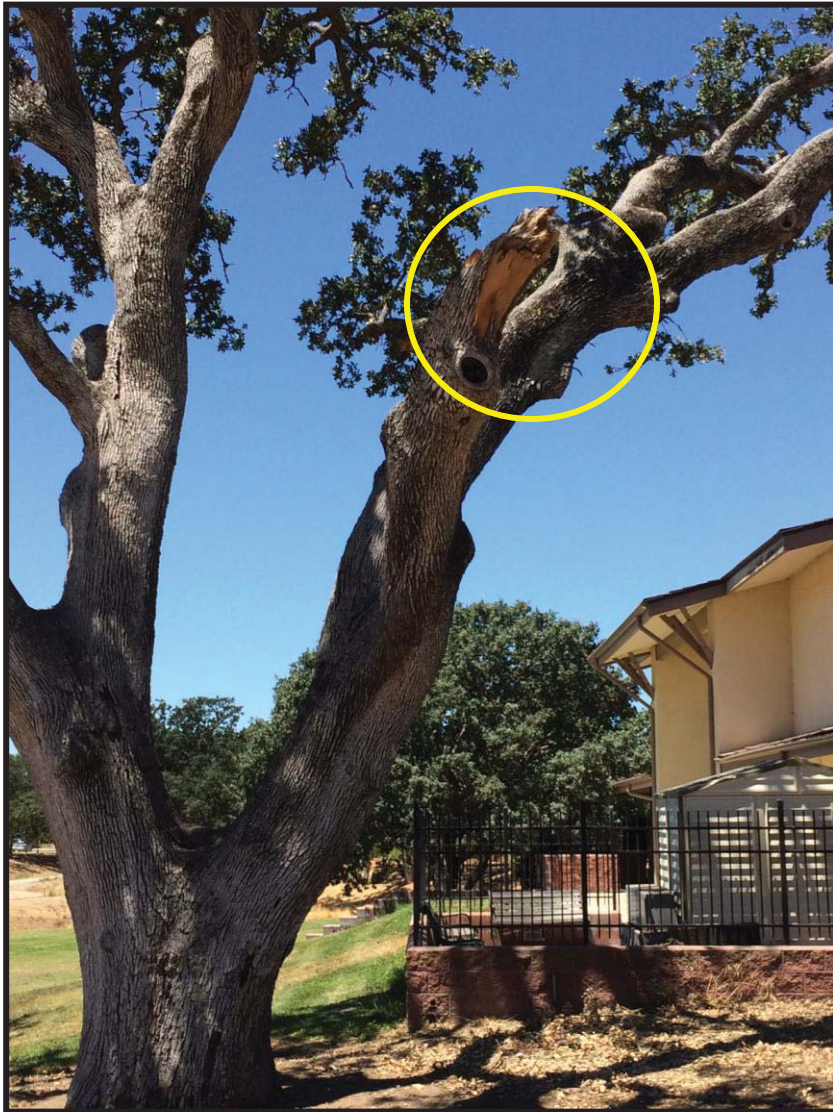
The main issue with the tree is a Phytophthora fungal infection, which is blocking the vascular system of the tree and causing areas of the tree, including large branches, to die or decline. Recent scaffold failures occurred in July 2017. I also observed older scaffold branch failures. Remaining branches are in similar condition as previously failed branches and have a high likelihood of failing.

**Photo 2-** Recent scaffold failure- July 2017- Indicated by yellow circle.

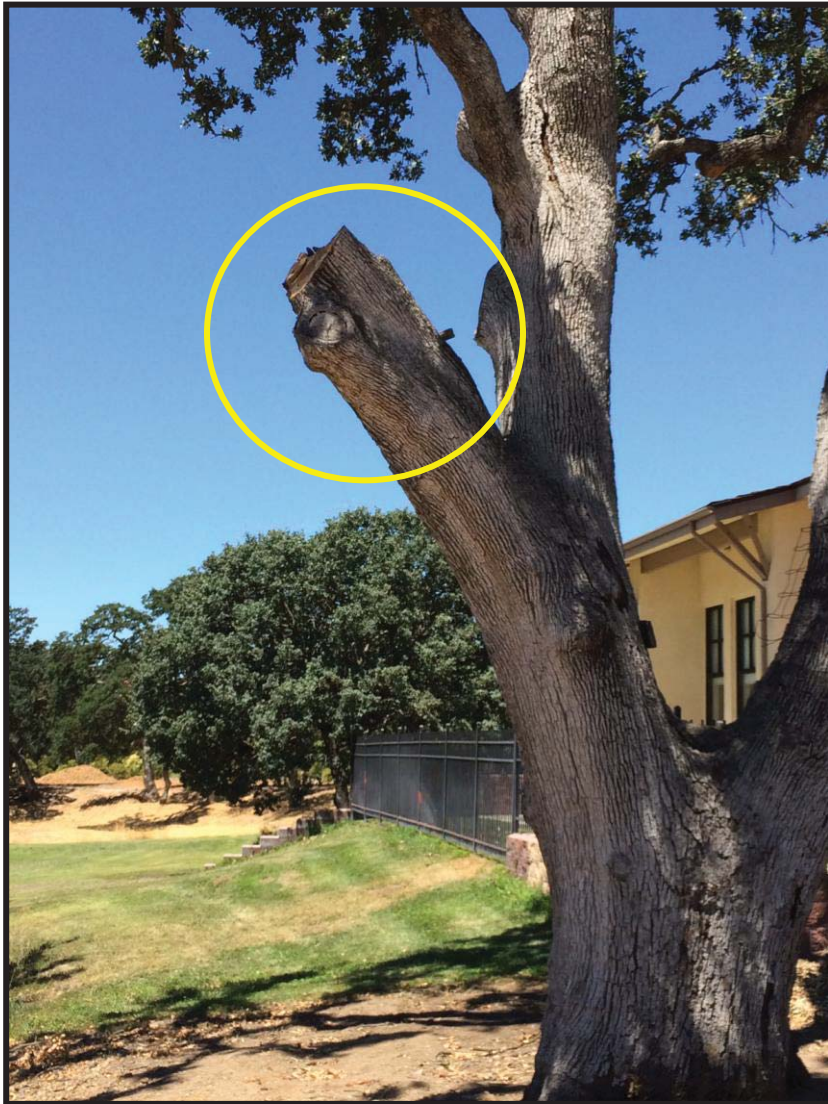
**Photo 3-** Older scaffold -branch failure indicated by yellow circle.

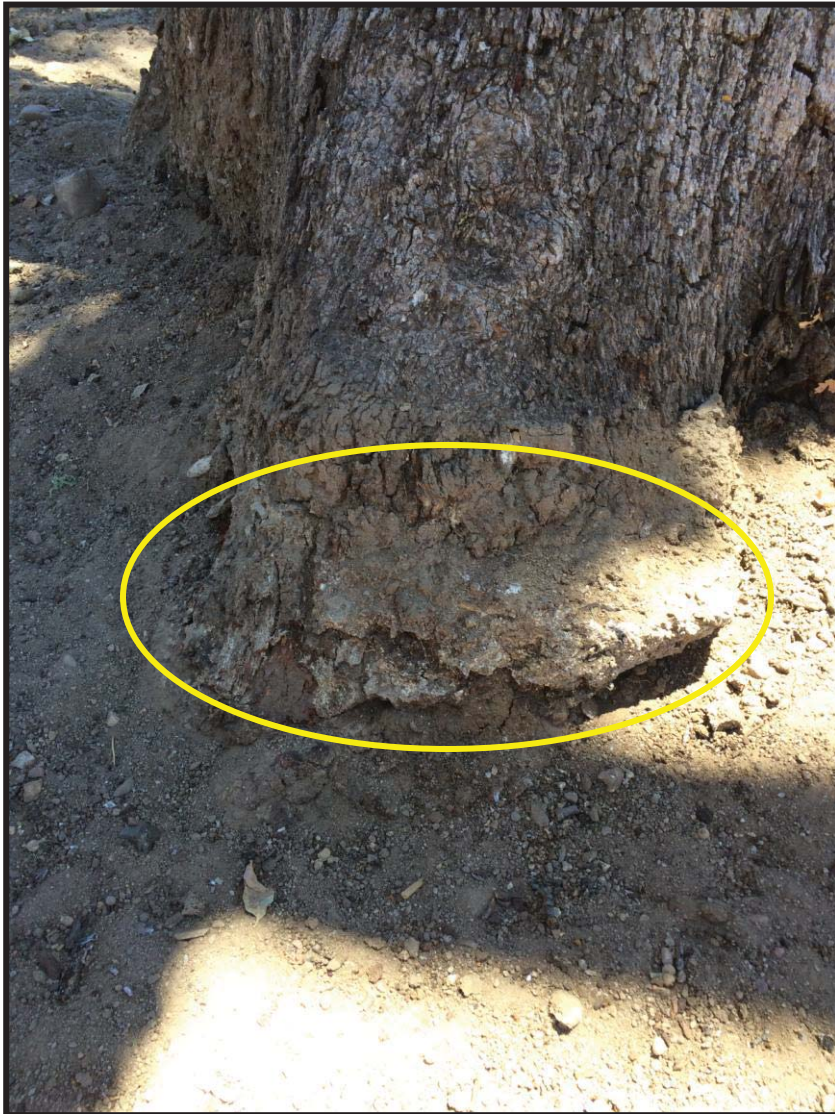
A secondary fungal infection caused by oak root fungus (*Armillaria mellea*) a known decomposer of roots is also contributing to root rot. Root rot has begun to decay anchor roots and makes the tree prone to complete failure.

**Photo 4-** Fruiting fungal bodies at root crown indicated by yellow circle

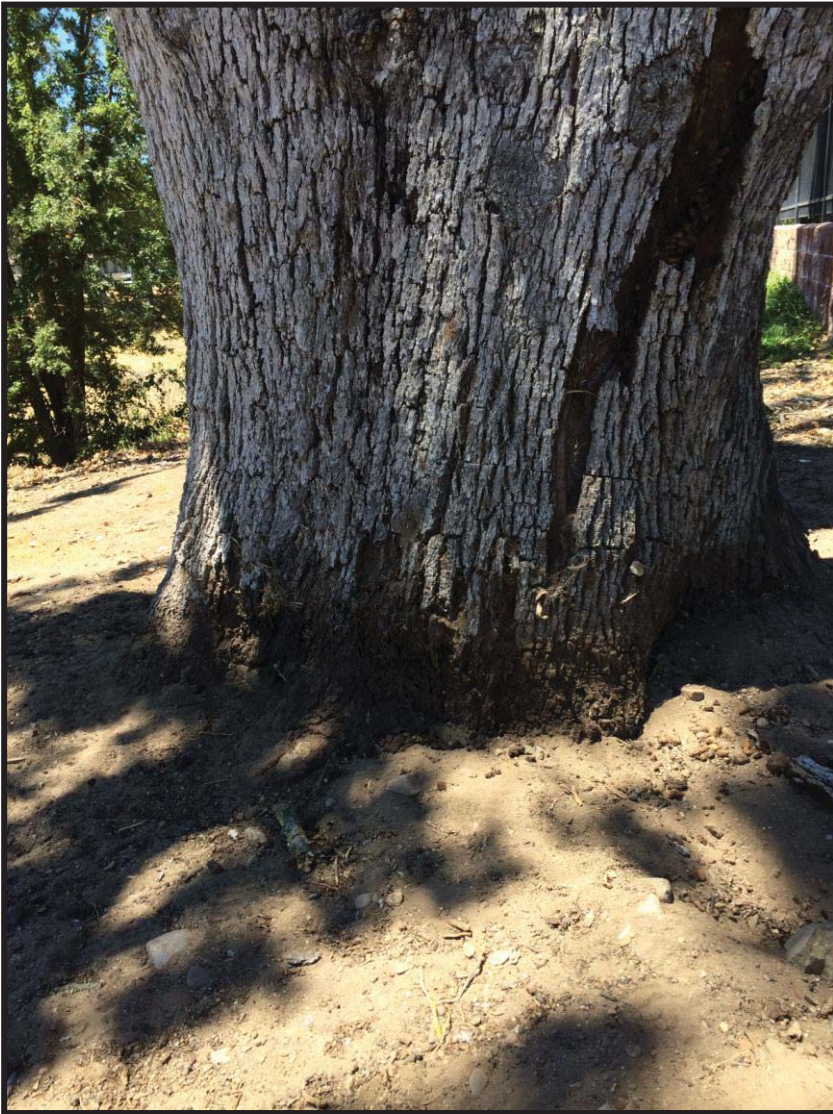
- I observed large areas of shedding and dead bark on the lower trunk at west side of tree. See Appendix A- Photo 5.
- Multiple cankers and bark shedding throughout the tree in scaffold branches. See Appendix A- Photo 6.

**Photo 5-** Shedding bark on lower trunk indicates root rot and vascular disease.

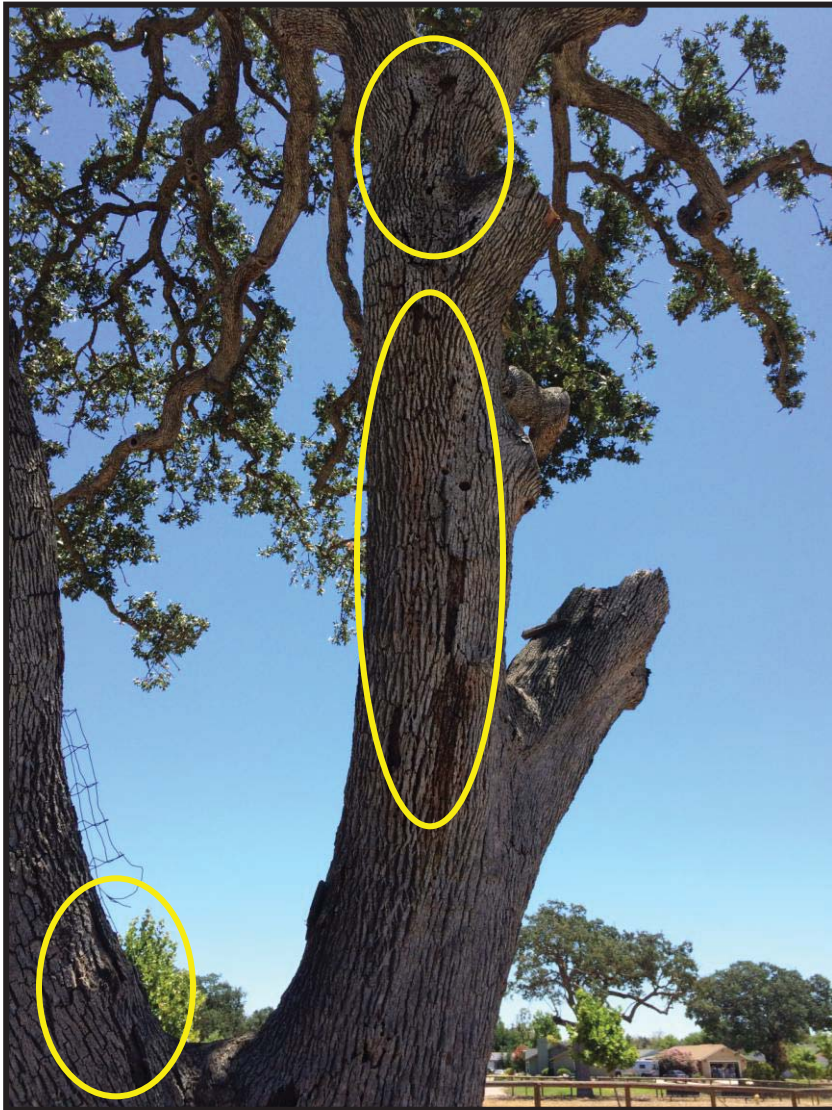
This tree is in severe decline. Fruiting fungal structures at the root crown, cankers and shedding bark on the main trunk and scaffold branches of this tree indicate root rot and vascular disease.

**Photo 6-** Canker and shedding bark on scaffold branch indicated by yellow circles. Cankers are caused by Phytophthora fungus.
