RESOLUTION NO. 17-035

A RESOLUTION OF THE CITY COUNCIL OF THE CITY OF PASO ROBLES
AUTHORIZING THE REMOVAL OF ONE 54" VALLEY OAK TREE
AT 1600 COUNTRY CLUB DRIVE
(OTR 17-004 / PASO ROBLES GOLF CLUB) APN: 009-461-049

Re: Paso Robles Golf Club

RE: Tree Inspection

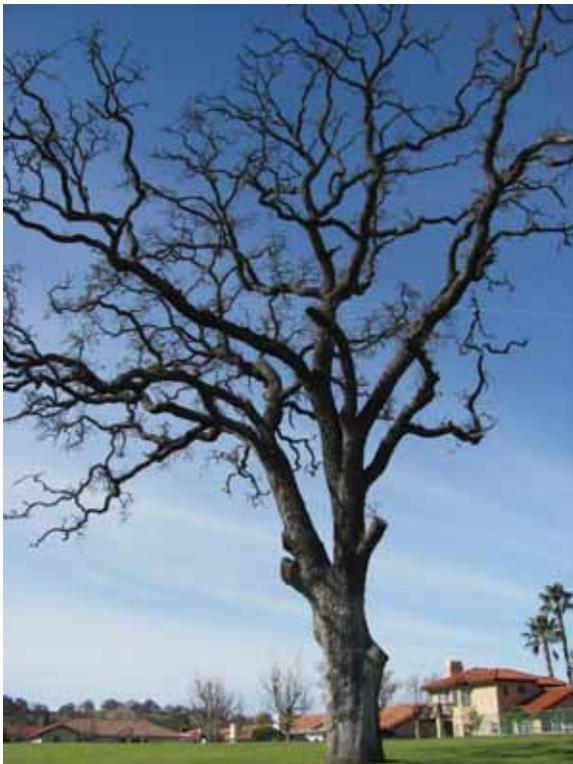
Of the 13 trees, I found one tree in particular that alarmed me with its severe degree of structural deterioration. This tree is located on hole #5, and is the subject of my 3/7/17 letter to Mr. Mike Rawitser, a copy of which I am attaching to this letter. It is also pictured in the photo here.

The tree is a Valley oak with a 54" trunk diameter. It is located in the middle of the fairway just where the hole turns to the right. This location is where most golfers first shot lands from the #5 tee, so is frequently occupied by golfers all day long. Additionally, employees are frequently passing below the tree.

My recommendation to the property owners is to remove the tree as soon as possible.

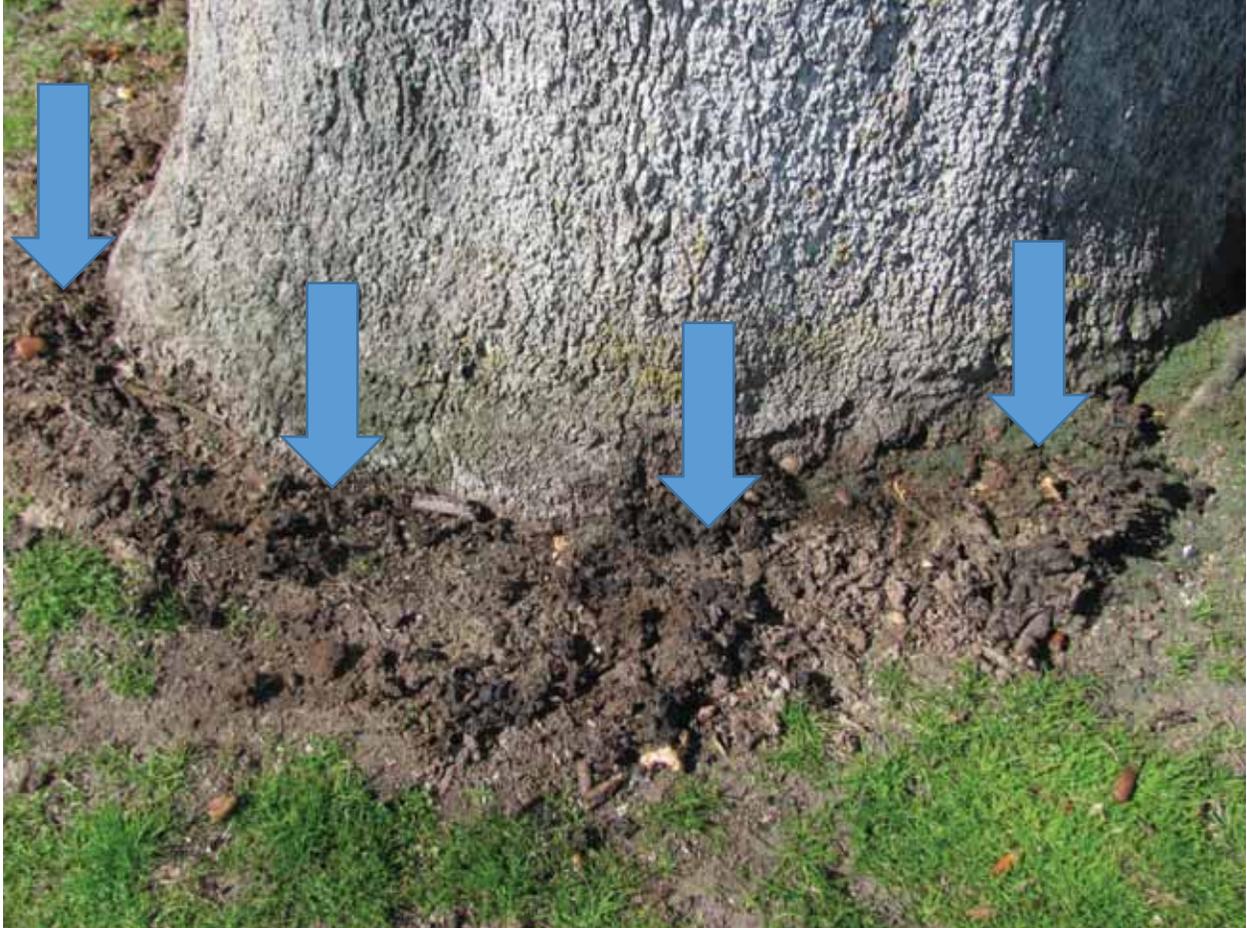
I found at least four clusters of dried mushrooms that are most likely Oak root rot disease, *Armillaria mellea*. The photo above of the base of the tree above with the dried mushrooms indicated by the arrows.

The clusters were located on about 75% of the trunk circumference. When I chipped into the bark at the trunk base, I found the entire bark and inner sapwood to be rotted by the disease.

In the meanwhile, the tree is in extremely high likelihood of falling over. The disease is rotting away all of the structural root support. It is highly hazardous.

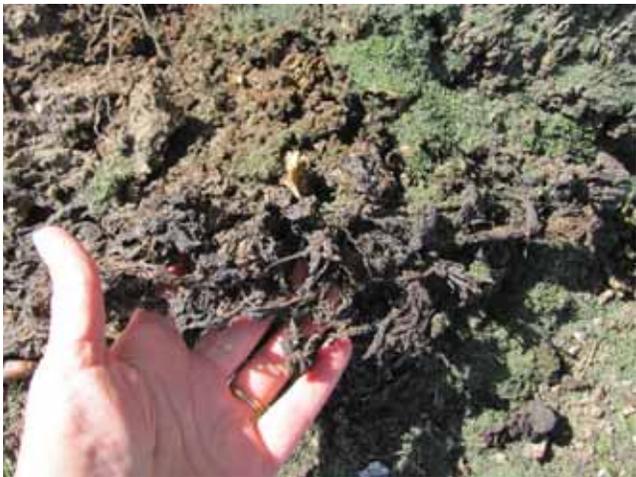
Here is a photo of me holding one of the mushroom clusters.

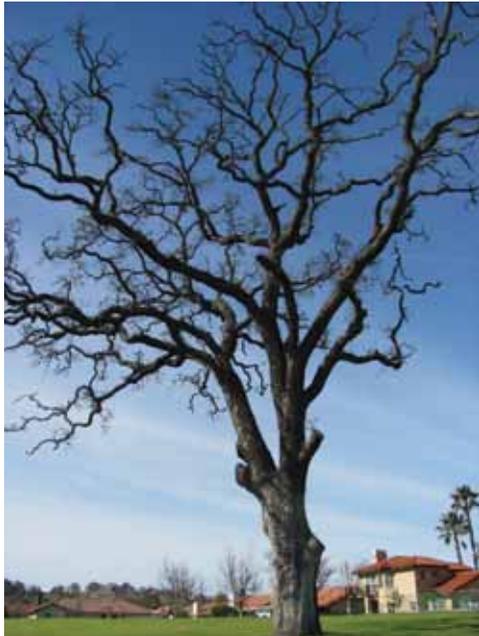
During my inspection, I found a tree in such poor condition that I immediately gave you my verbal opinion that it is in **imminent risk of sudden failure**. This tree, shown in this photo, is in the middle of the #5 fairway. It is a *Quercus lobate* with a 54" trunk diameter. The entire circumference of the root crown area, where the trunk meets the ground, is decayed.

I dug down below soil level all around the tree base and found it entirely rotted. Additionally, I saw the remains of 4 clusters of mushrooms which appeared to be *Armillaria mellea*, also known as oak root fungus. This decaying disease infects the woody roots as well as the root crown area, leaving behind pulpy textured wood with no holding capacity.

I am shocked that the tree is still standing with that vast amount of decay.

Please remove this tree as soon as possible.

Until the tree is removed, I suggest roping off the area with caution tape, to alert the golfers and your employees of the risk.
