**TO:** JAMES L. APP, CITY MANAGER  
**FROM:** JOHN R. McCARTHY, DIRECTOR OF PUBLIC WORKS  
**SUBJECT:** OAK TREE REMOVAL REQUEST  
TENTATIVE TRACT 2276  
**DATE:** APRIL 6, 1999

**A RESOLUTION OF THE CITY COUNCIL OF THE CITY OF PASO ROBLES, CALIFORNIA,  
GIVING PERMISSION TO REMOVE AN OAK TREE AT AIRPORT ROAD (TENTATIVE TRACT 2276)**

RE: One 54" diameter valley oak (Quercus lobata) tree, located on Airport Road,  
South of Linne Road, Paso Robles, Ca.

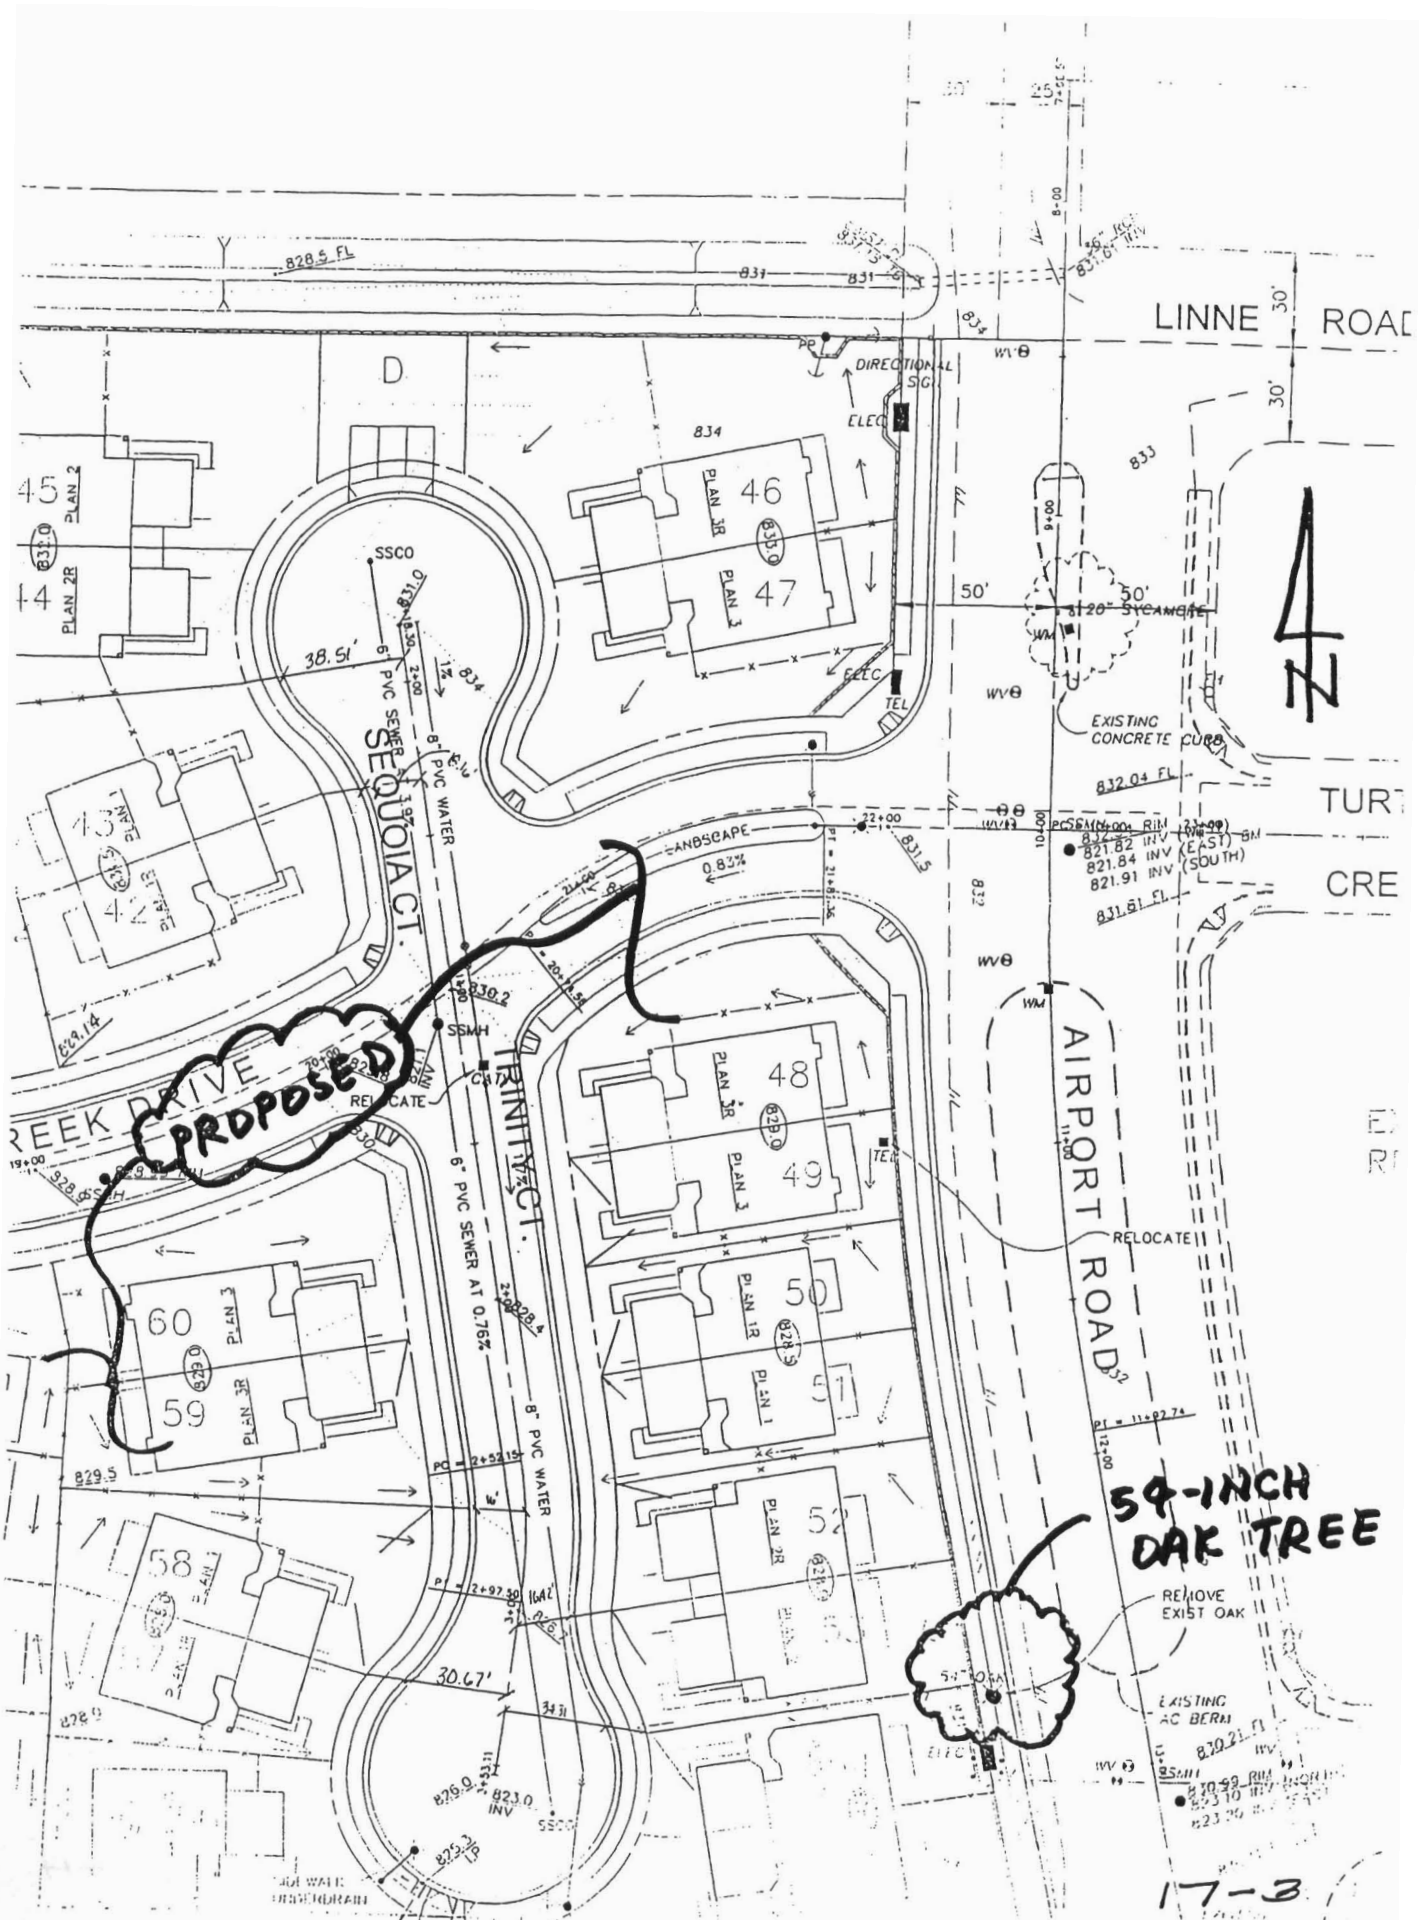
**54-INCH DAK TREE**

**WHEREAS**, the health of the tree has deteriorated and is severely infected with heart rot.

Due to the foliage of the tree at the time it was difficult to view the extent of the rot and decay of the main trunk of the tree. During the winter, when the leaves were absent, it became very clear that the damage and decay of the tree was extensive and presents a public hazard. The existing branch which points to the north joins the trunk directly adjacent to the portion of the trunk which is cracked and rotten. It is only a matter of time before the trunk fails and the branch falls. At my request, John McCarthy visited the site with me to re-evaluate the tree. His conclusion, as was mine, is that the tree poses a public safety hazard and should be removed. Councilman Mecham has also taken a look at the tree and concurs. This was also the recommendation of the Arborist.

I have attached photographs which clearly show the extent of the decay and cracking of the main trunk. Please feel free to share these photos with members of Council and Staff. Additional photos can be supplied on request.

This large tree stump is located on an unimproved site adjacent to Airport Road, at the Bonita Homes tract area. All but 1 of the original branches have failed, leaving a large stump approximately 20 feet tall that is covered with second growth (suckers). This is a common characteristic of valley oak trees that can be observed throughout the inland valleys of California. Severe heart rot is existing in this tree leaving only the outer shell to support the branches. As the second growth becomes large and heavy, the potential for additional branch failure will increase. Valley oak trees reaching this stage of maturity can live for many years if the root system is left undisturbed or if the root system is not severely impacted. However, branch failure will always be a safety factor to deal with.

1. This valley oak tree is very old.
2. This tree is severely infected with heart rot.
3. Pruning and maintenance can lessen the hazards associated with this tree but will not guarantee safe passage for pedestrians or vehicular traffic.

Section 1. That the City Council of the City of Paso Robles does hereby give permission for the removal of one (1) oak tree at Airport Road as part of the development of Tentative Tract 2276.

The proposed improvements on Airport Road will create an unsafe condition beneath this tree for pedestrians and vehicular traffic. To mitigate this unsafe condition, removal is recommended.
