TO: JAMES L. APP, CITY MANAGER
FROM: ROBERT A. LATA, COMMUNITY DEVELOPMENT DIRECTOR
SUBJECT: REQUEST TO REMOVE ONE OAK TREE – 2503 STARLING DR.
(ROGER & PATRICIA GREENE)
DATE: MARCH 1, 2005

A RESOLUTION OF THE CITY COUNCIL OF THE CITY OF PASO ROBLES
AUTHORIZING THE REMOVAL OF ONE OAK TREE AT 2503 STARLING DRIVE
(ROGER & PATRICIA GREENE)

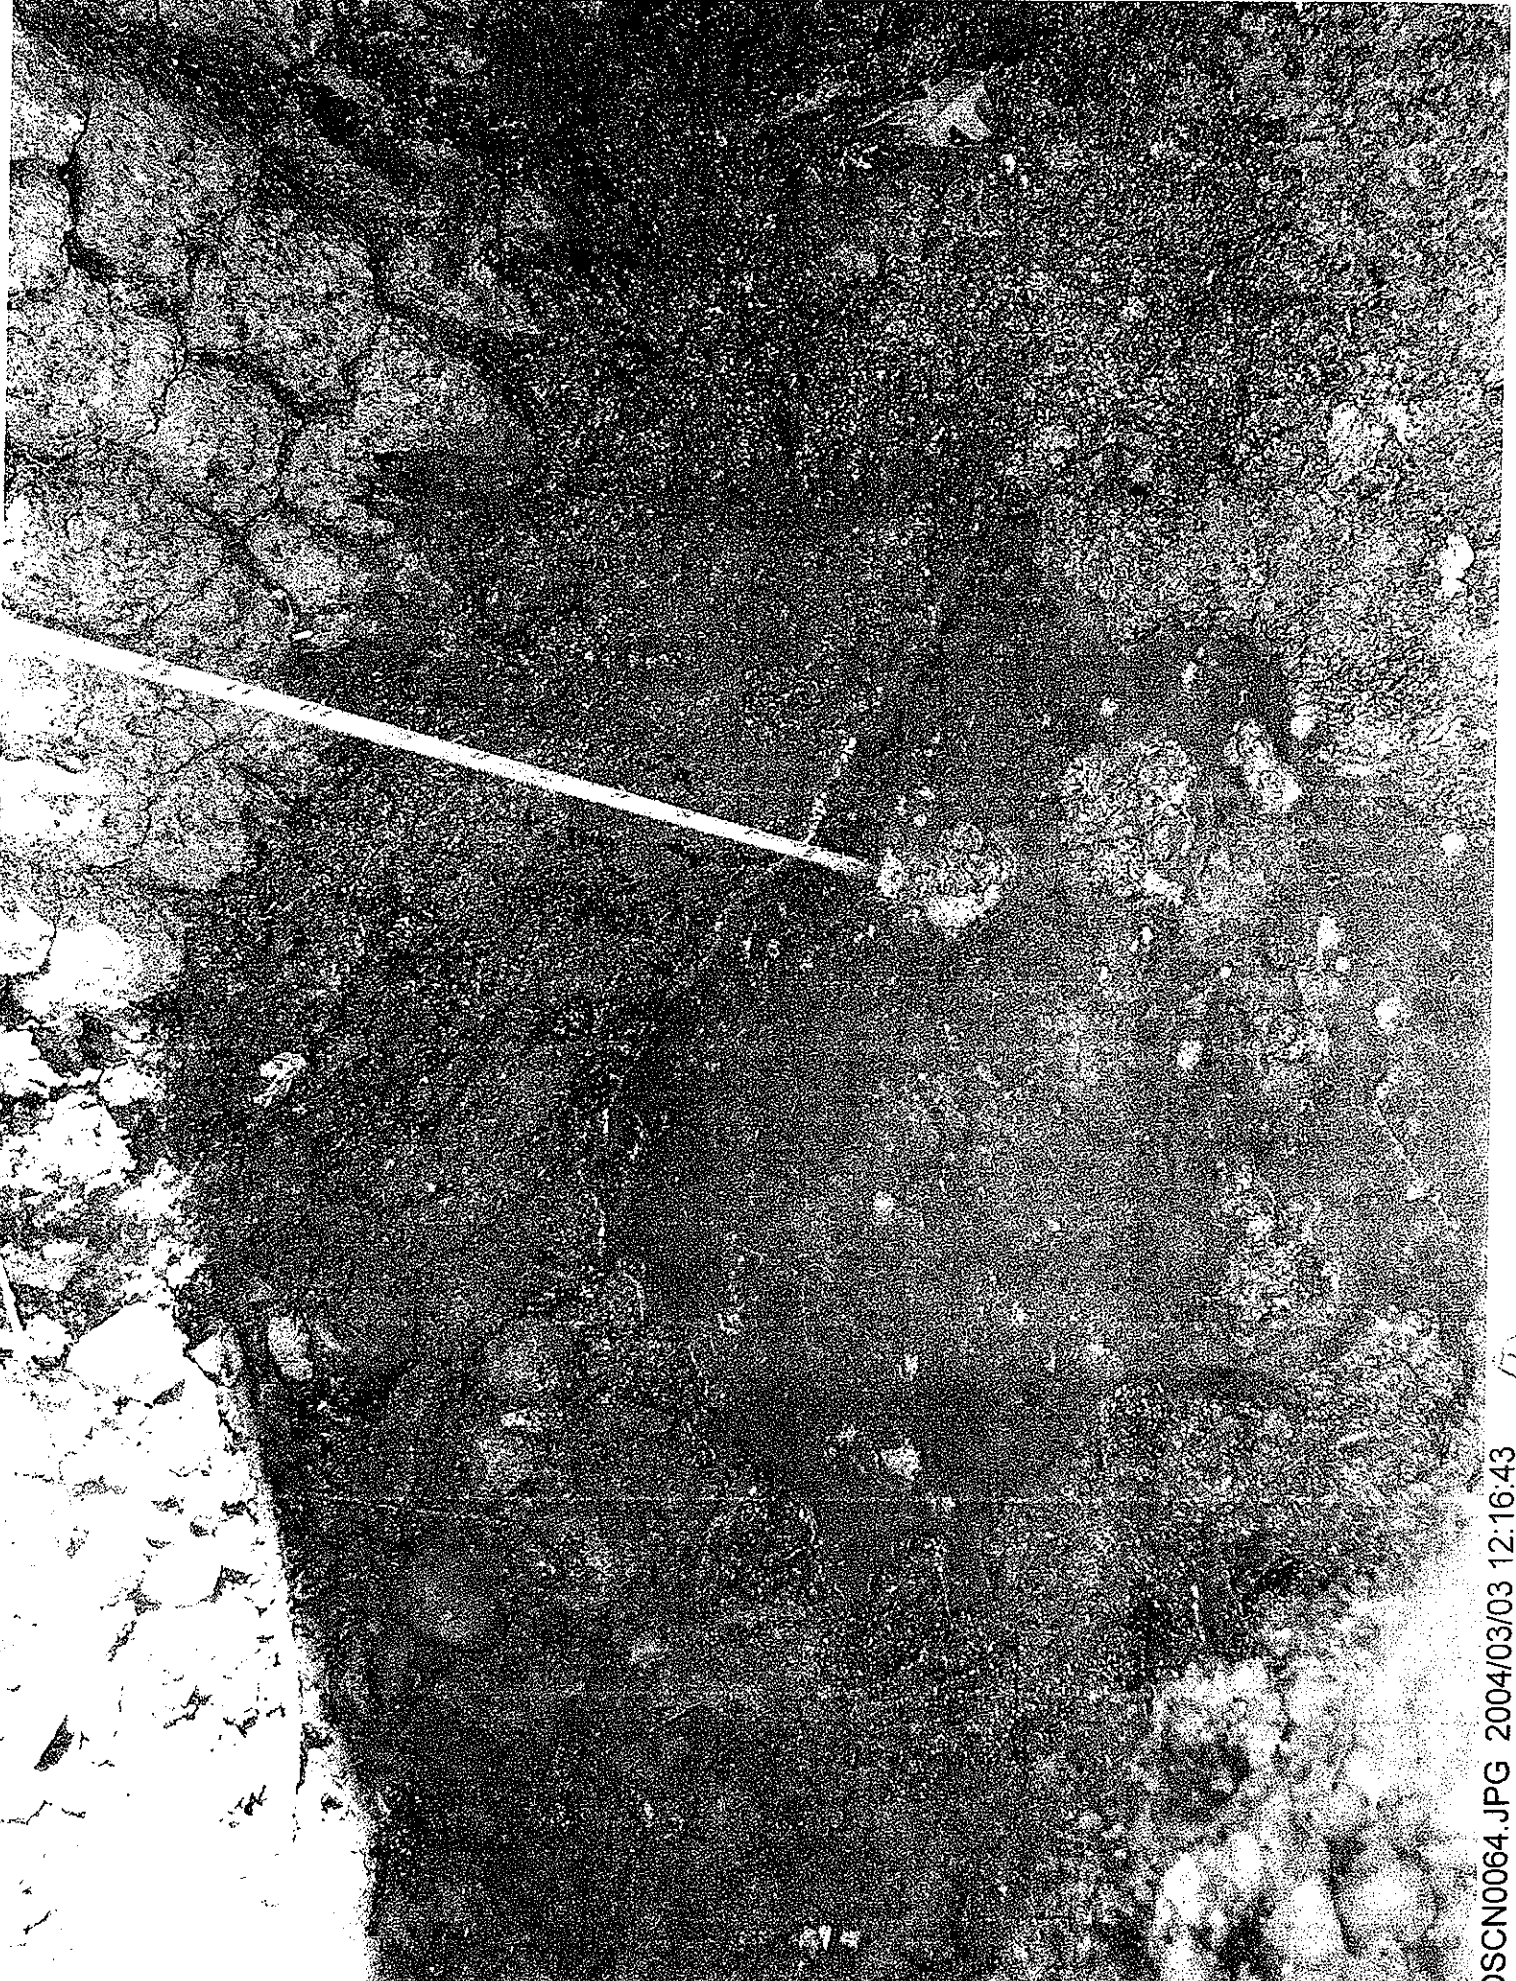
①

On 3-04-04, I removed soil next to the main stem attempting to determine the original grade inside the well. I came to the conclusion, approximately eight inches of soil was added in this area by digging until I discovered the root flair. Within minutes, the hole I excavated filled with water. Pictures #1 and #2 illustrate the amount excavated and the resulting water that filled the hole. Oak trees cannot withstand constant water in the soil column. The drainage tiles installed during construction are 10 inches above the current water level providing absolutely no benefit to the tree. I can only ascertain, the original grading provided improper drainage for the lot that is resulting in this ponding effect.

At this point in time, the tree appears to be approximately 50% dead. This was determined by observing the amount of live crown left on the tree. This tree will most likely not survive in its current condition unless the original grade is re-established under 70% of the drip-line with proper drainage provided and additional pruning is performed.

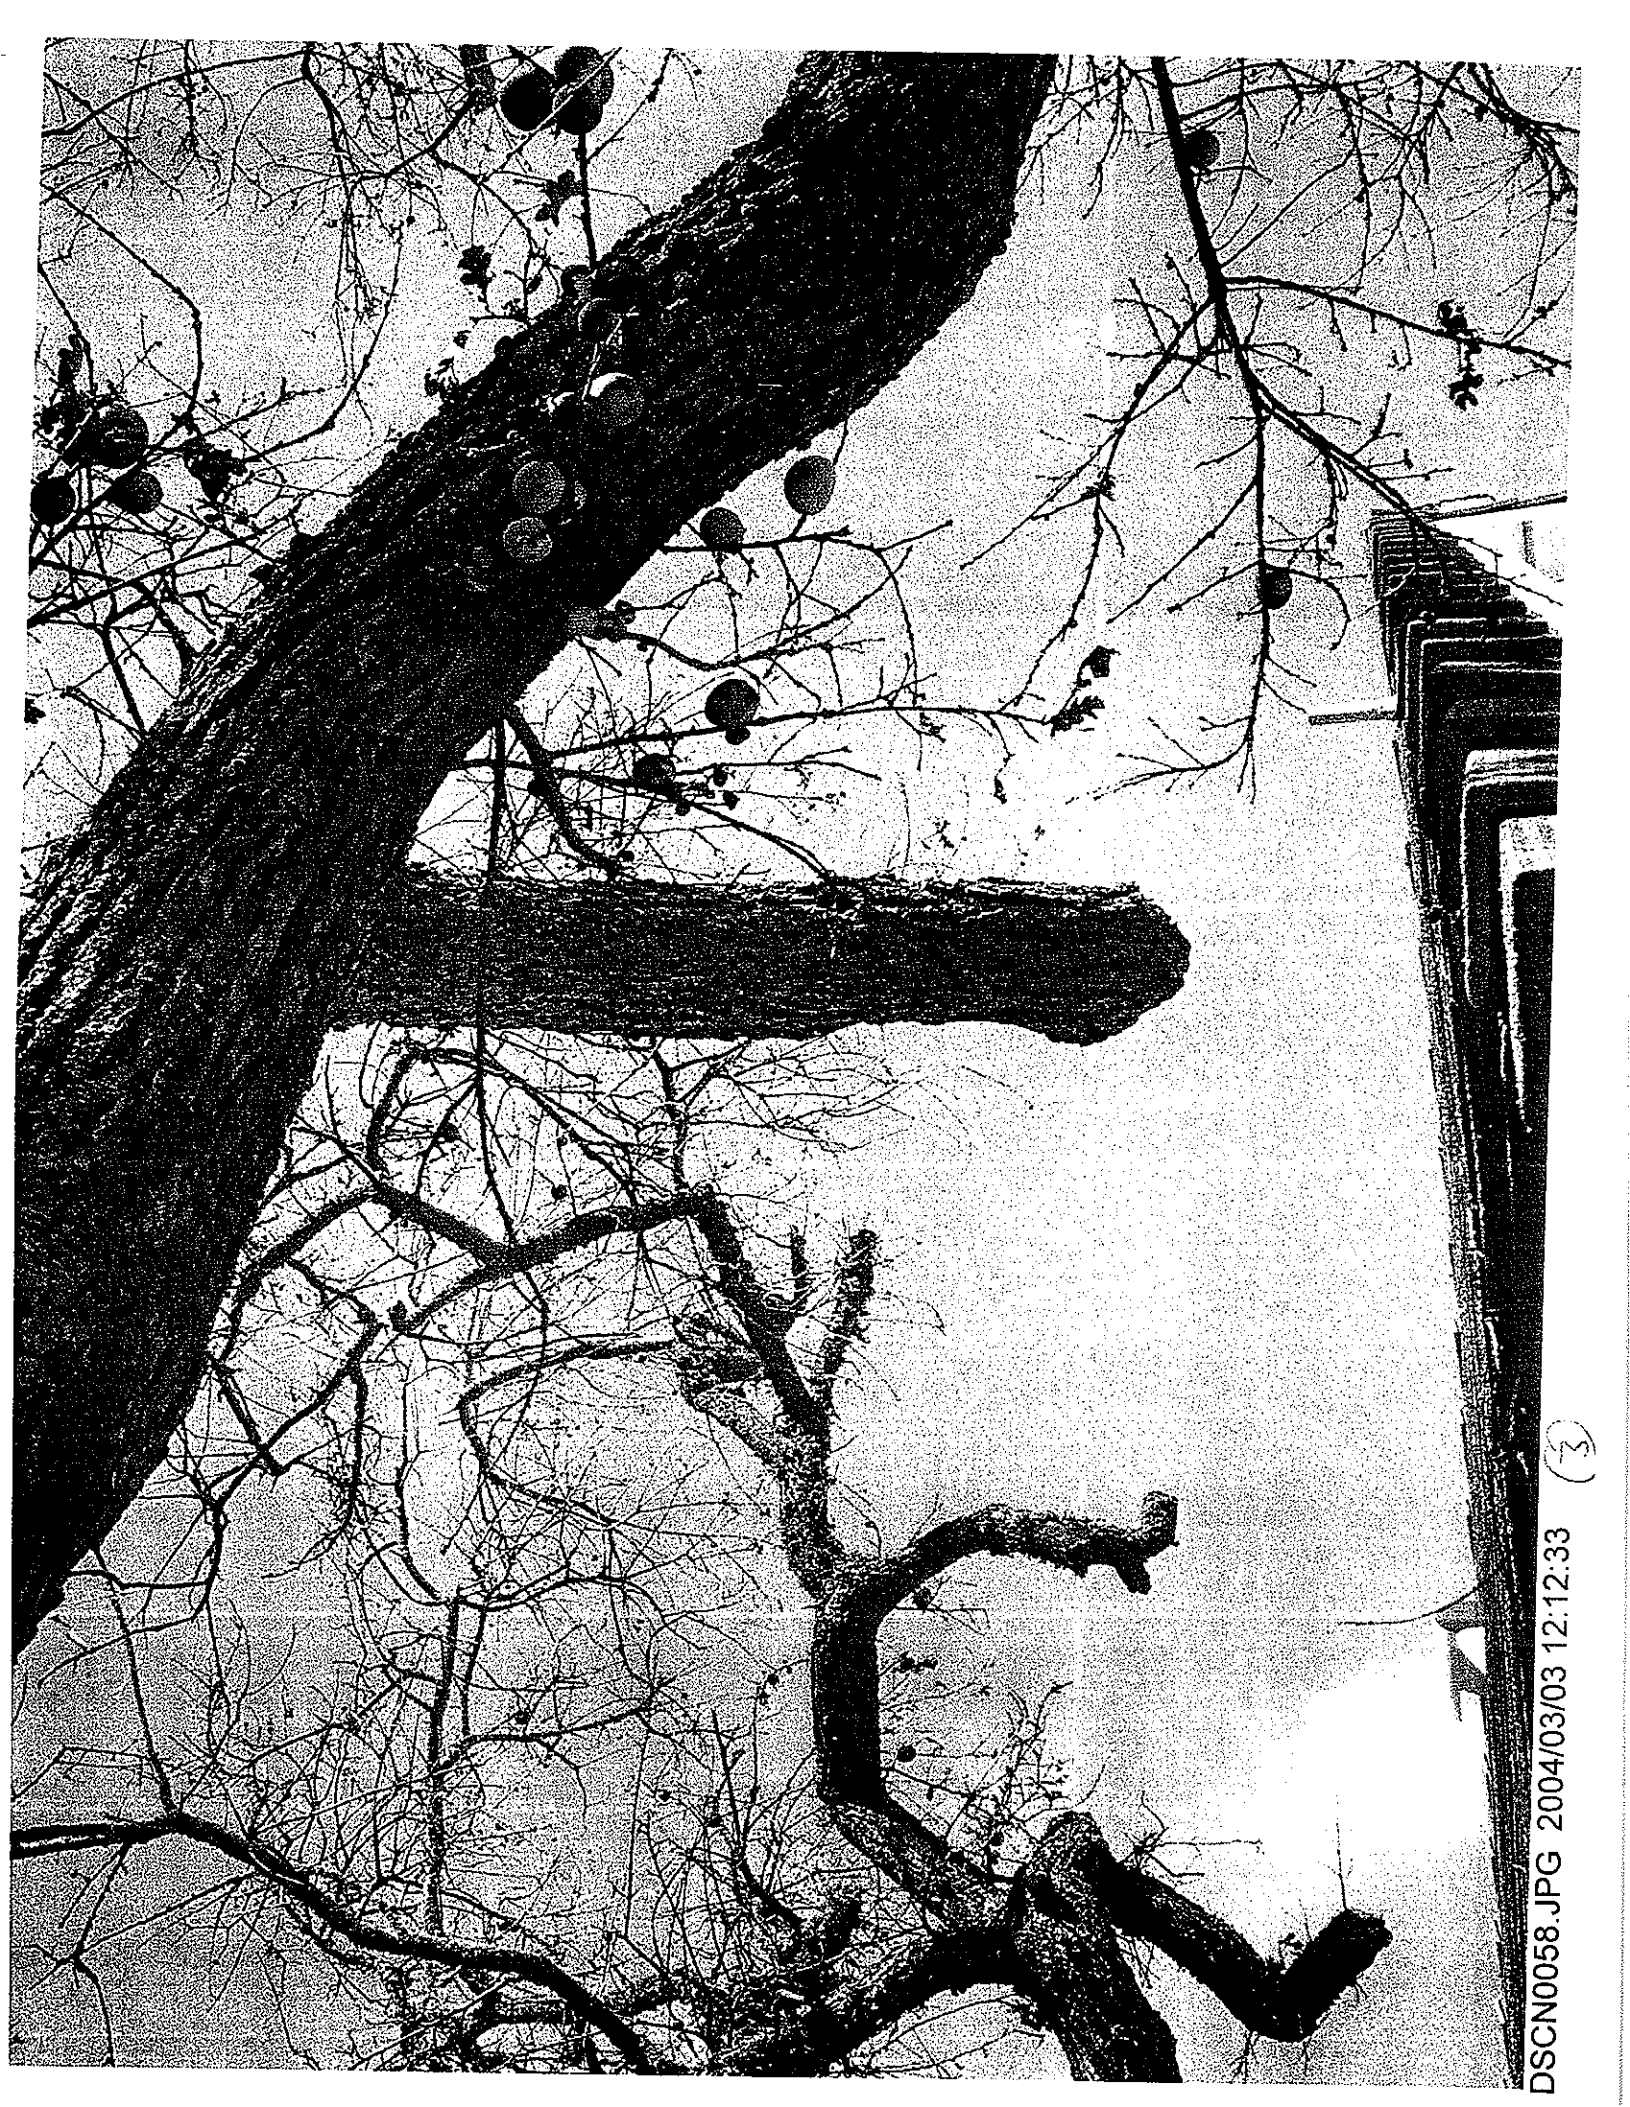
(3)

Additional damage to the tree was also noted. Pictures #3-#5 illustrate the improper pruning techniques performed on the tree. According to the International Society of Arboriculture, proper pruning requires pruning a limb back to a lateral branch at least one-third the diameter of the parent limb. This allows the secondary branch to assume dominance. This also allows for the formation of proper callous tissue to close the wound thereby preventing disease/decay. There are currently close to one dozen improper cuts that were made for home and yard clearance. The pictures also show some of the cuts are greater than six inches in diameter which requires a signed permit in the City of Paso Robles. Picture #6 illustrates probable tractor damage to one of the limbs during construction. There is also a broken limb approximately five inches in diameter that most likely is the result of tractor damage.
