TO: JAMES L. APP, CITY MANAGER
FROM: ROBERT A. LATA, COMMUNITY DEVELOPMENT DIRECTOR
SUBJECT: REQUEST TO REMOVE ONE OAK TREE IN RELATION TO THE UNION ROAD WIDENING PROJECT (CITY INITIATED)
DATE: MARCH 15, 2005

Subject: Horticulture Tree Evaluations and Report for Union Road Widening Project – Riverglen to Kleck

Project: CITY OF PASO ROBLES UNION ROAD WIDENING

Subject: TREE PHOTOGRAPHS

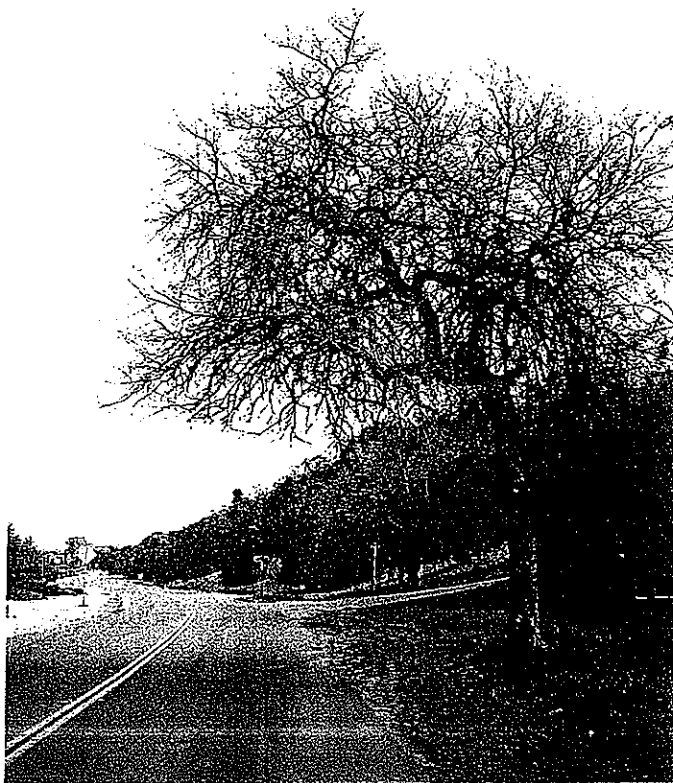
Oak No. 14 View East

WHEREAS, Tree No. 14, a 19-inch Blue Oak is located at the edge of the road shoulder which will require a 12-inch compacted base with paving over one-half of the root zone of the tree and the construction will severely impact the tree and be detrimental to its future health and survival; and

WHEREAS, the report also indicates the tree currently leans east and exhibits a weak structure, branch cavities, trunk damage and poor form. It has a low health and aesthetic rating of 3 out of 5.

Only one (1) tree is recommended for removal. Tree number fourteen (14) is located at the edge of the road shoulder which requires a 12" compacted base with paving covering one-half of the root zone. This construction would severely impact this tree and be detrimental to its future health and survival. The tree has a 19" diameter trunk with a height and spread of 40' x 37'. The tree leans east and exhibits a weak structure, branch cavities, trunk damage and poor form. It has a low health and aesthetic rating of 3 out of 5.

1. Authorize the removal of one (1) 19-inch Blue Oak tree in relation with the Union Road Widening Project, as shown on Exhibit A to this Resolution;
2. Require the planting of four (4) 1.5-inch diameter replacement blue oak trees, to be placed within the project as directed by the Arborist.
