**TO: JAMES L. APP, CITY MANAGER**  
**FROM: ROBERT A. LATA, COMMUNITY DEVELOPMENT DIRECTOR**  
**SUBJECT: REQUEST TO REMOVE ONE OAK TREE – 1733 MESA ROAD (GOMEZ)**  
**DATE: MAY 3, 2005**

# Tree Analysis of Hazardous Oak Tree

**Tara Gomez,  
1733 Mesa Road,  
El Paso de Robles, CA 93446  
(805) 712-4872**

**Elder & Elder Ltd. – Consulting Arborists/ Landscape Architects  
1207 Grassy Hollow Way,  
El Paso de Robles, CA 93446  
(805) 238-3750**

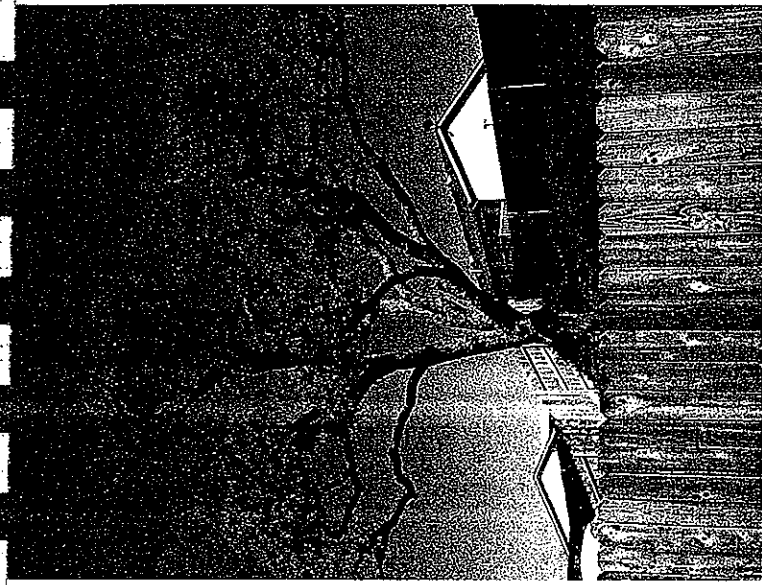
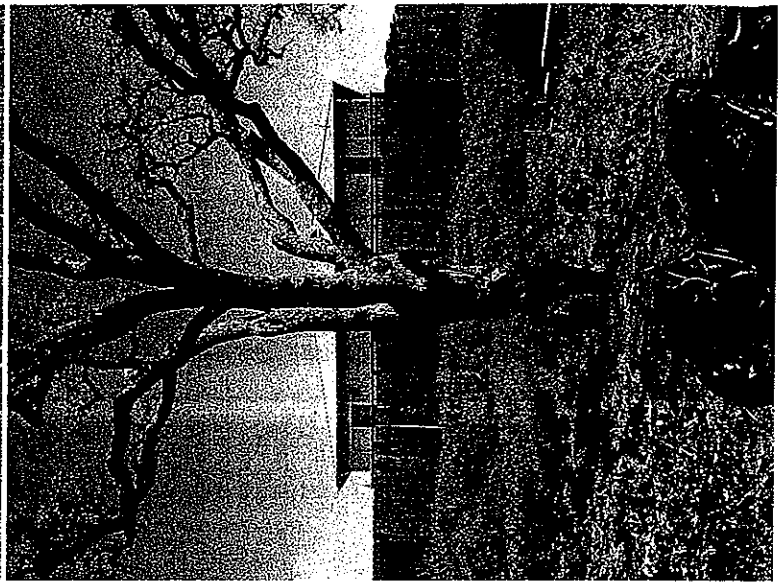
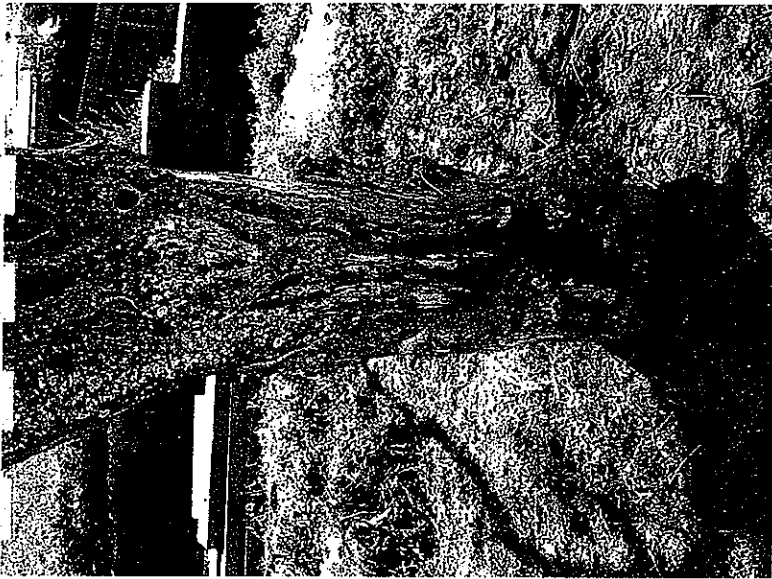
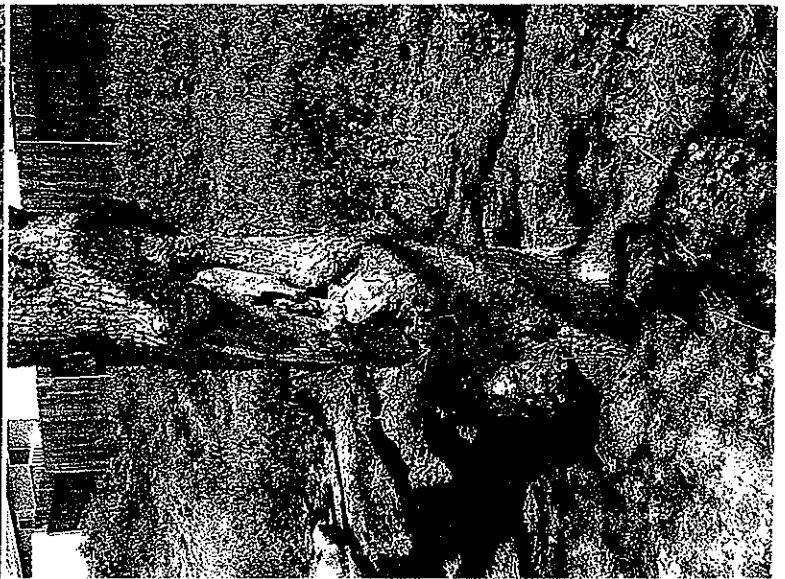
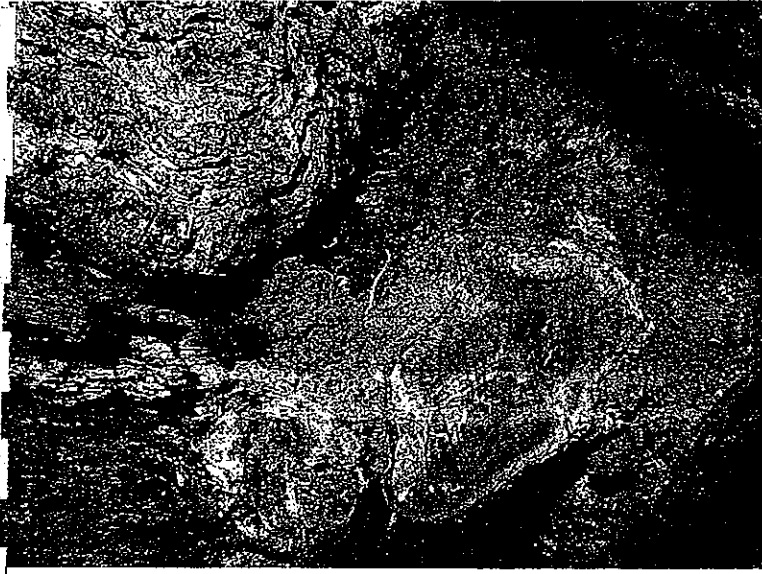
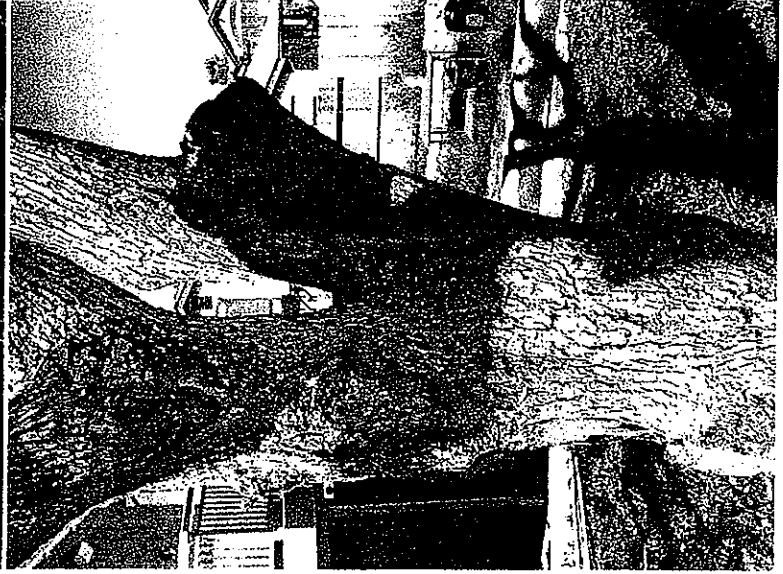
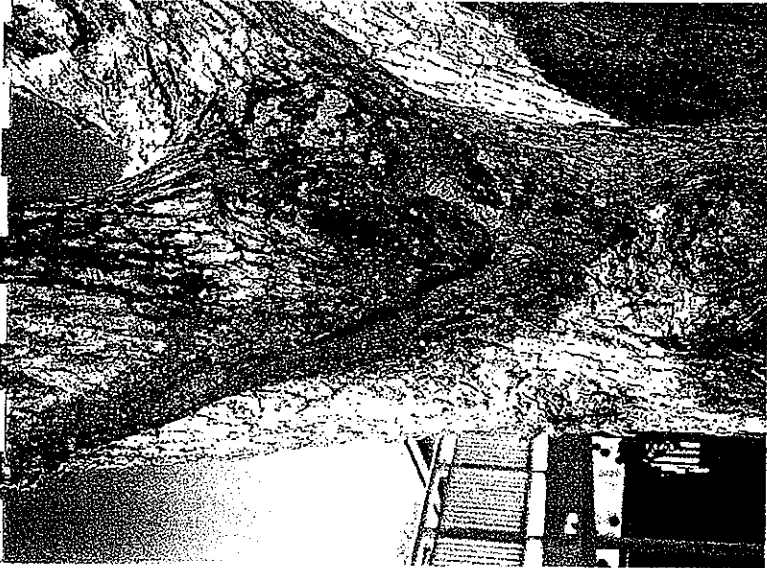
1. The tree is in very poor condition and using the ISA's letter assessment scale we would place it as a 'D' (almost dead to soon to be dead).
2. The distance views indicate that the lower area of the tree is destroyed possibly by fire.
3. The closer views show total destruction of the outer bark and cambium layer almost continuously around the tree.
4. The second page of pictures indicates rot, woodworm, scat from the burrowing insects and destroyed support system of the total tree. All areas that have died or have been injured have a large infestation of woodworm throughout. We did not think that it was necessary to drill the tree to see the extent of rot and death but upon knocking on the tree the damage is deep.

As stated in the abstract we recommend that this tree be removed as a health hazard.
