**TO: James L. App, City Manager**  
**FROM: Robert A. Lata, Community Development Director**  
**SUBJECT: Request To Remove Two Oak Trees – PD 02-016, South Vine Street**  
**DATE: July 5, 2005**

**Needs:** For the City Council to consider a request to remove two oak trees; a 32-inch diameter valley oak (tree #8) and a 25 inch diameter Blue Oak (tree #9) to accommodate pavement widening on South Vine Street.

RE: Palazzo Paso, P.D. #02-016  
Tree Report Addendum #1

Palazzo Paso Robles  
P.D. #02-016

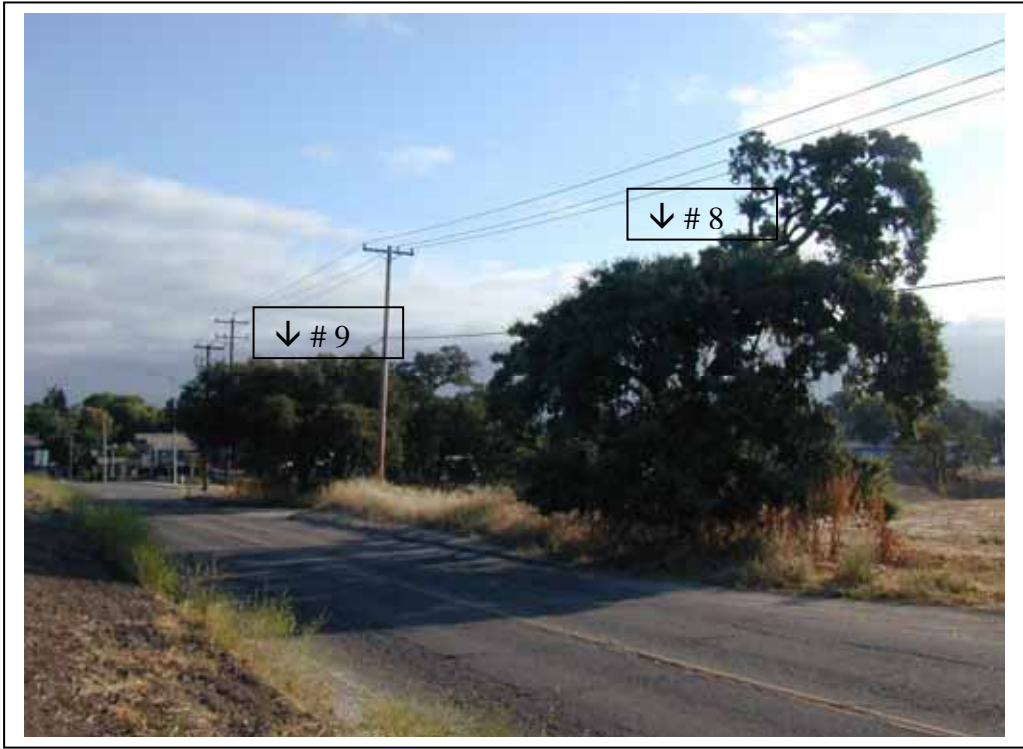
Clearly, this amount of impact is far greater than a tree can tolerate. Cutting roots within eight feet of a trunk will sever the principal roots that hold the tree upright. There will greatly increase the likelihood of the trees falling over. This is the most imminent concern. Additionally, long term problems will arise, including loss of vigor, increased susceptibility to attack from insects and diseases, and reduced ability to fight off wood decay – leading to compromised structural integrity. This last issue is a grave concern for tree #8, which has already

become infested with decay in its main structural limbs. This decay has caused a large (15" dia.) limb to break. Many of the other large limbs are infested with decay. The impact from additional root and canopy loss will cause the decay to get the upper hand in this tree, further increasing the risk for persons or property near the tree.

The chart above shows tolerable impacts to trees #5, 6, 7, 10 and 11. The impacts to trees #8 and 9 are beyond normally tolerable amounts.

I highly recommend removal of trees #8 and 9 if Vine Street will be widened.

My suggestion is to mitigate the removal of these two trees by planting several mature boxed oak trees within the landscape area next to Vine Street. My view is that you should plant four 36" boxed oaks for the loss of tree #8 and three 36" boxed trees for the loss of tree #9. Since tree #8 is a larger tree, it should be replaced with one additional tree. Total mitigation is re-planting seven 36" boxed trees.
