**TO: James L. App, City Manager**  
**FROM: Robert A. Lata, Community Development Director**  
**SUBJECT: Request To Remove Two Oak Trees – PD 02-016, South Vine Street**  
**DATE: August 16, 2005**

**Needs:** For the City Council to consider a request to remove two oak trees; a 32-inch diameter valley oak (tree #8) and a 25 inch diameter Blue Oak (tree #9) to accommodate pavement widening on South Vine Street.

RE: Palazzo Paso, P.D. #02-016  
Tree Report Addendum #1

# Tree Preservation Report

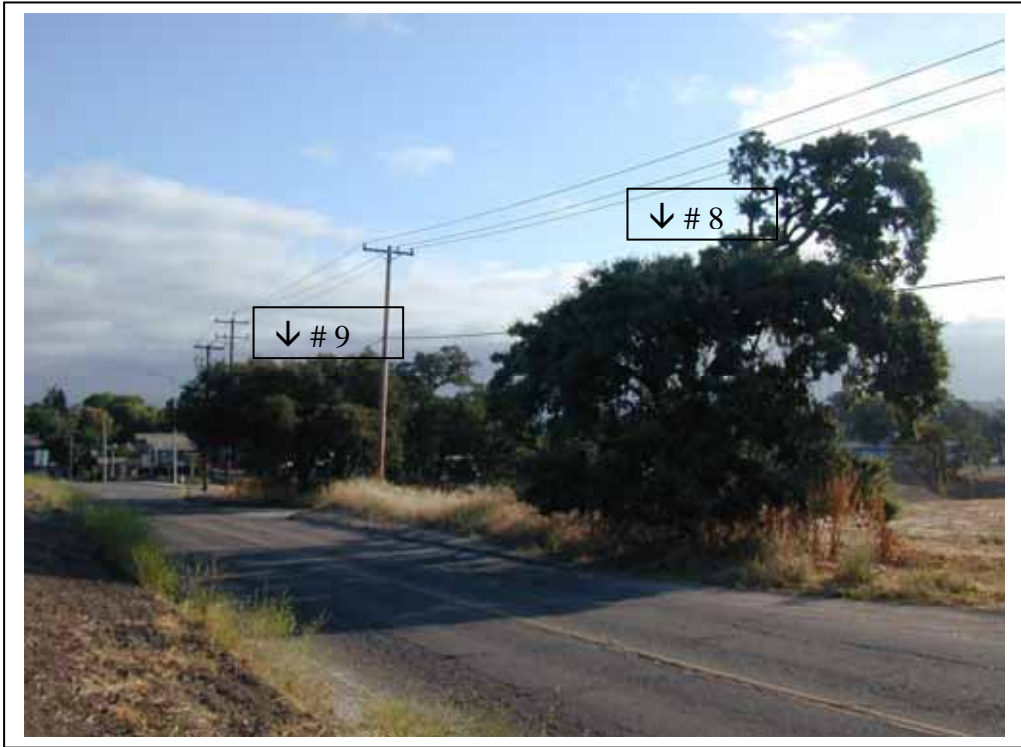
Planned Development PD 02-016  
Request to Remove Two Oak Trees  
To Accommodate Pavement Widening on South Vine Street

5. An arborist report prepared by Carolyn Leach, dated 3-18-03 and subsequent letter dated 5-6-05 (both attached) describe the trees as "infested with decay" and unable to survive the widening of South Vine Street.

become infested with decay in its main structural limbs. This decay has caused a large (15" dia.) limb to break. Many of the other large limbs are infested with decay. The impact from additional root and canopy loss will cause the decay to get the upper hand in this tree, further increasing the risk for persons or property near the tree.

I highly recommend removal of trees #8 and 9 if Vine Street will be widened.
