SUBJECT: OTR 05-008 - REQUEST TO REMOVE TWO OAK TREES (CARDINALE/MORRIS)

TREE EVALUATION REPORT

Cardinale Property
South-west corner Oak & 4th Streets
Paso Robles, California

INSPECTION OF OAKS ON VACANT PARCEL OF LAND
APN 009-256-008 IN THE CITY OF PASO ROBLES

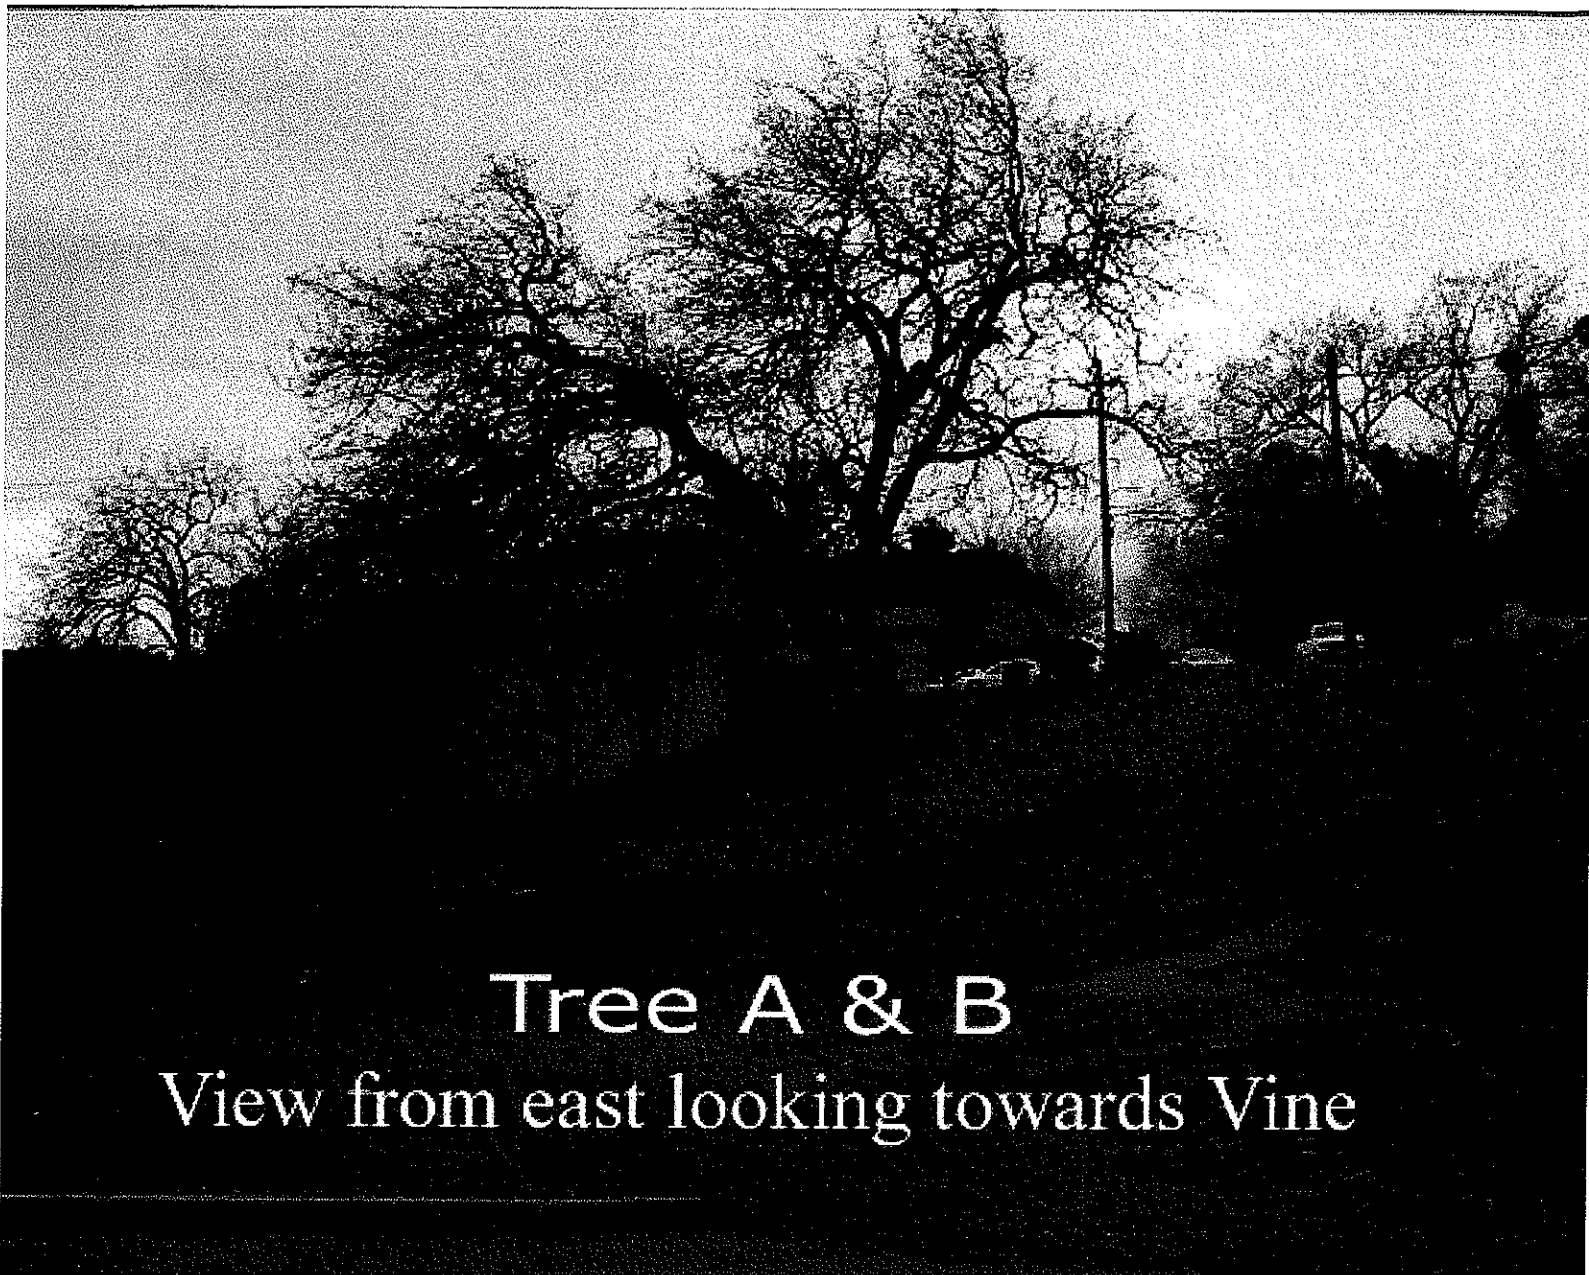
**Attachment 3 (c)
Photos
OTR 05-008
(Cardinale/Morris)**

Tree A & B
View from east looking towards Vine

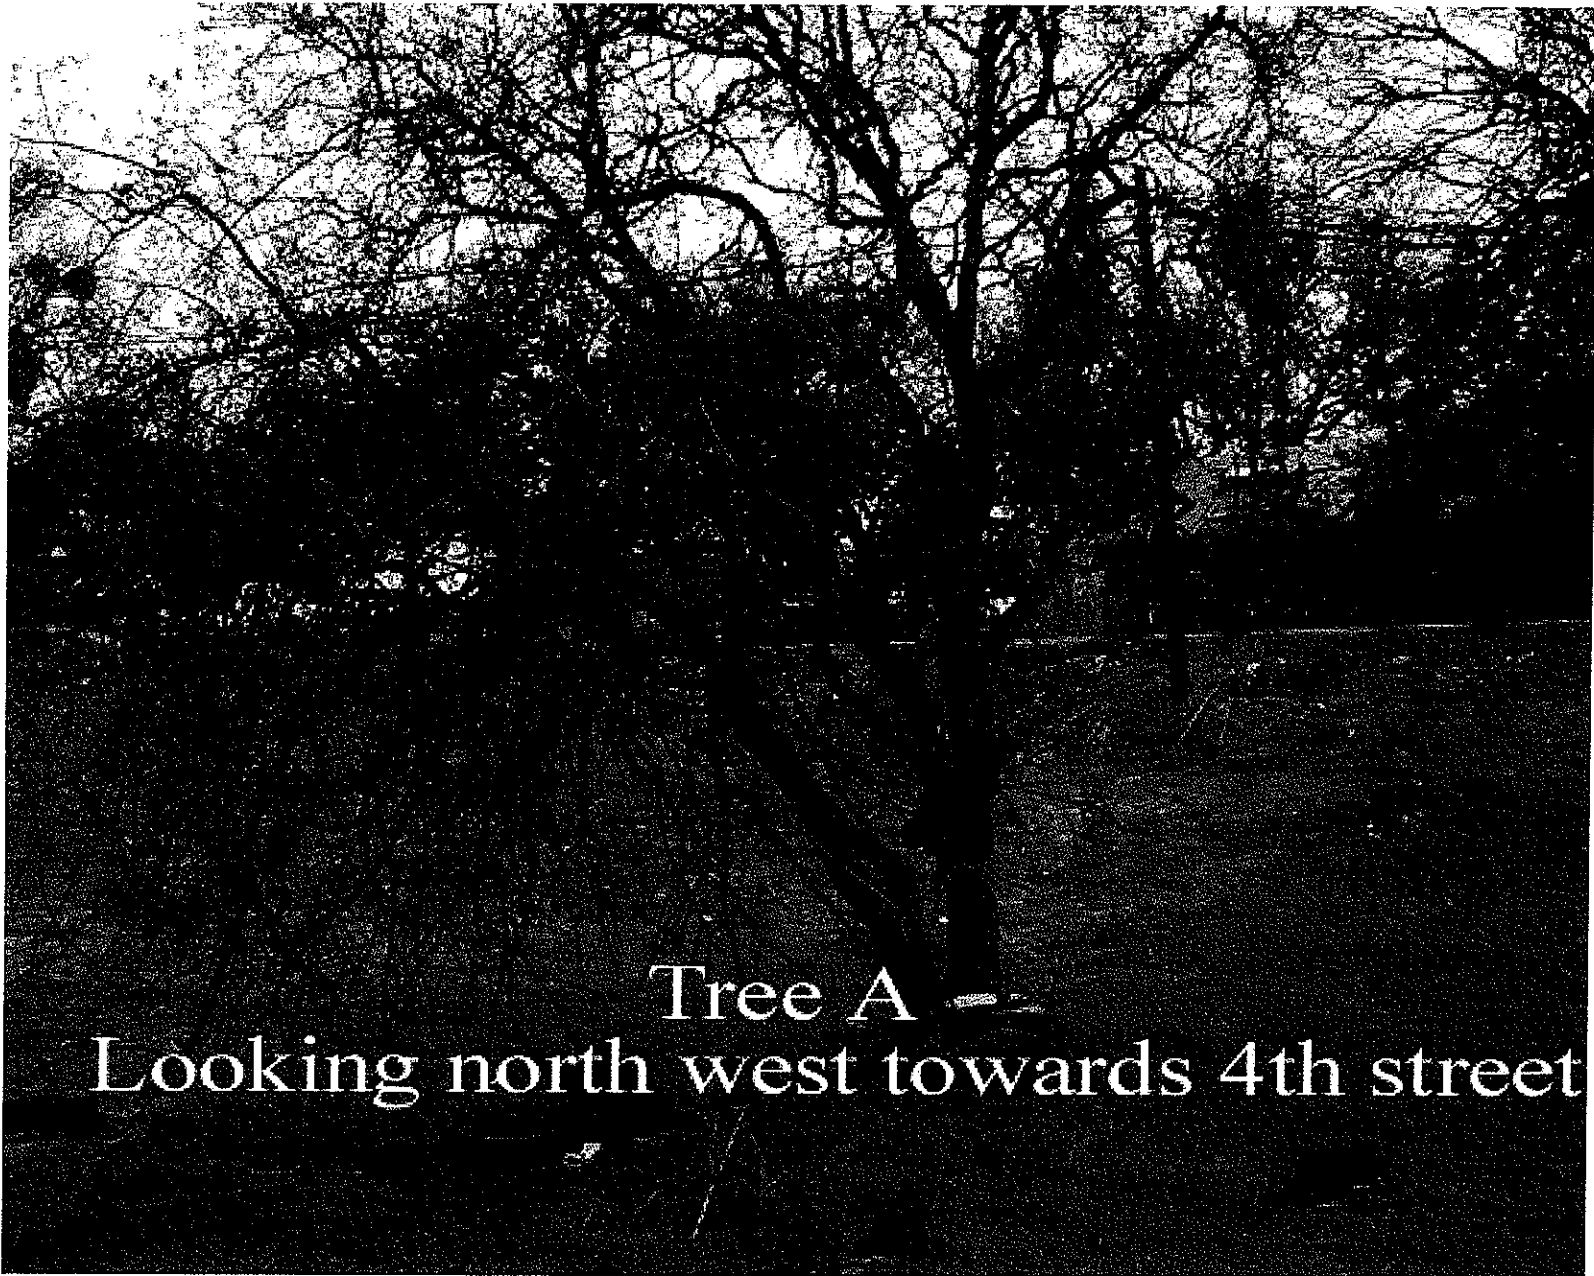
Tree A
Looking north west towards 4th street

- Tree "A" is a blue oak (*Quercus douglasii*) with a triple trunk that measures 14" / 8" / 12" in diameter. These three trunks join at about a foot above grade with a very wide, strong crotch. The smaller of the trunks has been cut back to a stub about eight feet long, and has since sprouted much new sucker growth. The tree has an overall canopy density of 75%, which is normal for this specie. The canopy is nearly symmetrical, with slightly more growth on its south side, where it reaches down to ground level. It is growing at a normal rate, with last season's twig growth measuring from 6 to 14 inches long. The size and quantity of leaves on the ground are normal. All of next year's buds appear plump and normal. There is no tip dieback of the outer canopy.

The structural integrity of Tree "A" is very good. I found little or no decay within the trunk and main scaffold branches. Some dead branches exist within the interior of the canopy, mostly two inches in diameter or less. They most likely died when the interior leaves became overly shaded by the parts of the canopy that grew above them. The deadwood can be easily pruned away.

There is a slight wound on the top of the 8" trunk from a hand ax, and a small pocket of decay (3" wide) at its base. Since this trunk has very little limb weight, this does not pose a risk.

Tree “A”	Prune deadwood, train new branches on 8” trunk, monitor
Tree “B”	Prune deadwood, monitor
Tree “C”	Perform full hazard tree inspection to assess strength loss from lower trunk cavity, remove deadwood
Tree “D”	Fence entire area around tree to prevent injury in case of root failure, excavate soil at tree base to provide air to major buttress roots, provide positive drainage away from trunk and root area.

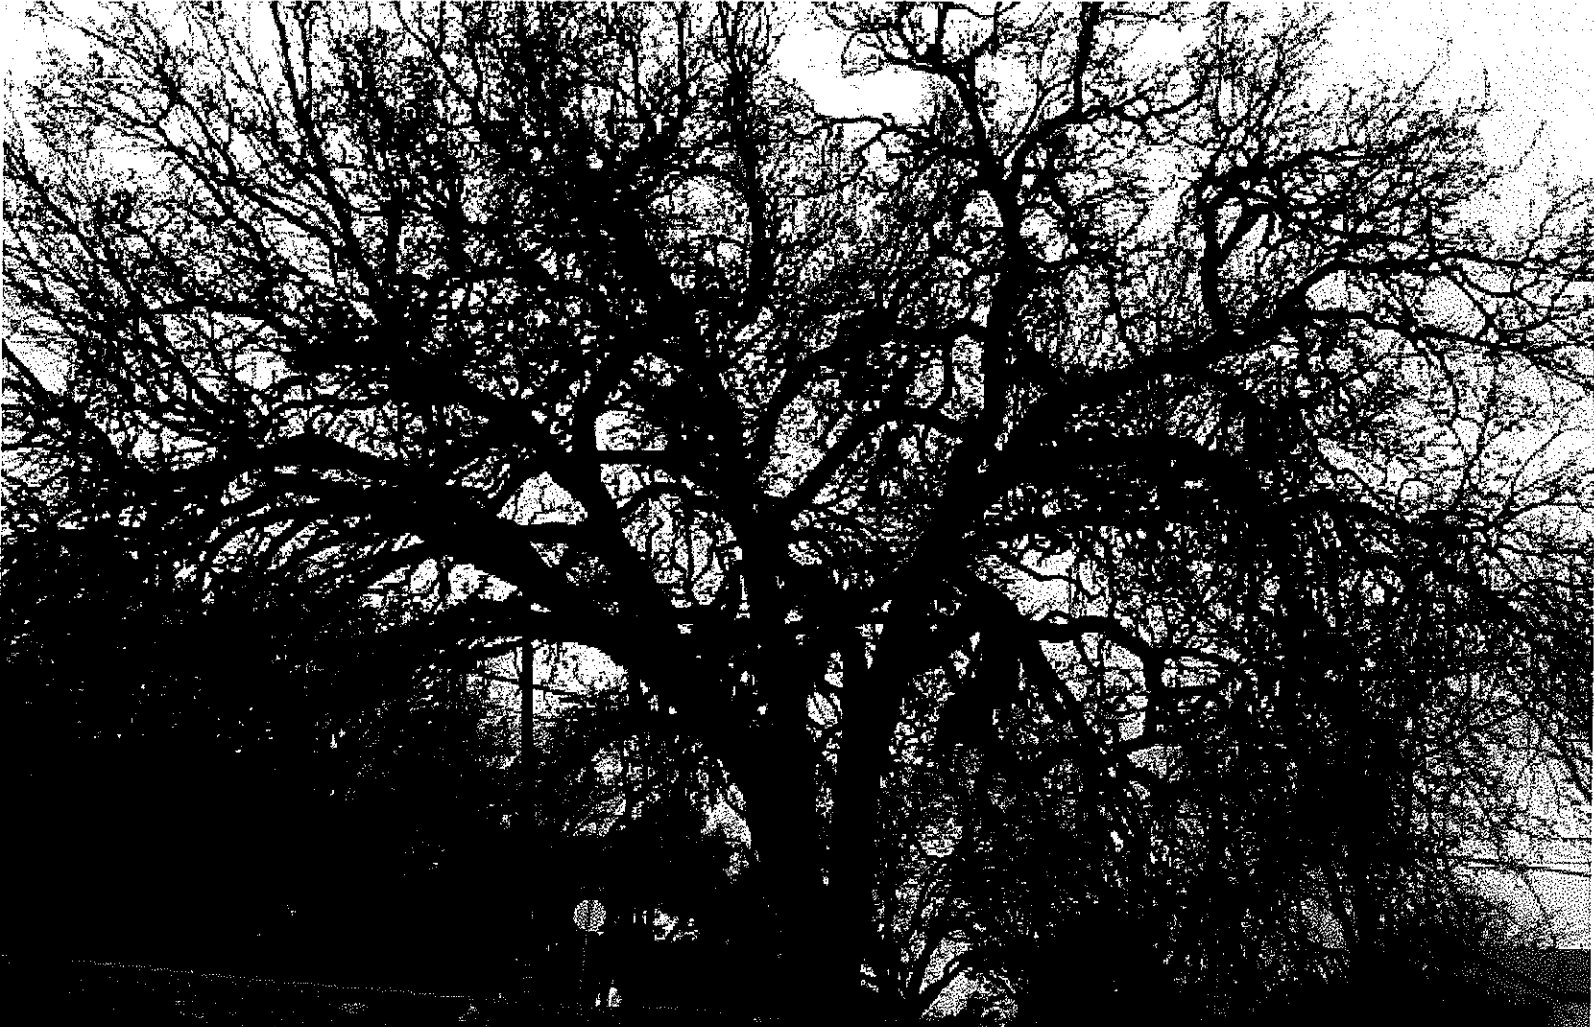
**Attachment 3 (e)
Photos
OTR 05-008
(Cardinale/Morris)**

Tree B
Looking north towards 4th street

- Tree "B" is a blue oak with a single trunk measuring 26 inches in diameter. The main trunk forks into two trunks of equal size at 8 feet above grade. A large 14" diameter main scaffold limb was removed from the north side of this tree about two or three years ago, removing about 20% of the canopy of this tree. There is no decay visible in this cut. The remaining canopy

has a 70% density – normal for the specie. The tree is symmetrical in shape and has good branch spacing throughout the canopy. Twig growth from last season measures 3 to 20 inches long. Leaf size and quantity observed on the ground was normal. New buds were plump and numerous. The canopy spreads to within five feet of the ground on the south side of the tree. The vigor of this tree is normal.

The trunk generally appears normal, with no decay visible (or by sounding with hammer taps). The bark on the trunk is normal with the exception of three recent mechanical wounds measuring 4", 4" and 10" wide. There was no decay visible within these wounds. The tree should be able to easily withstand these injuries. Decay might, over time, start in the largest of the three wounds, and should be monitored.

The main scaffold branches have very little visible decay. There are a few smaller branches in the interior of the canopy that are dead. Again, these are from canopy shading and can easily be resolved by pruning the deadwood away.
