SUBJECT: OTR 05-008 - REQUEST TO REMOVE TWO OAK TREES (CARDINALE/MORRIS)

DATE: APRIL 4, 2006

Attachment 2 (b)
Photos
OTR 05-008
(Cardinale/Morris)

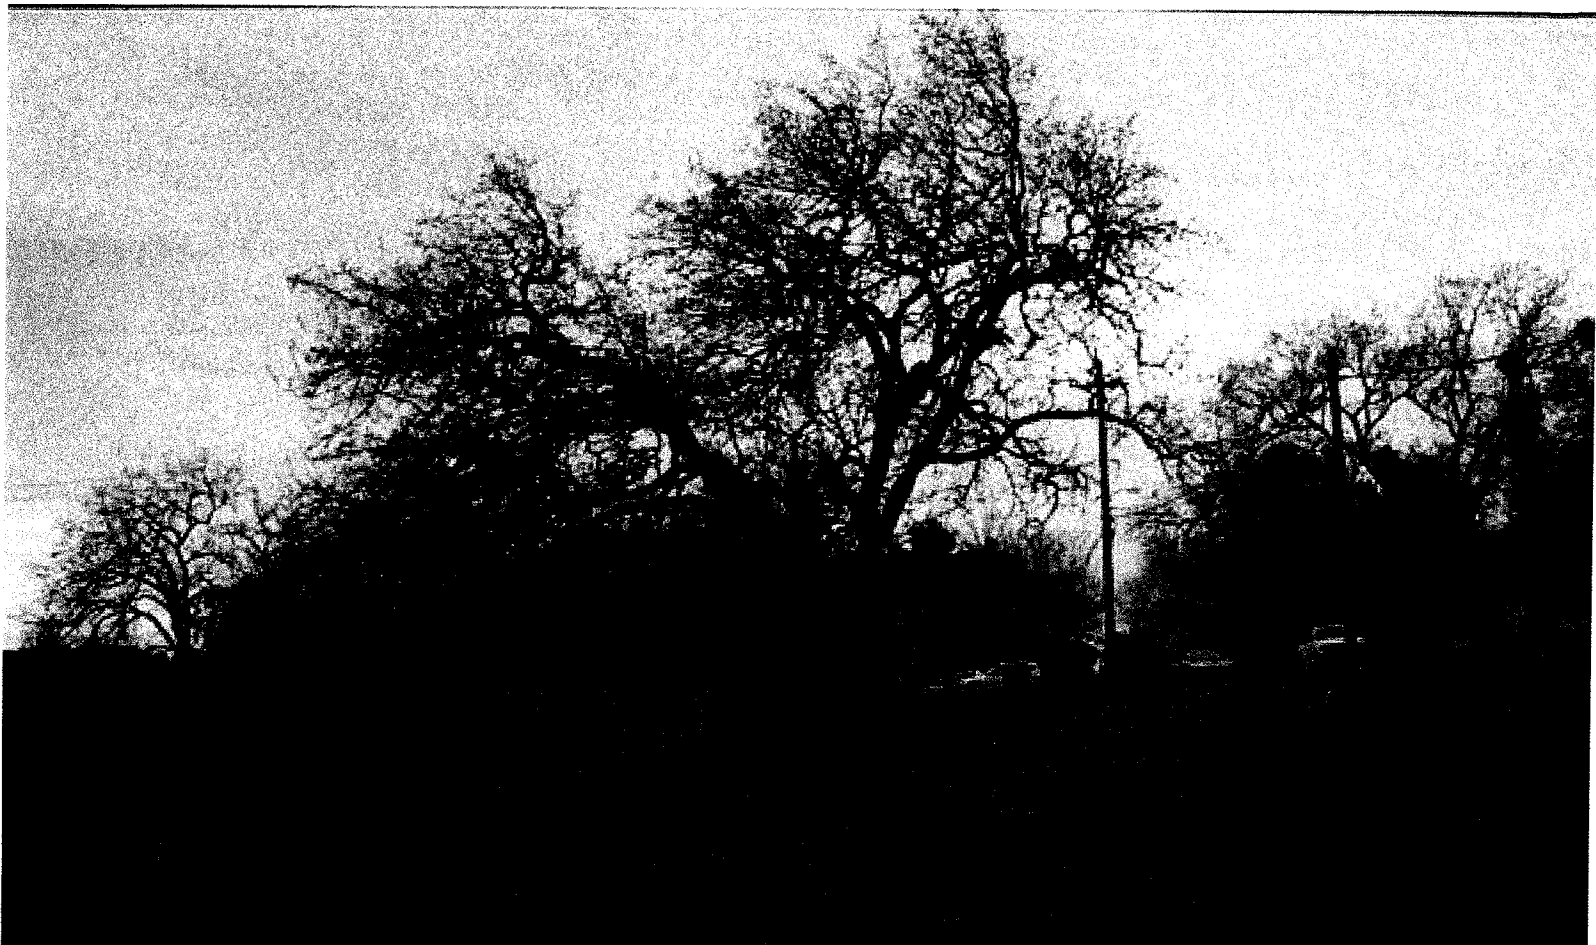
Attachment 2 (c)
Photos
OTR 05-008
(Cardinale/Morris)

Tree A & B
View from east looking towards Vine

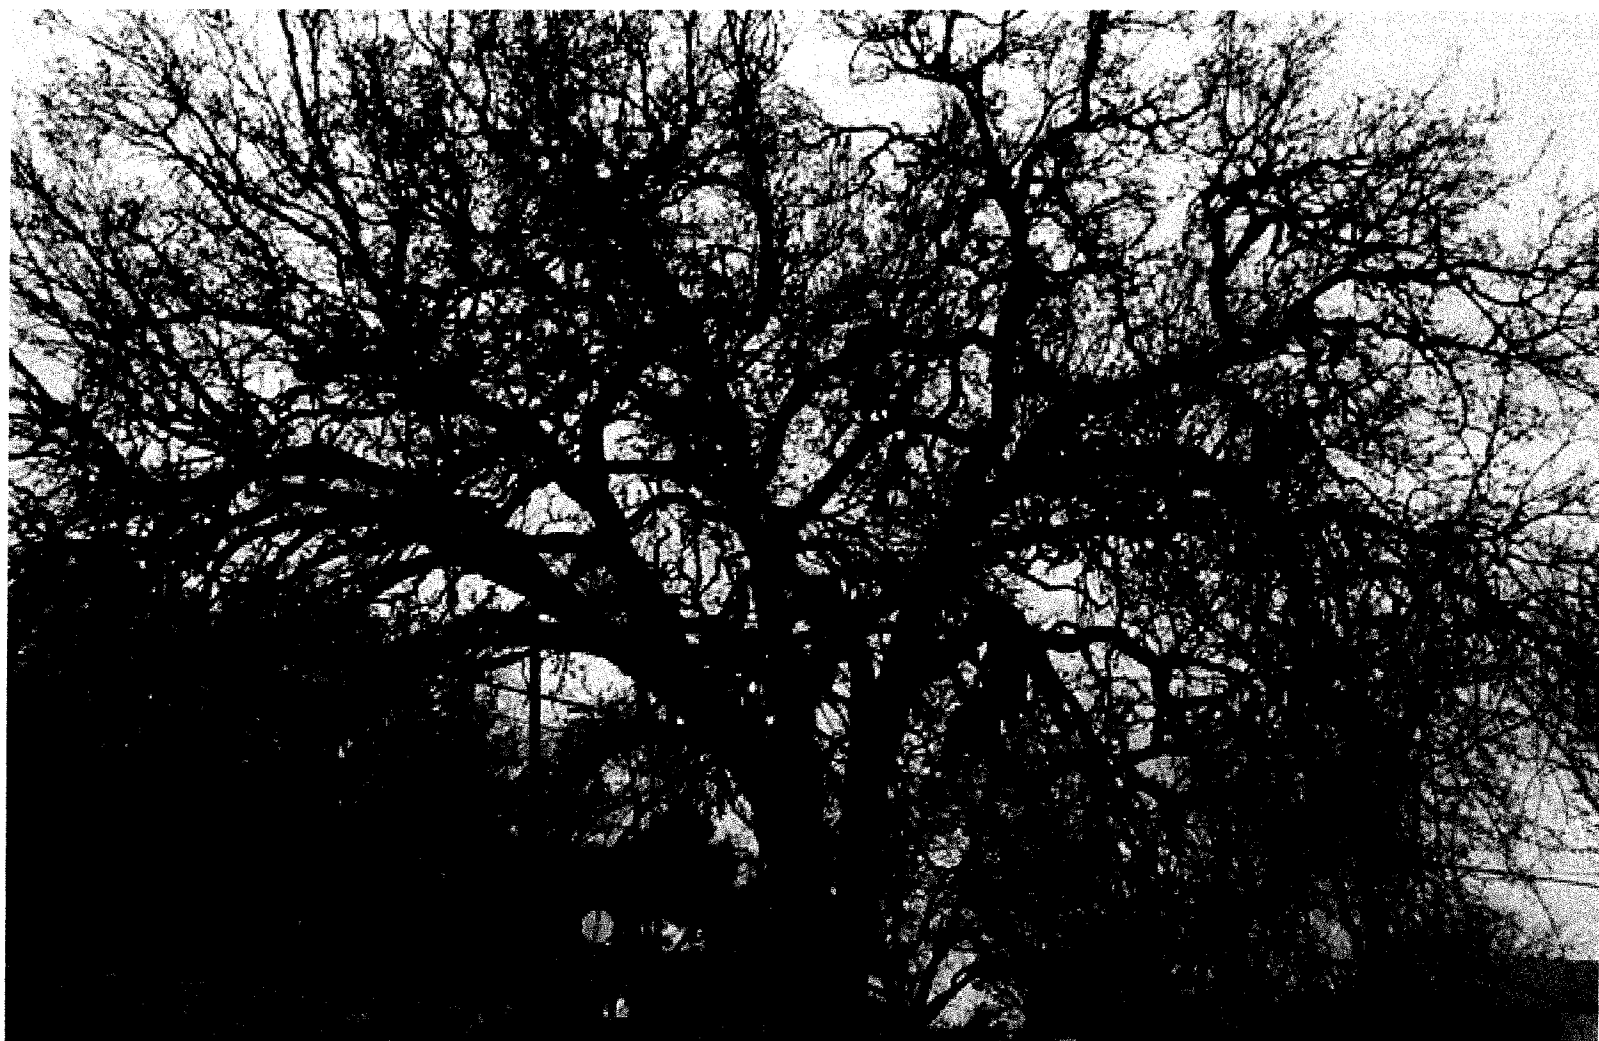
**Attachment 2 (e)
Photos
OTR 05-008
(Cardinale/Morris)**

Tree B
Looking north towards 4th street

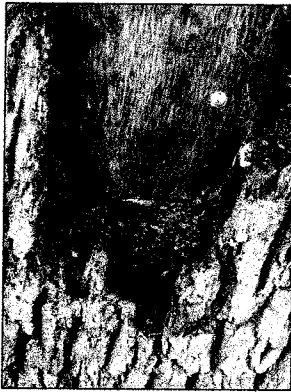
The pictures on page four are examples of various types of damage done to the trees over the years. If you look closely, you will find that in some of the cases the tree made an attempt to seal itself from its injuries. There is a tan colored callous material formed around the wound. In some of the pictures you will see that the tree was unable to protect itself with that callous material. These unprotected areas are where the various pathogens were able to enter the tree.

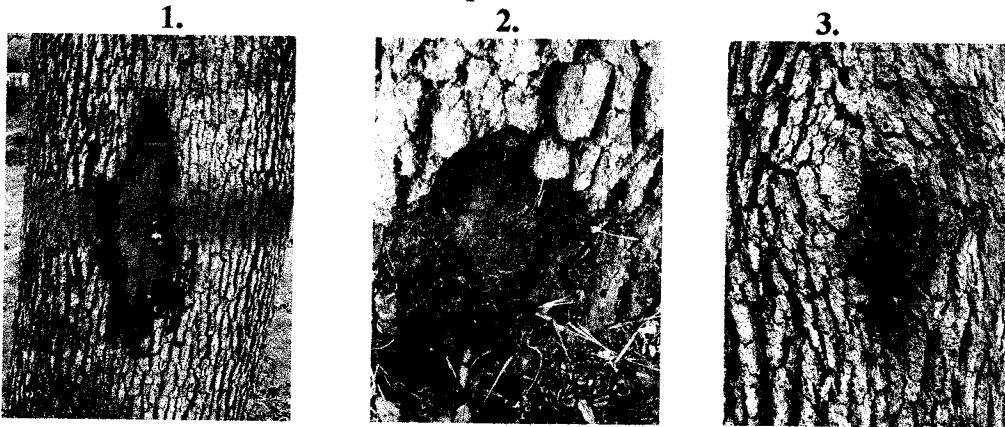
TREE HEALTH, THE TRUNK OF "A"

As mentioned earlier, a tree has the ability to seal itself in response to some injuries. From a distance the trunk of tree "A" appears to be sound and healthy. Taking a closer look, it becomes evident that there are serious problems associated with this tree's vigor. There are two prominent injuries to the bole (trunk) of this tree, pictures 1 & 2. Both appear to have been caused mechanically, something or somebody striking the tree in the past.

The injury in picture number three appears to be a result of the loss of a branch. The important issue regarding all three injuries is that none of them have been able to seal themselves. The wound in picture 1 is to a greater extent than meets the eye. Upon examining the wound, I found that the bark has separated from the tree several inches in all directions beyond what is visible to the eye. There is evidence of rodent activity, nesting in the separated portion of the bark. With the tree unable to seal this wound, the damage will only worsen. The wound seen in picture two is similar to that of picture 1. This wound is at ground level, probably mechanical in nature. Again, the tree has not been able to seal itself. The damage will only increase with time. There is evidence of insect activity associated with this wound. In picture three, there is a small wound, which is not sealing; there is evidence of weeping with fluid oozing from the break in the bark. This is another entry point for pathogens.

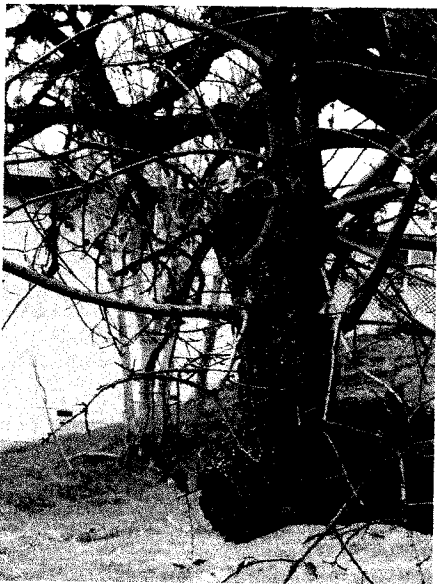
TREE HEALTH, THE CROWN OF "B"

The crown of this tree is producing less vegetative material than that of tree "A". Comparing the live portion of the crown in this tree to what a healthy tree of same size and species should have, I estimate that this crown is approximately 30% live.

This tree is in a much Further stage of decline than tree "A".

Most of the live portions of the crown can be seen in the very upper portion of the tree, the very fine, long, thin stems in the upper crown are the stems still producing vegetative buds. In the lower portion of the crown, the thicker branches are not producing much in the way of vegetative buds. In many of these thicker branches, one can see where the rot and decay has set in. In a normally healthy tree these branches should be producing vegetative buds; again, as with tree "A", these are not. It was also noted that in the lower portion of the crown there is evidence of improper pruning. The end result of this pruning is shown in the picture below. There are two pruning locations in this

picture. The upper cut shows signs of the tree attempting to seal itself, evidenced by

the tan colored callous material surrounding the pruning cut. It almost sealed it completely. The lower cut seen in the picture did not seal at all. Both of these wounds are entry points for pathogens. Another issue to consider with the upper pruning cut is the response by the tree. Though the wound began to seal itself, it also produced "water sprouts". Those small branches emanating from around the pruning cut will eventually increase in size but because of the nature of water sprouts, they will produce attachment to the parent limb. They will be more susceptible to failure at the attachment point.

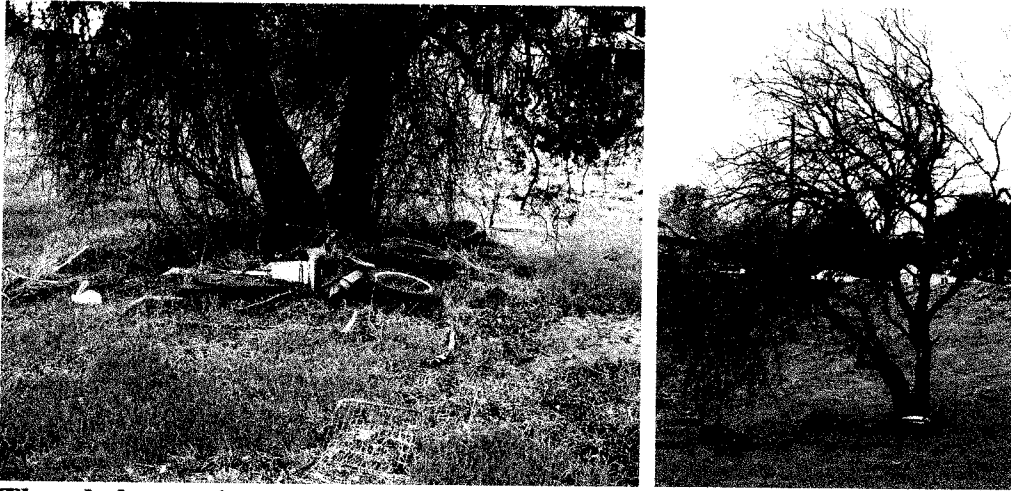
TREE HEALTH, LAND USE

The following are pictures illustrating how this parcel has been abused in the past.

The whole area is scattered with various types of debris, old tires, shopping carts, auto parts, household items all dumped near or around the base of these trees. Judging by the debris dumped in and around the trees on this parcel indicates to me that there is little concern shown for the condition of these trees.
