SUBJECT: OTR 07-002 - REQUEST TO REMOVE ONE OAK TREE AT 751 LONGHORN COURT (TOM HORNE)

DATE: MAY 15, 2007

Vicinity Map
 OTR 07-002
 751 Longhorn Court
 (Tom Horne)

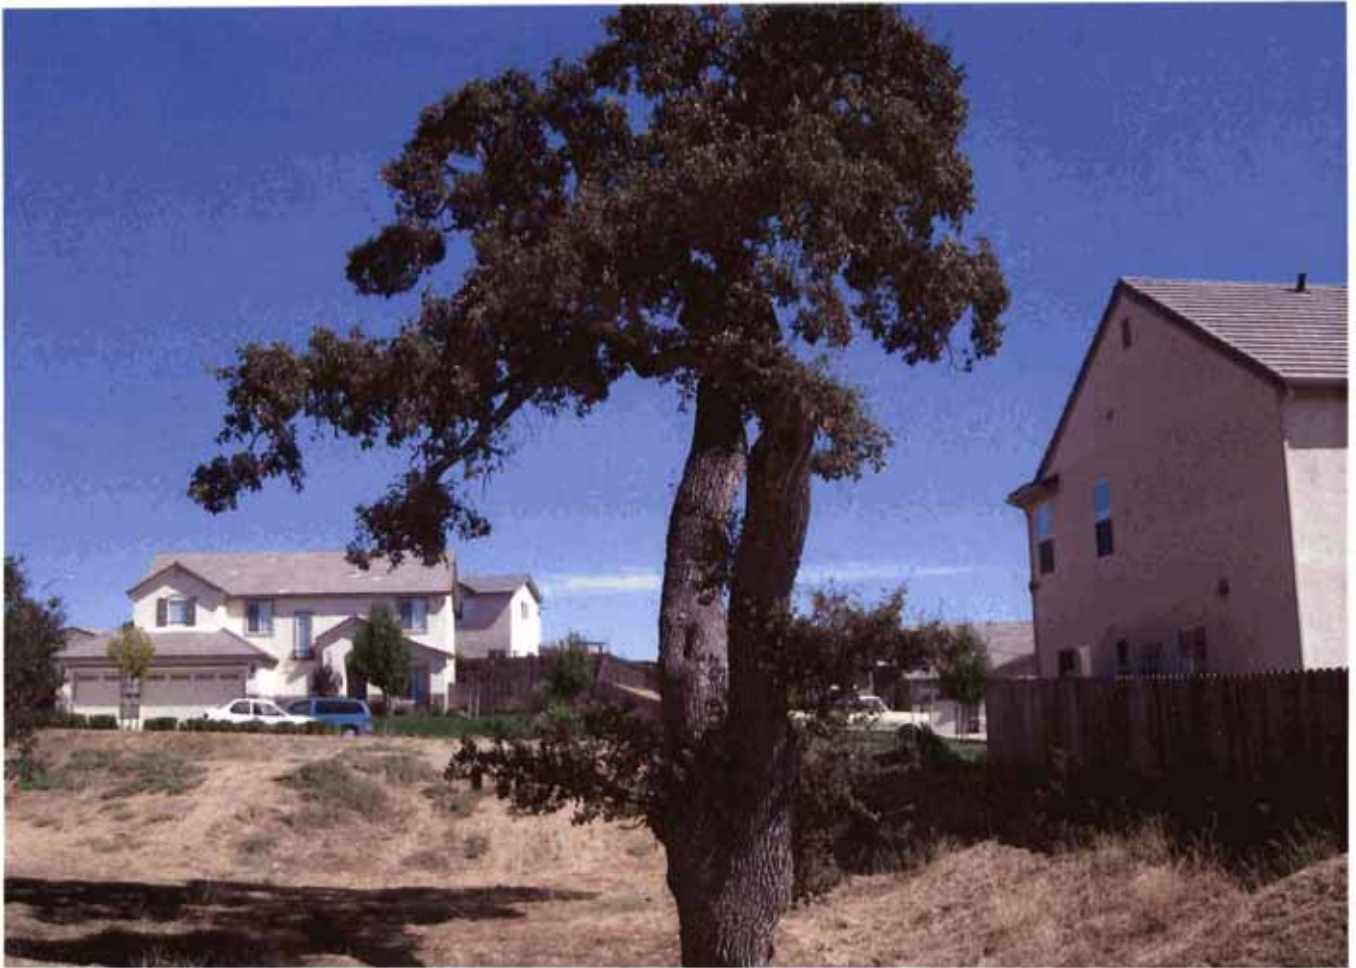
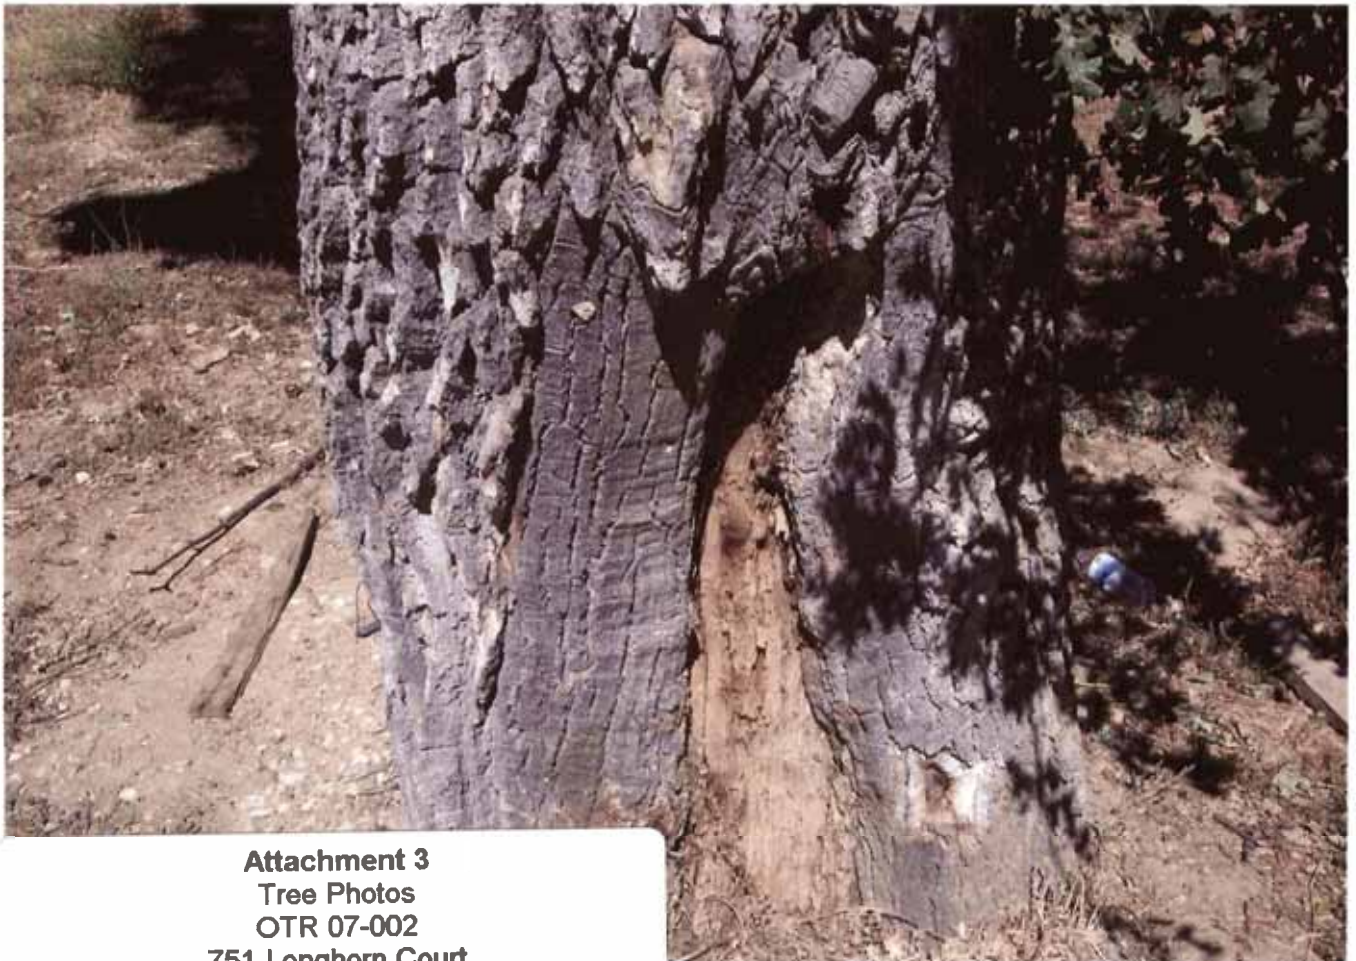
Attachment 3
Tree Photos
OTR 07-002
751 Longhorn Court
(Tom Horne)

- a. the tree has had recent massive failures, resulting in 1/3 to 1/2 of the canopy of the tree falling off;
 - b. the remaining scaffold has multiple cavities;

- c. the base of the tree is decayed, resulting in 30 percent cambium loss;
6. Section 10.01.050, of the Oak Tree Ordinance, allows the City Council to waive the requirement for the applicant to provide replacement trees if it can be proven by a City approved Arborist that the trees decline was from natural causes.

Chip Tamagni from A&T Arborists submitted a report along with a request for removal on May 12, 2006. The report (Attachment 3) describes the health of the subject tree as being a 1 on a scale of 1-10, with 10 being the best. Tamagni states that the tree is in severe decline, is a hazard, and needs to be removed, based on the following reasons:

- a. the trees has had recent failures, resulting in 1/3 to 1/2 of the canopy of the tree falling off;
- b. the remaining scaffold has multiple cavities;

- c. the base of the tree is decayed, resulting in 30 percent cambium loss;
2. *The necessity of the requested action to allow construction of improvements or otherwise allow reasonable use of the property for the purpose for which it has been zoned. In this context, it shall be the burden of the person seeking the permit to demonstrate to the satisfaction of the director that there are no reasonable alternatives to the proposed design and use of the property. Every reasonable effort shall be made to avoid impacting oak trees, including but not limited to use of custom building design and incurring extraordinary costs to save oak trees;*

- Options:**
- A. Adopt Resolution No. 07-xx approving OTR 07-002, allowing the removal of the 46-inch Valley oak tree, based on the tree being in poor health and low aesthetic value and that the removal is necessary in order to prevent damage to existing and proposed homes, and require two (2) 1.5-inch diameter Valley Oak replacement trees;
 - B. Amend, modify or reject the above options.
