**TO: JAMES L. APP, CITY MANAGER**  
**FROM: RON WHISENAND, COMMUNITY DEVELOPMENT DIRECTOR**  
**SUBJECT: OTR 07-001 - REQUEST TO REMOVE ONE OAK TREE AT 849 OLIVE STREET (FRED SEAVER)**  
**DATE: JUNE 5, 2007**

# A & T ARBORISTS

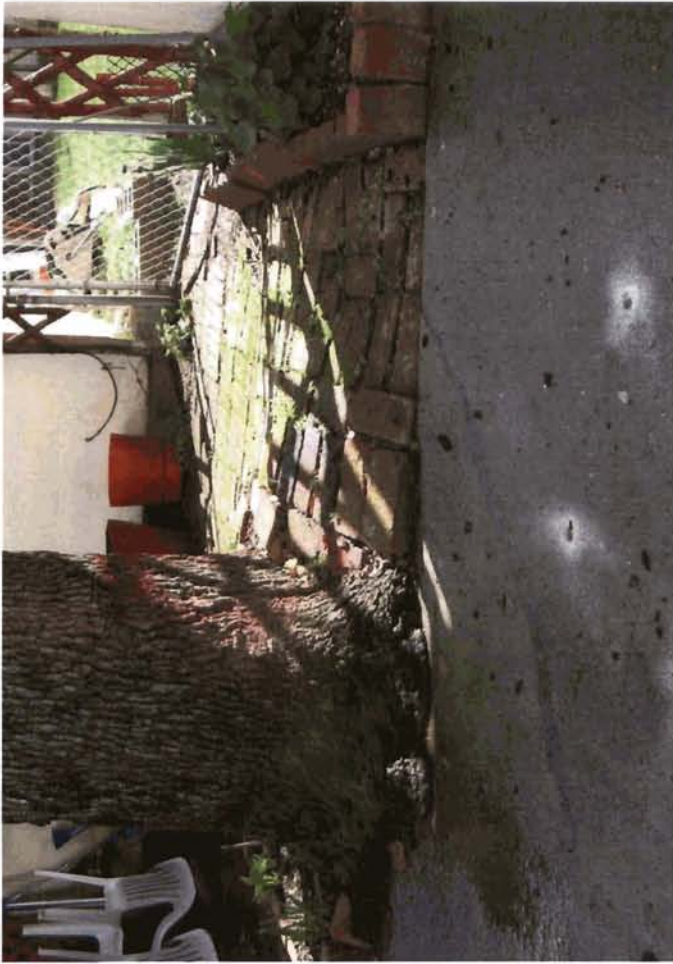
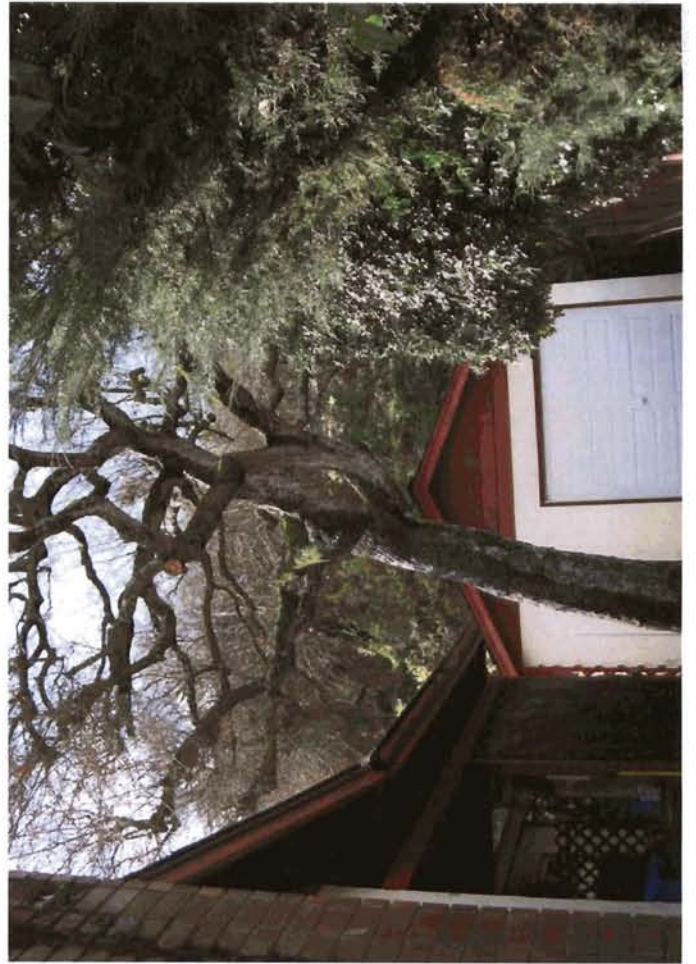
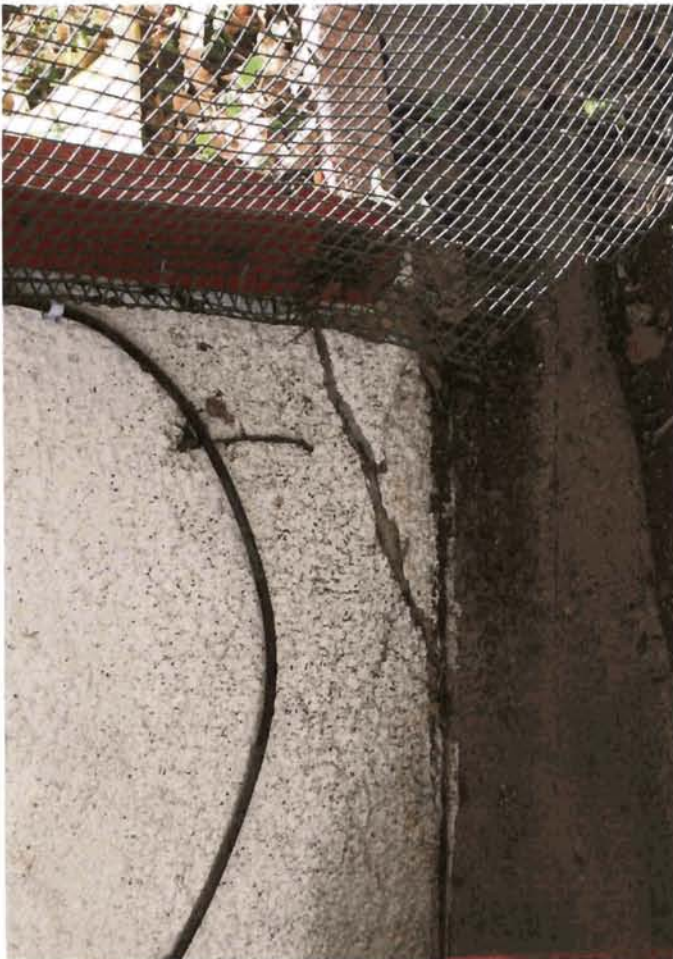
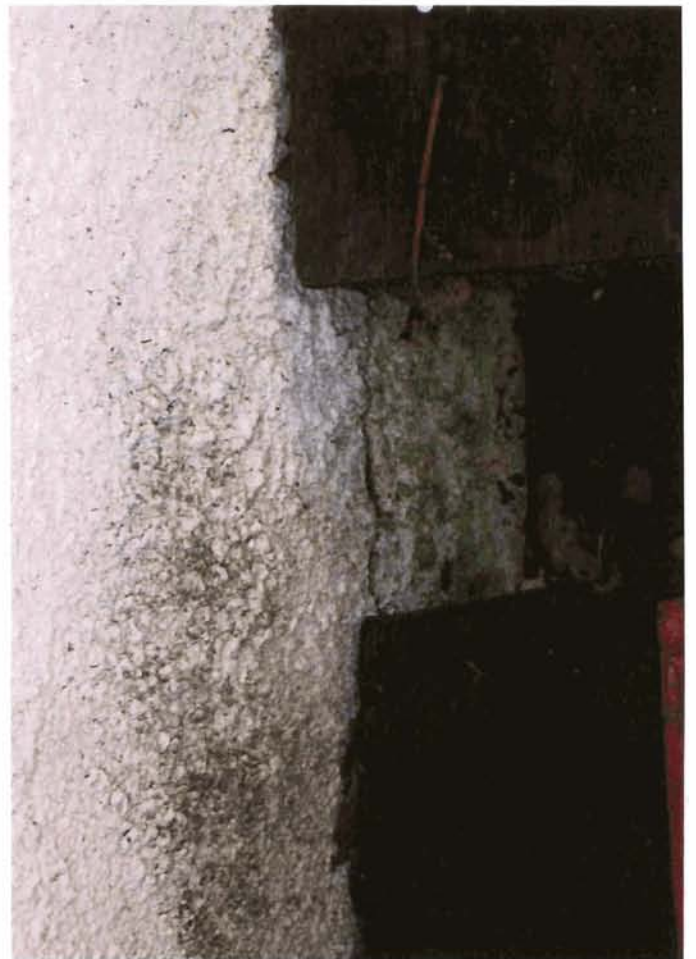
**Observations:** Over the years, the tree has continued to grow in the limited root space available. It has buckled the driveway in places resulting in cracks and heaving of the concrete. In addition, roots appear to be causing concrete cracking in the garage. Within the last two years, cracks have developed along the foundation of the home (see photos). The tree has a 20 degree lean over the garage. There are no apparent major above ground deformities in the tree.

**Conclusions:** Utilizing current building practices within the critical root zone, the tree would have to be removed in order to build safely in that location. The tree was approximately one half its current age at the time of the home construction. The tree has adapted to its current environment with regard to concrete and footings. In order to mitigate the damage being caused from the root system, roots would have to be severely pruned that could easily render the tree unstable. Root expansion will continue and additional damage will occur to the Seaver's property. The tree is outgrowing its environment and root area.

**Recommendations:** Remove the tree to halt the continuing damage from the root system. The owner is willing to donate to the city tree fund per 10.01.050 section F and make the appropriate deposit per section 10.01.050 section A to move this action to the city council.
