TO: JAMES L. APP, CITY MANAGER
FROM: RON WHISENAND, COMMUNITY DEVELOPMENT DIRECTOR
SUBJECT: OTR 08-005 - REQUEST TO REMOVE ONE OAK TREE AT 550 RIVER OAKS DRIVE (JERRY FELGENHAUER)

DATE: April 15, 2008

December 3, 2007

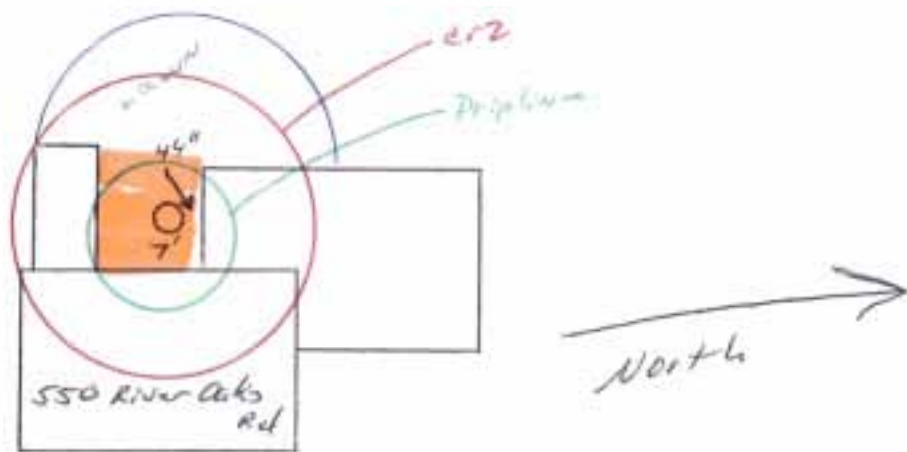
550 River Oaks Road
 Jerry Felgenhauer
 Poso Robles, CA 93466

The site is landscaped nicely the subject tree has a multi event hardscape setting taking up 80% of the trees critical root zone with the remaining 20% in well watered lawn.

The subject blue oak tree is growing at the rear of the home 7 feet from the foundation and 44" from a patio covering. Tree is approximately 45' tall and has a 45' spread, the trunk diameter is 33".

The soil within the CRZ is compacted, sealed with hardscape and excessive watering from the lawn area.
