SUBJECT: OTR 09-003 - REQUEST TO REMOVE ONE OAK TREE AT 803

**HOGAN PLACE (GRANT NIELSON – RICHARD GRACIE)**

**DATE: JANUARY 19, 2010**

Attachment 3
Arborist Report
OTR 09-003

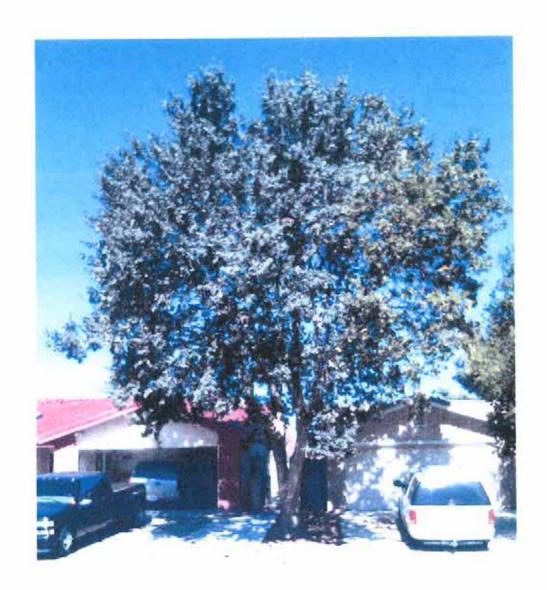
Photo I

•			
Cable/Brace:	<u> </u>			☐ decay ☐ aerial ☐ monitor
Remove tree: N Repla	ace? Y (N) Move targe	et: Y Other:		
Effect on adjacent trees: Kr	ione 🔲 evaluate			
Notification:	anager 🗆 governing agenc	v Date: 11-4-0	9	
COMMENTS		<del></del>		***
!) Please Revi	ew afachec	Report Dat	Ed 11-4-09	
) Trease c res	,			
) Photo # 1 ou	er all View	s site about	eristre g	
y provide		1	-1	. touch and

Show lover all Ht & Width, 80% L.C.R and ste charter residence between Drive ways. Photo #2

After examination and review of the subject tree we recommend that the tree be removed.

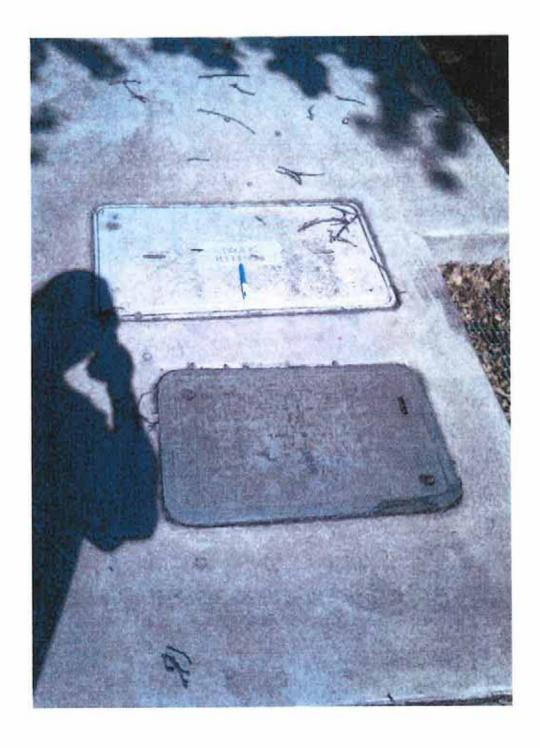
The tree part most likely to fail is not the question for the subject tree, what needs to be focused on is the subsoil structure of the tree as the tree has been planted as a landscape tree between two driveways and within growing distance of the nearby resident foundations, the trees roots are currently impacting the driveways, foundations, sidewalks and utility vaults.

1) Photo#2 She	ows Elect, To	phone valts	8 from man	3
0	- all Ready	impacting fo	cilities.	
) of 1, 4/2 i	all rection		in the contract of	1 1 Halingt
photo=3 Show	scaffold .	attachments,	these Verot	ched attachement
are	very weak, a.	Howing Futher	Growth w.	ell evente a
West	hazard si	Freakon		
			11 4	1. 20 -1
The bygest &	woblesen wit	h the subject	y-tver is the	in perdeng por
Agenda Item No.	71/442age_10_0	JADON of Drive	ewin - The w	il be runed.

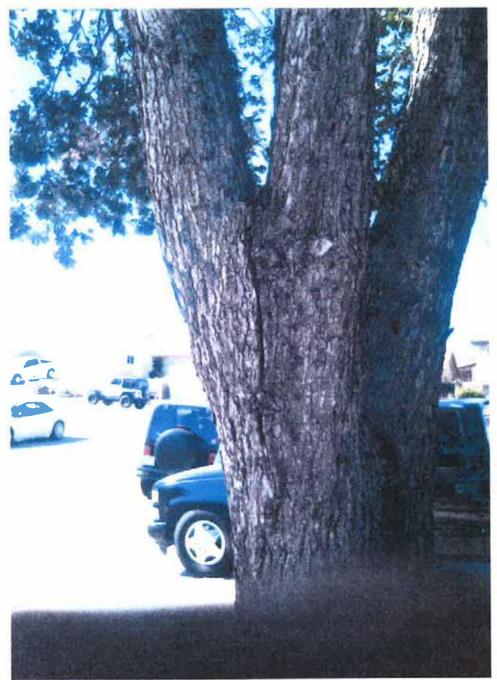
Photo#3

Tree defects have been documented as having excessive "V" crotches, such crotches are very structurally weak and a prone to failure when allowed to grow.

shows V' drotable - those are structurely weak - vertually all major scaffold brivalen are growing the this, This will evente a most thereof situation of allowed to brow larger

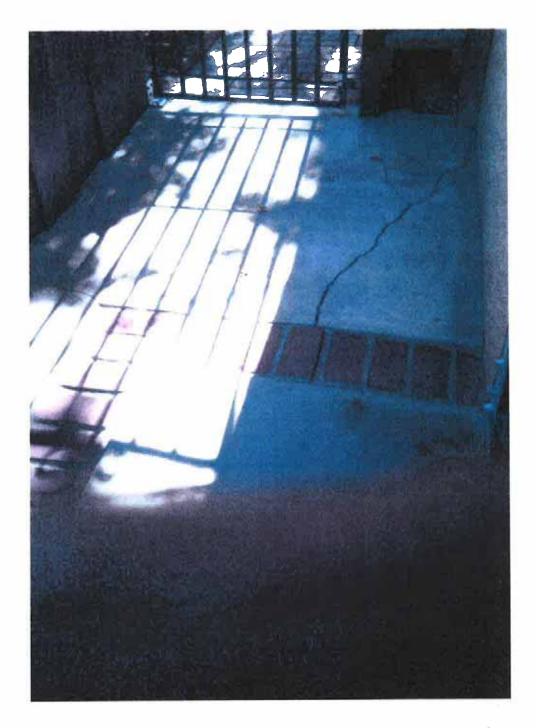
Ple to # 4

The subject tree's roots will most certainly ruin the nearby driveways, foundations, sidewalks and utility vaults.

Hows: cracked walk way No tree
