## Council Agenda Report

Subject: Continued Hearing -- Oak Tree Removal Permit (OTR 16-004) / 1803 Spring Street.  
regarding a request by Bruce Eisengart (property owner / applicant) to approve the  
removal of one potentially hazardous 44-inch Valley Oak tree

November 1, 2016

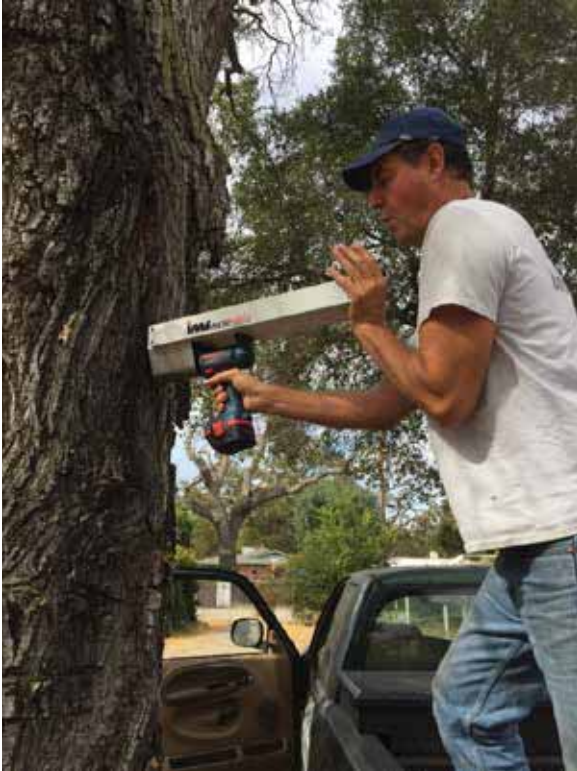
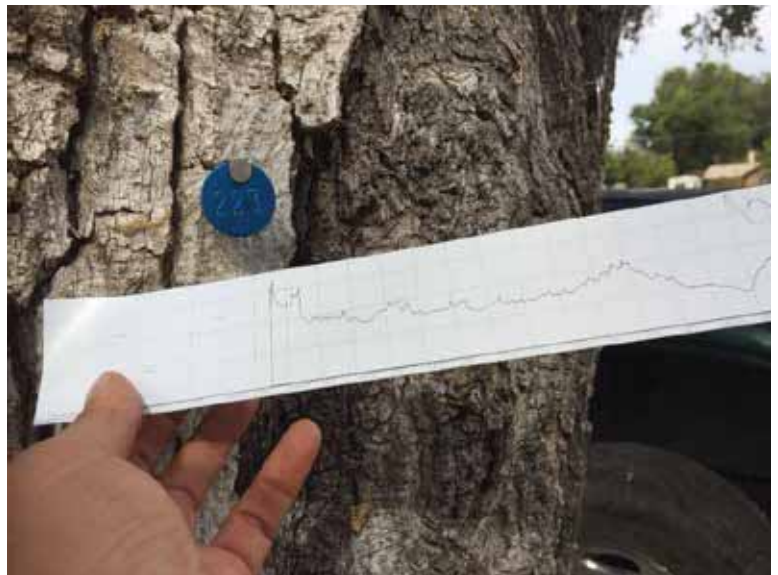
6. On October 13, 2016, Chip Tamagni of A&T Arborists performed additional wood density testing with the use of a resistograph. After drilling numerous holes, additional information was provided by the resistograph. See Arborist letter dated October 14, 2016. (Attachment 4, Exhibit A).

8. Chip Tamagni concludes that as a result of the resistograph test, that there are patches of decay in various areas within the trunk of the tree that does "pose a risk today". He indicates that significant pruning of the tree, including the removal of the northerly scaffold branch, would reduce the risk of failure at the present time, but at the point when the lot develops, any structures built on the site would be at immediate risk. Mr. Tamagni recommends that the tree be removed at this time, prior to future development.

**October 13, 2016 resistograph test of tree by arborist Chip Tamagni**

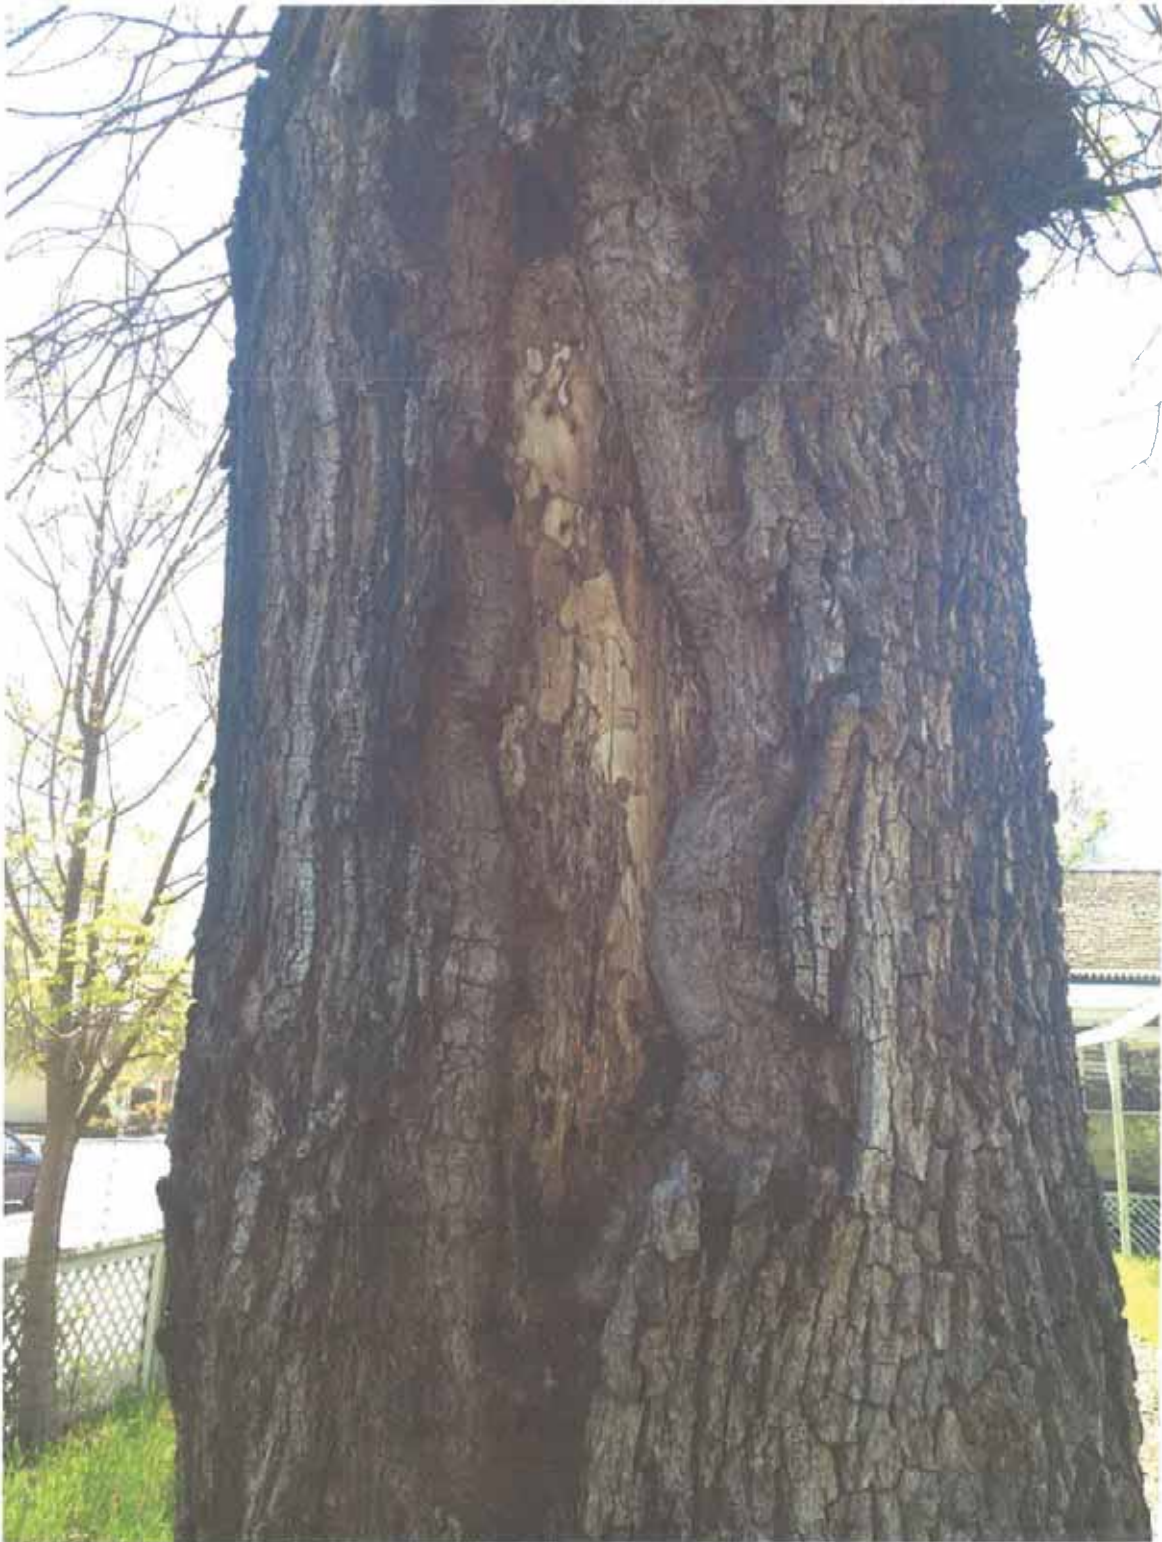
This report is in regard to the diseased 44" valley oak (*Quercus lobata*) located at the old hometown nursery site in the 18<sup>th</sup> block of Spring Street. We inspected the trees on this property many years ago for potential development and this tree concerned us back then as far as safety is concerned. The tree has a significant cavity that encompasses well over the 30% cross sectional threshold that would dictate it as a hazard tree. The cavity is located at about four feet above the ground as seen in the photograph. There are two nesting holes that extend deep into the cavity. Concern is that this tree may fail at this location which would result in entire tree failure. This consequences could be catastrophic as a large portion of this tree extends over Spring Street. We strongly recommend removal at this point in time. Pruning at this point in time will not sufficiently reduce the hazard.

Notice the nesting holes at the upper left and top of the cavity.

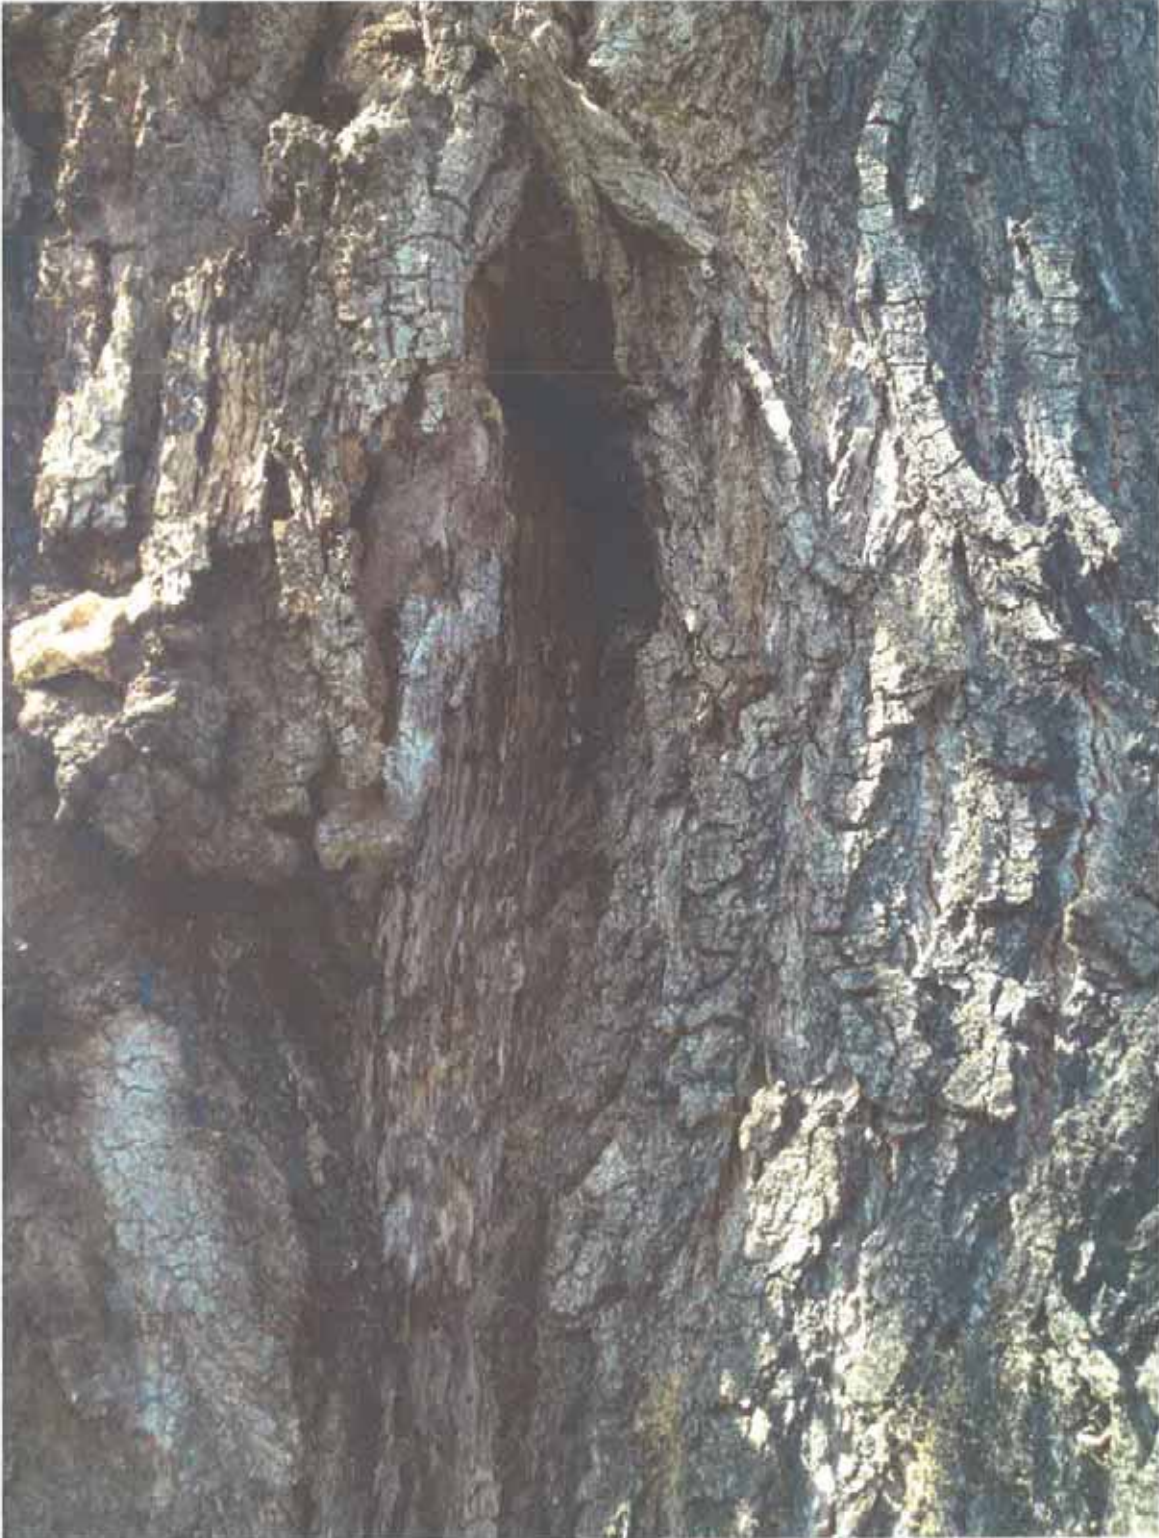
This view is from the backside of the tree illustrating the cavity extends through the entire trunk.

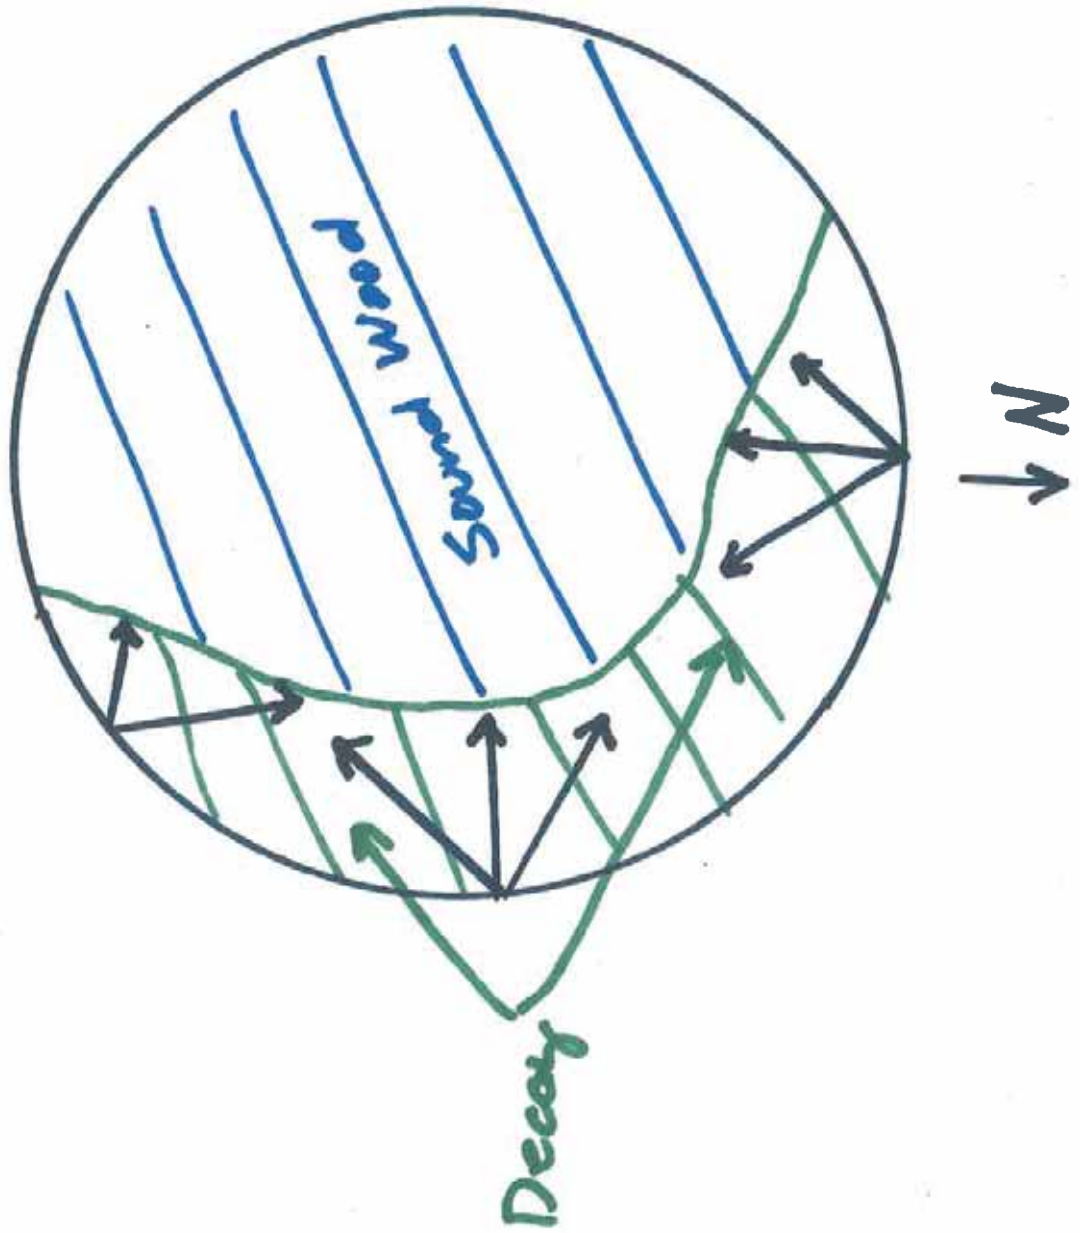
Old Hometown Nursery Valley Oak

- When drilling from the north facing cavity, sound wood was reached at 8” drilling to the southwest, 9 inches to the south and I buried the 12” drill and hit no sound wood when drilling to the south/southeast.
- When drilling from the eastern cavity, sound wood was reached at 8” when drilling due west, no sound wood was reached when drilling to the northwest, and no sound wood was found when drilling to the south west.

From the diagram, it appears that there is at least 25-30% decay across the plane of the tree. Most likely, the decay extends to at least 30% which is the ISA threshold for action to the tree. That action could be trimming to reduce weight which may prevent failure at this time, however, that may be “kicking the can down the road” if the tree continues to decay. Furthermore, the test drilling was done in one plane at approximately 4.5 feet above the ground. There most likely are additional pockets of decay either above or below the testing area. The tree appears to be trying very hard to compartmentalize this decay by trying to close up the wounds which could have been a result of excess water throughout the years when the nursery was in operation.

Included is a diagram illustrating the approximate locations of the decay at the 4.5 foot level. We feel this tree is potentially hazardous and consideration should be given to removing this tree before it collapses onto Spring Street.

While this tree is an aesthetically important tree, it appears to be in a hazardous condition from the testing that we performed. Granted, it is a difficult decision to remove it, however, public safety has to take precedence in this situation.

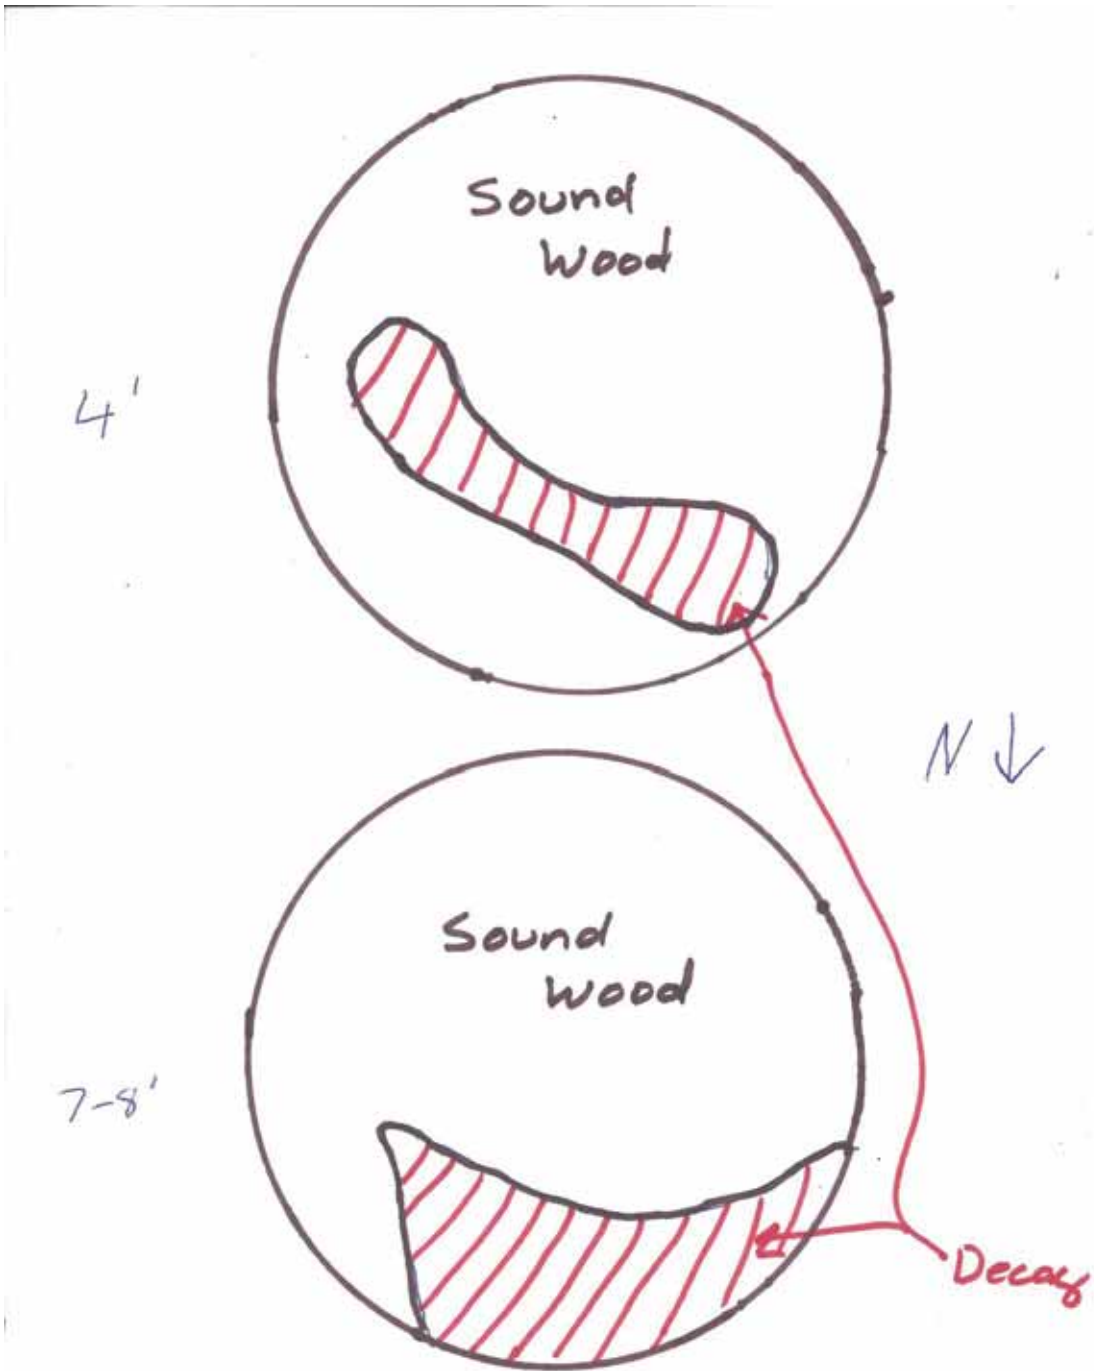
We tested four locations at the four foot level. We found one continuous pocket of decay that varies from six to three back to nine inches wide by about three feet long. The decay is located towards the north side of the tree where there are some visible sections of the decay.

We tested six more locations at approximately seven to eight feet off of the ground. We discovered a section of continuous decay that varied from three to 12 inches thick by about 30 inches wide also on the north side of the trunk. It is fairly obvious that the decay is continuous from the four foot level and increases in size up to the eight foot level. The decay at this level originates at the surface and extends inward whereas the lower level decay is mainly internal due to some wound wood development. The seven to eight foot level was as high as we could reach to test, however, the visible decay extends higher up the tree and this testing gives us a pretty good idea of the extent of the decay.

In our opinion, the tree does pose a hazard today. The known decay varies from about 18% at the four foot level to about 28% at the seven to eight foot level. We know with certainty that the area of decay extends longitudinally from below the four foot level to above the eight foot level in varying degrees. We also know with certainty that the decay has spread from the initial wound area to deep within the trunk both above and below the visible area. There is a potential for main stem failure both within the site and onto Spring Street. Due to the periodic traffic, both vehicular and pedestrian, a target is not always in the potential fall path of the tree. There is no guarantee someone or something would not be struck, but the odds are reduced as use under the tree is not 100% of the time. Some extensive pruning including removing the large scaffold limb to the north and other weight reduction measures will possibly, with absolutely no guarantee, reduce this risk for the *present time*. Once the site gets developed, the tree would absolutely have to be removed as the degree of risk would be unacceptable per this assessment. We included a hand drawn graph illustrating the extent of decay.
