Council Agenda Report

Subject: Oak Tree Removal Permit (OTR 17-005) - A request by Linda Thorndyke (property owner / applicant) requesting that the City Council allow the removal of one Valley Oak tree (38 inch dbh) at 515 21st Street.

Re: Tree Risk Assessment for Linda Thorndyke 515 21st Street in Paso Robles, CA

This letter is to inform you of the current tree health and structural stability of one (1) Valley Oak (*Quercus lobata*) located on the east side of 515 21st street. I visited the property on February 13, 2017 and did a ground based inspection of the tree and found the following:

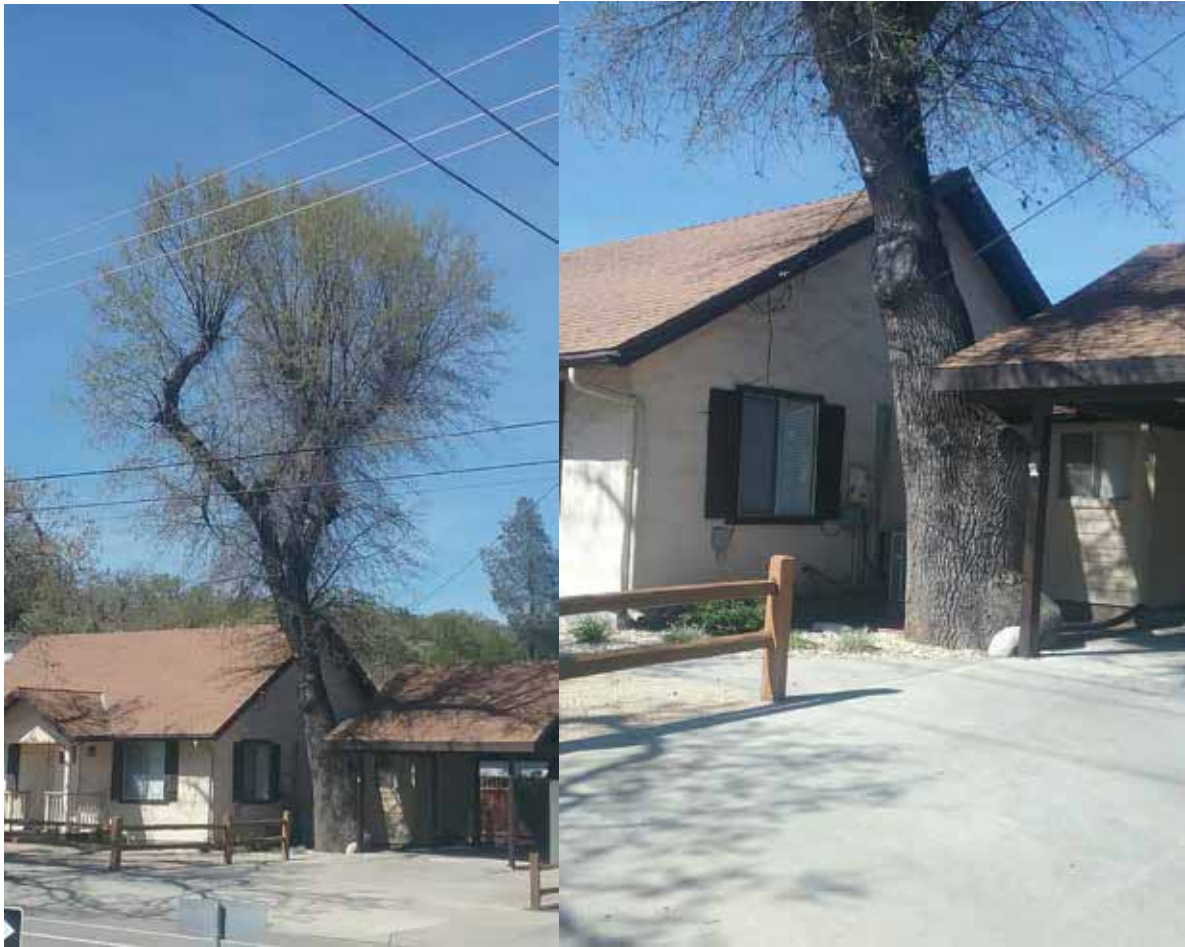
3. Over the years the tree has grown to a point where it has been in conflict with the house, resulting in past limb removals, which has caused wounds which are now showing signs of decay. As a result of the tree making contact with the cement driveway/carport and the tree having a 30 percent lean towards the house, Ms. Thorndyke is requesting that the tree be removed to prevent further damage.

Photos of 38-inch Valley Oak

Option 1. Approve Resolution 17-xxx finding the trees is in poor condition and likely will cause damage to the property if it were to remain, and approve the removal of the tree and require one (1) replacement Live Oak tree on site, and payments to the oak replacement fund for the remaining five (5) replacement trees would be required as mitigation to the tree removal.

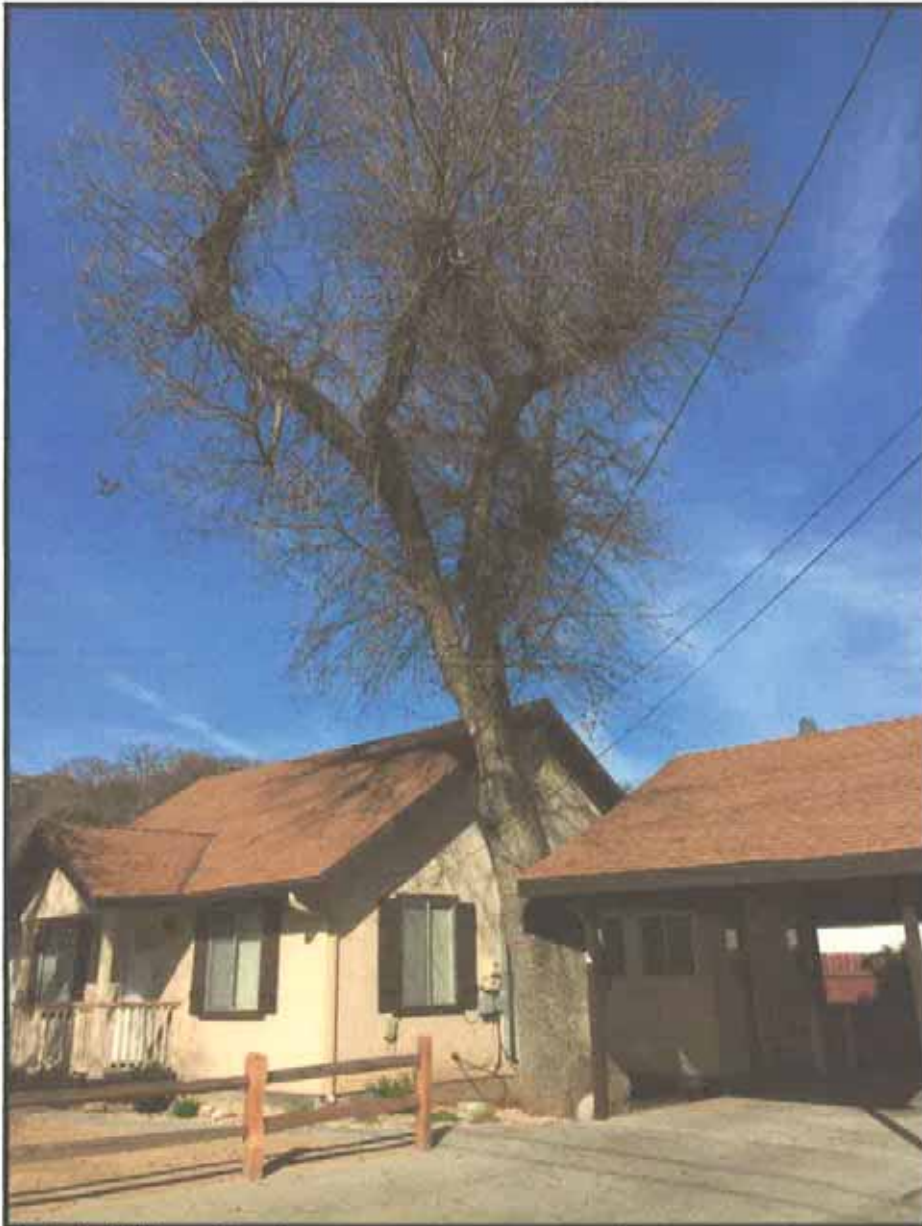
- The tree is a single stem measuring 38 inches in diameter at breast height (DBH), measured at 4.5 feet above ground level. The tree height is approximately 50 feet tall with a crown spread of approximately 40 feet. **See Appendix A- Photo1**

- The tree has a 30 degree lean west toward the home. **See Appendix A- Photos 1&4**
- The tree has been topped in the past and no lateral branches are left. Only epicormic re-sprouts are forming the canopy. **See Appendix A- Photo 5**

Photo 1- Full view of tree from street and southeast side of home

Recommendation: I recommend full removal of this tree.

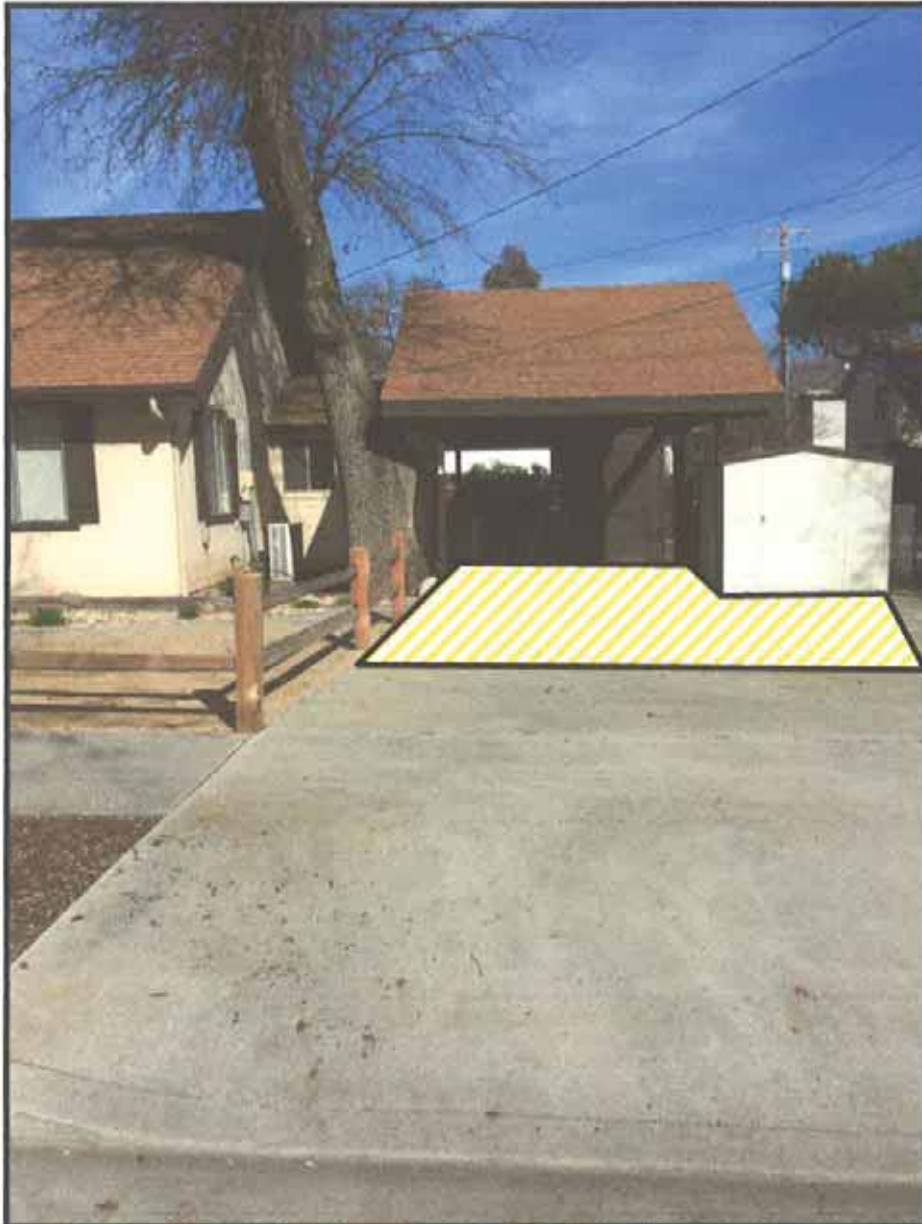
- The critical root zone (CRZ) has had been covered approximately 50% by a cement driveway and parking area. Another 30% of the CRZ is covered by the footprint of the house. Open yard area for root growth is approximately 20%. **See Appendix A- Photos2&3**

Up to 80% of the CRZ of this tree is covered by cement and the footprint of the house. The driveway and parking pad for the carport appears to have been reconstructed since the house was built in the mid 1940's. Because of these construction activities, grading and soil movement occurred. Roots were potentially damaged and the original grade of the soil around the tree was raised at least 12 inches. When soil depth is changed and soil is placed against the trunk of a tree, the stem can suffocate and begin to decay. Often times structural roots rot over many years due to the suffocation. Secondary or adventitious roots form to feed the tree but provide no structural support and make the tree prone to failure.

Photo 2- View of paved and restricted CRZ highlighted in yellow hash marks. House footprint also contributes to restricted root-space.

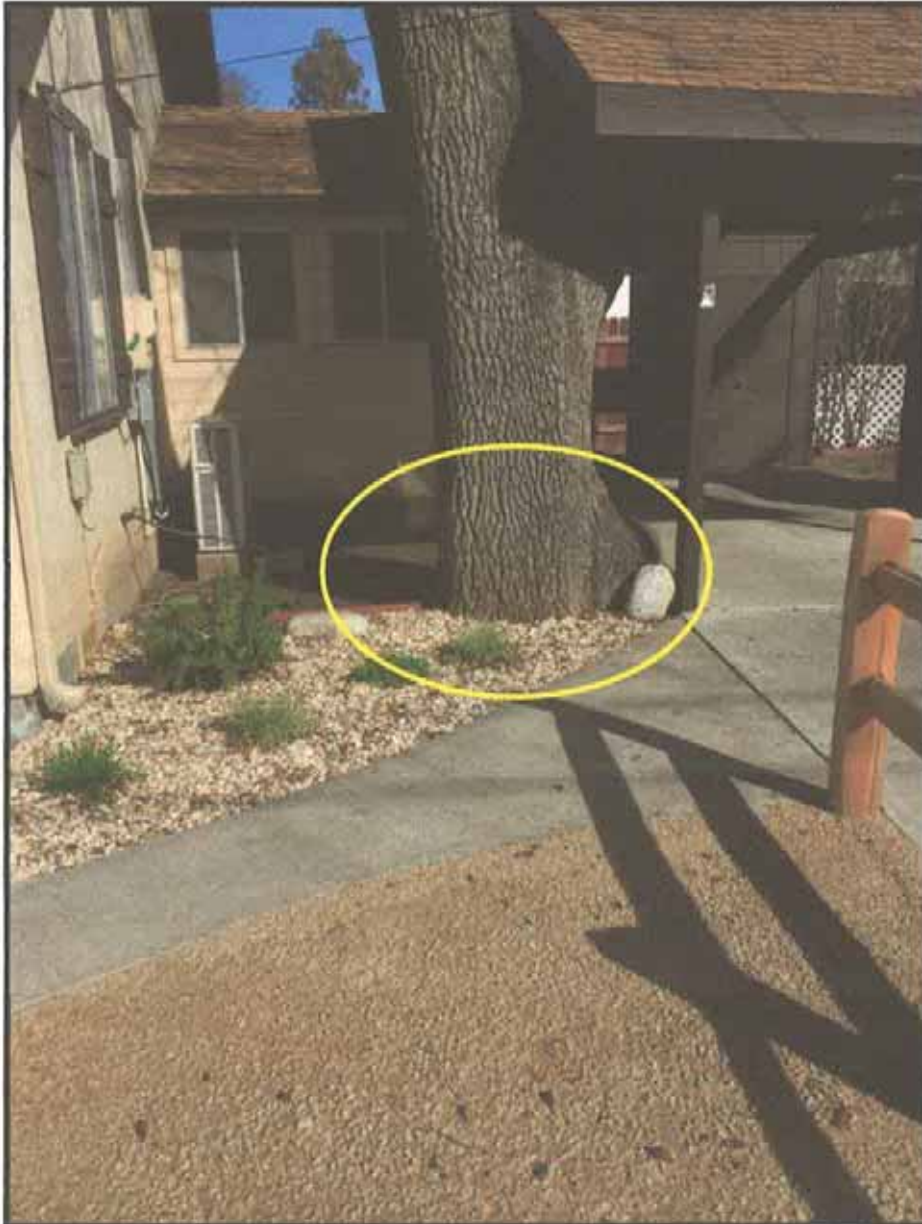
- The tree is located 5.5 feet east of the foundation of the house and the root crown is making contact with the cement parking pad of the carport. **See Appendix A- Photos 3**

- The root crow has been buried below grade at least 12 inches. **See Appendix A- Photos 3**
- A large branch has been removed has been removed from the lower trunk of the tree on the north side. The wound created by the cut is approximately 18 inches X 24 inches and is showing signs of decay. **See Appendix A- Photo 4**

Photo3- Close-up of grade buried root crown and restricted root space.

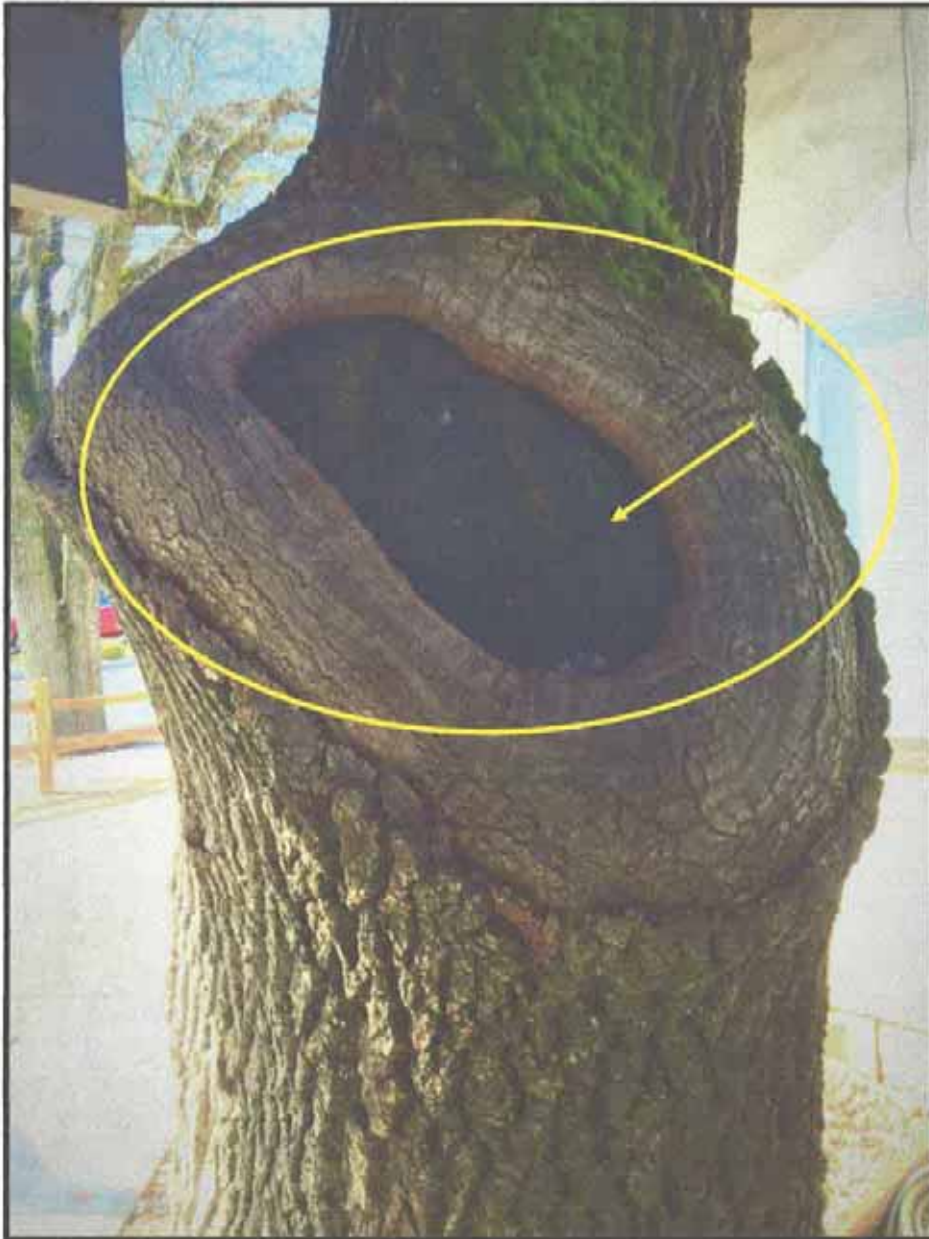
A large branch was removed from the north side of the tree 10 or more years ago. It is located approximately 6 feet above ground. The original diameter of the branch was approximately 36 inches. The open wound that remains is approximately 18 inches x 24 inches. The wound is callusing over, however decay has begun to form. It is not likely that the wound will seal over before decay advances significantly into the stem of the tree. The main stem of the tree above the wound has a lean of approximately 30 degrees to the west and over the house. The length of the stem above the wound is approximately 45 feet. The weak area of the stem with the large wound and decay combined with the lean and height of the stem make the possibility of stem failure at the wound point somewhat likely.

Photo 4- Close-up of large wound on north side of tree. Arrow indicates formation of decay.

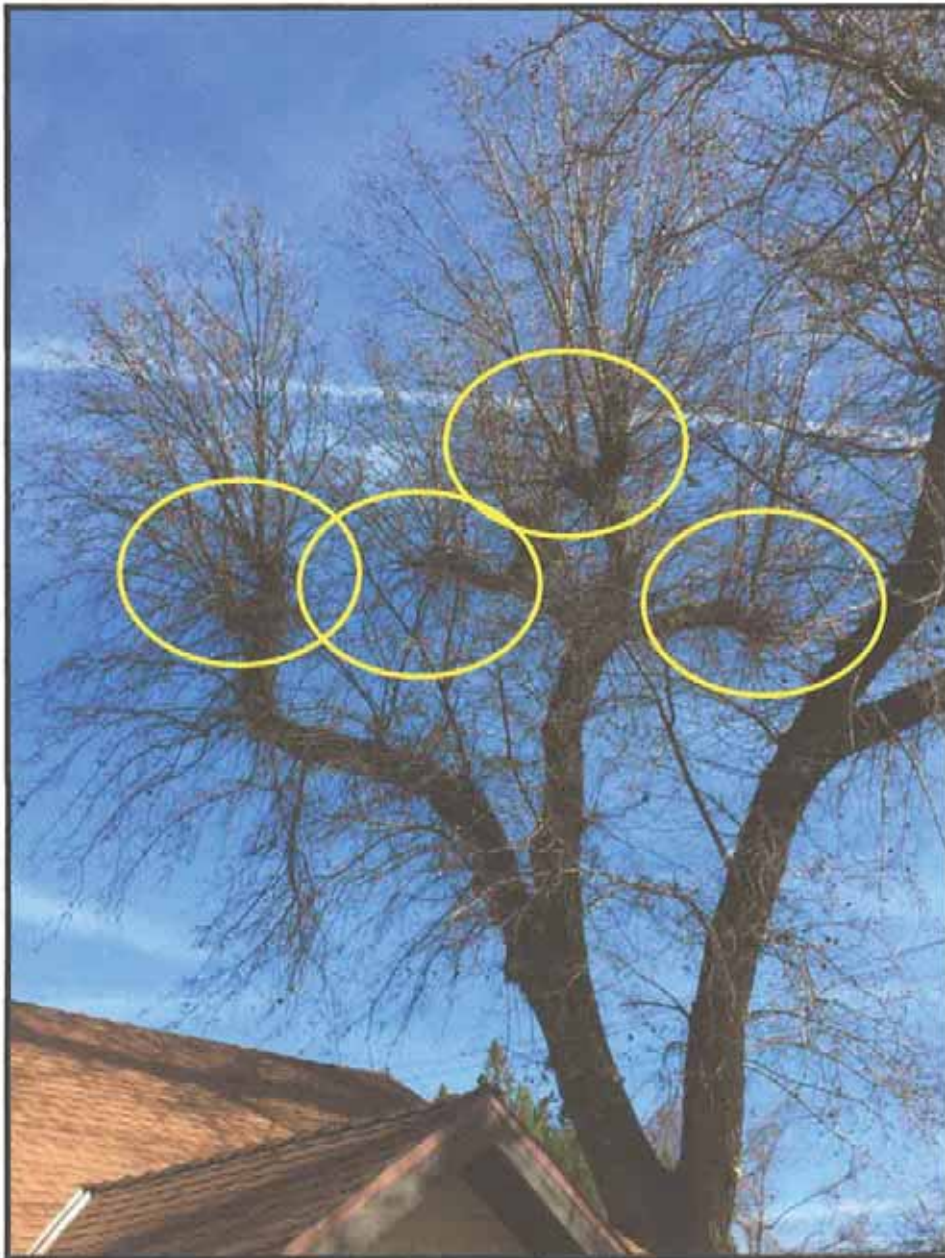
This tree has been topped significantly in the past. By my estimation of the re-growth, the work occurred in the last 10 years. Most of the lateral branches were removed leaving only 3 main scaffolds and some stubbed secondary branches. As a response to topping, epicormic shoots or "suckers" have re-grown from the topping points. Epicormic shoots originate from beneath the surface of the bark and are typically weakly attached to the parent branches. As these shoots gain height and diameter, they tend to fail during wind events.

Photo 5- Epicormic shoots growing form topping points.
