## Council Agenda Report

Subject: Oak Tree Removal Permit (OTR 17-008) - A request by Diane Duran (property owner / applicant) requesting that the City Council allow the removal of two Coast Live Oak trees (13 inch dbh / 18 inch dbh) at 1304 Fire Thorn Lane.

Date: June 20, 2017

Re: Tree assessment 1304 Fire Thorn Lane, Paso Robles, CA

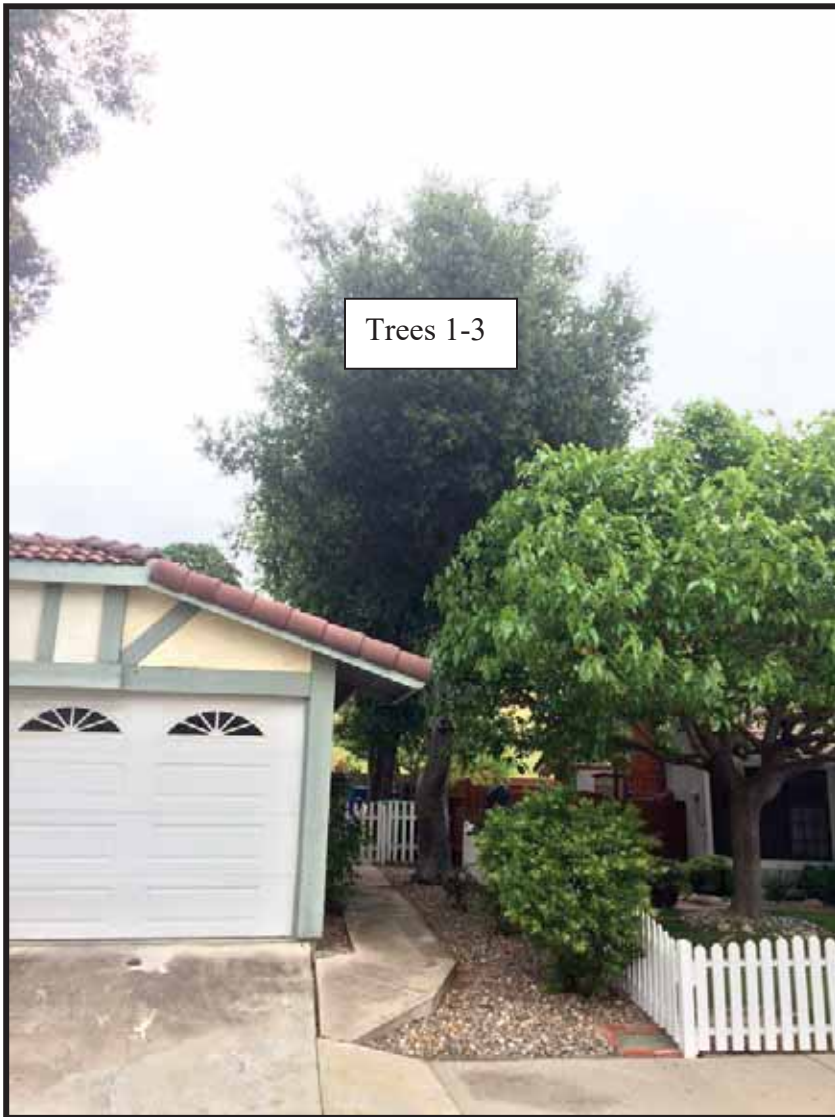
- Health of all trees was good, showing vigorous foliage.
- No major decay was observed in the roots, stem of canopy of these trees.
- Trees are planted within 6 feet of the house foundation **(See Appendix A- Photos 1, 2&4)**.

The area between the house and the trunks of these trees is 6 feet. Coast live oaks typically have a spreading form and can have a crown 60 feet wide, however these trees have been reduced to a few upright stems in order to give clearance from the building and prevent branch failure. (See Appendix A- Photos 1, 2, 4&6)

Photo 1- View of Trees 1-3 from street.

**Recommendation:** I recommend full removal all three trees.

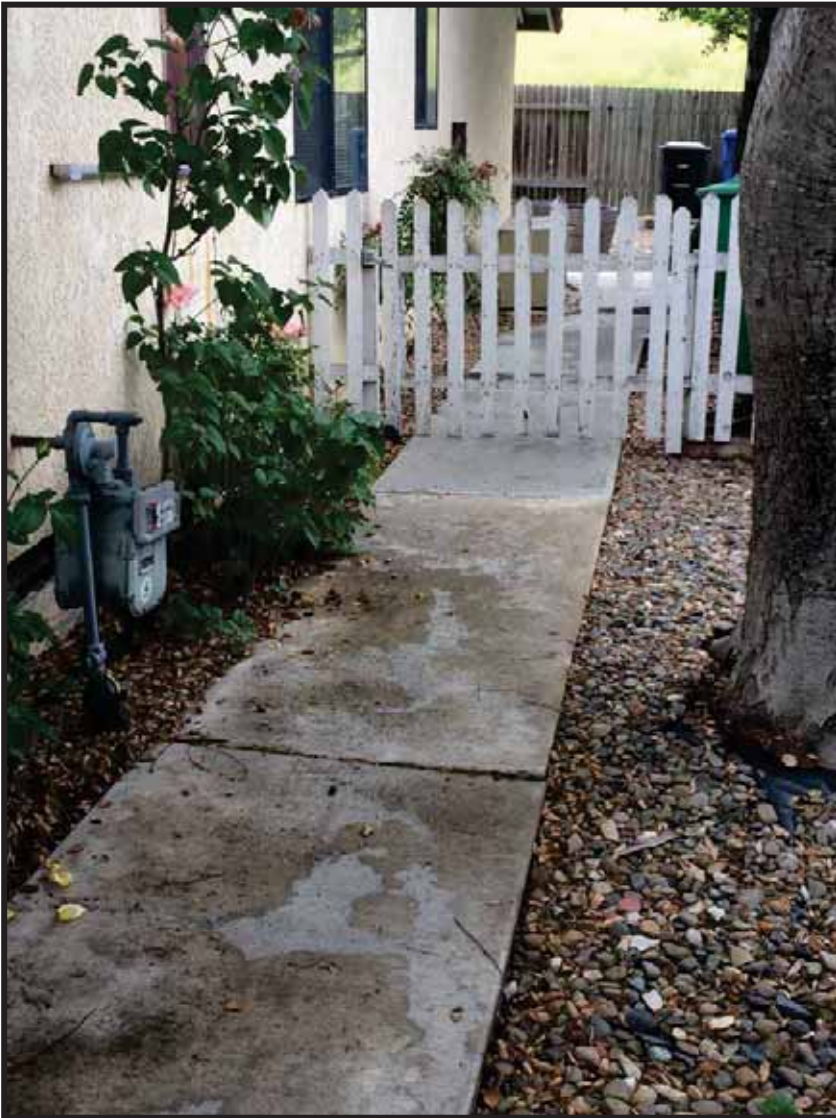
- Roots of all trees are uplifting the sidewalk to some degree.
- Tree 1 has lifted the cement sidewalk approximately 3/4 inch **(See Appendix A- Photos 2&3)**

Additionally the roots of these trees are uplifting the adjacent walkway as well as the pad that the air condition unit is mounted. The walkway at trees #1 and #3 is uplifted  $\frac{3}{4}$  inches. At tree #2 the walkway is lifted 3 inches. These root systems are very vigorous and will continue increasing in length and girth and will ultimately impact the foundation of the house. (See Appendix A- Photos 2, 3, 4, 5&6).

Photo 2- View of Tree 1 roots uplifting sidewalk adjacent to gas meter.

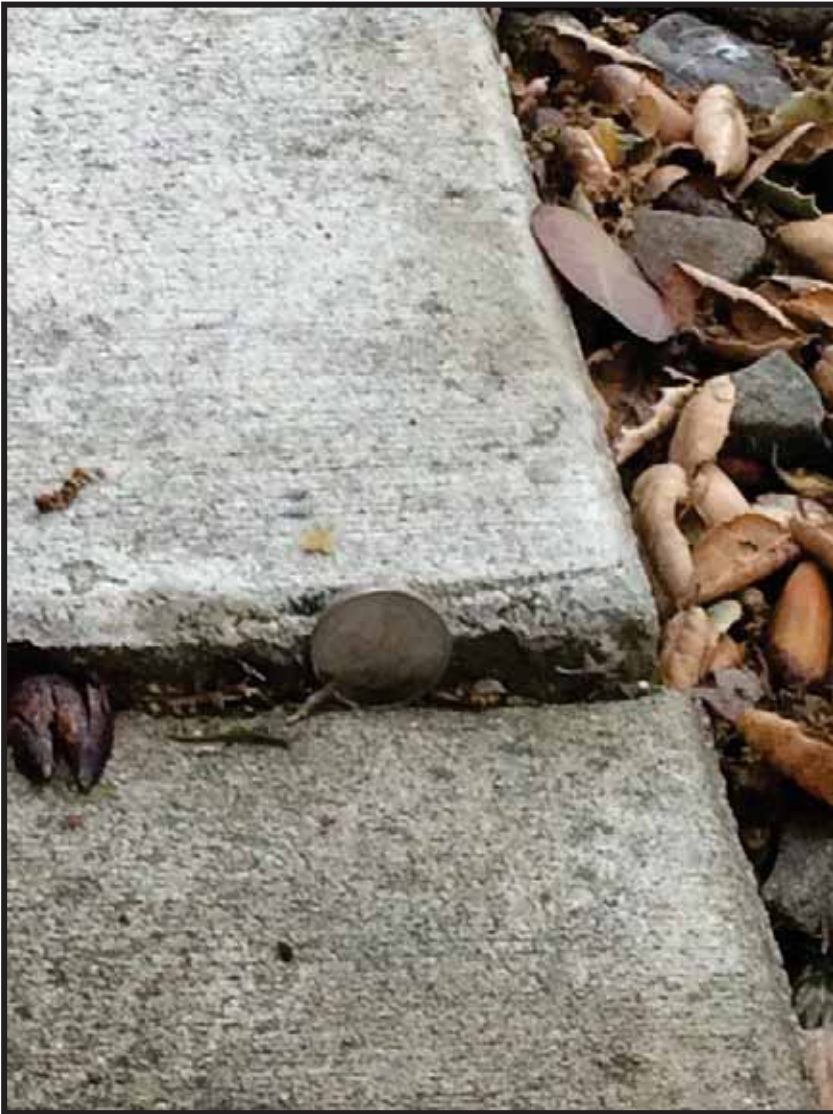
Photo 3- Close -up of sidewalk uplifting next to Tree 1, approximately  $\frac{3}{4}$  ".

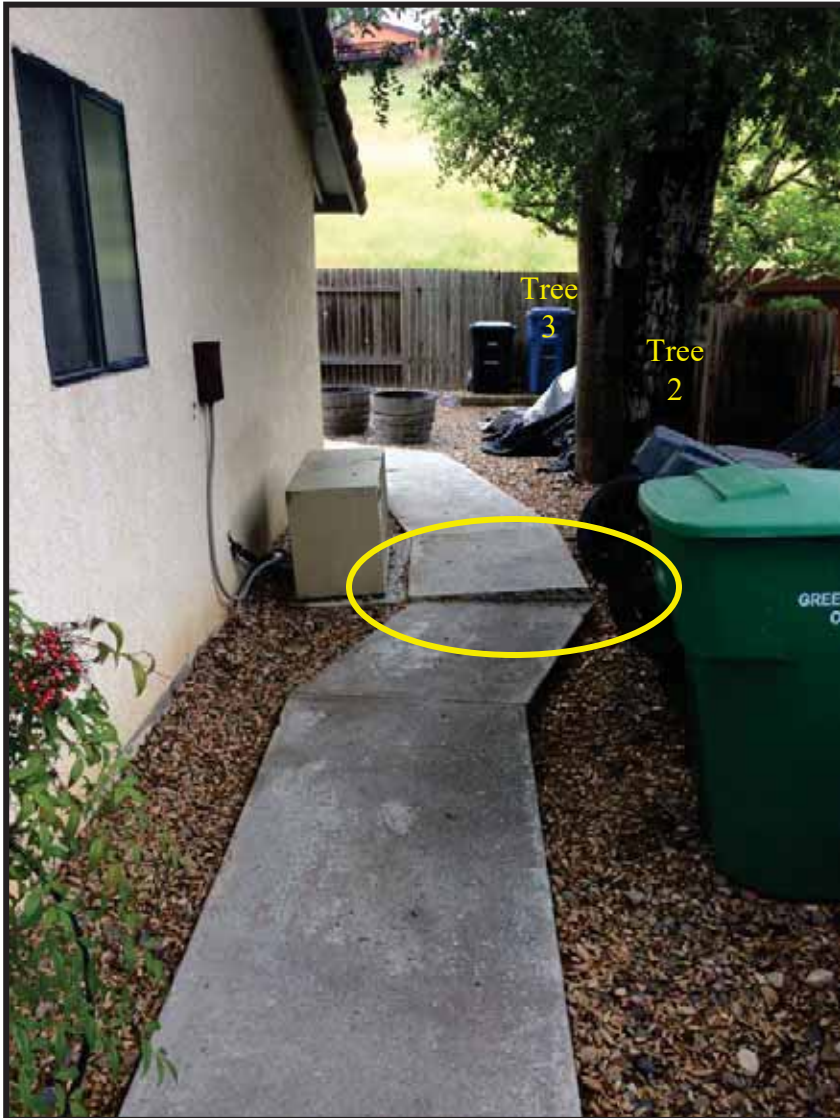
- Tree 2 has lifted the sidewalk approximately 3 inches and has started to uplift the cement pad that the air conditioner sits on. **(See Appendix A- Photos 4&5)**

Photo 4- View of sidewalk uplifting next to Tree 2, indicated by yellow circle.

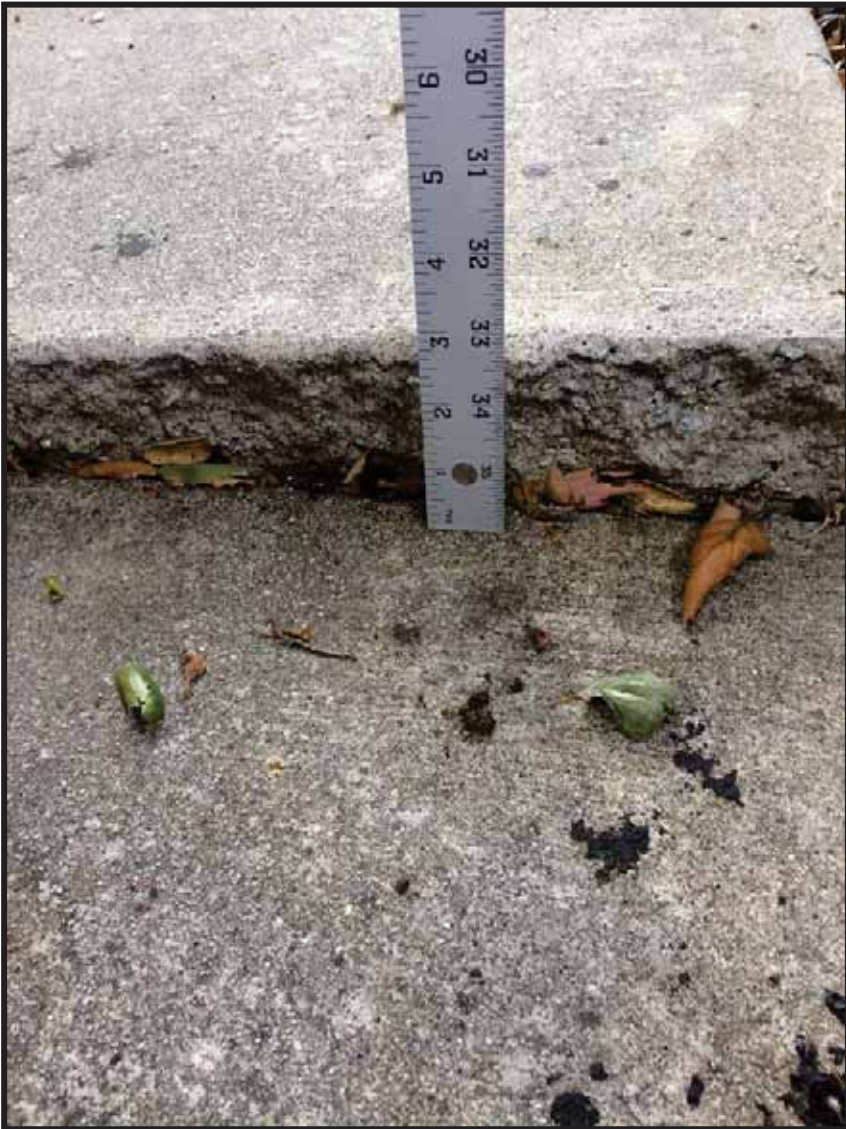
Photo 5- Close- up of sidewalk uplift next to Tree 2, approximately 3".

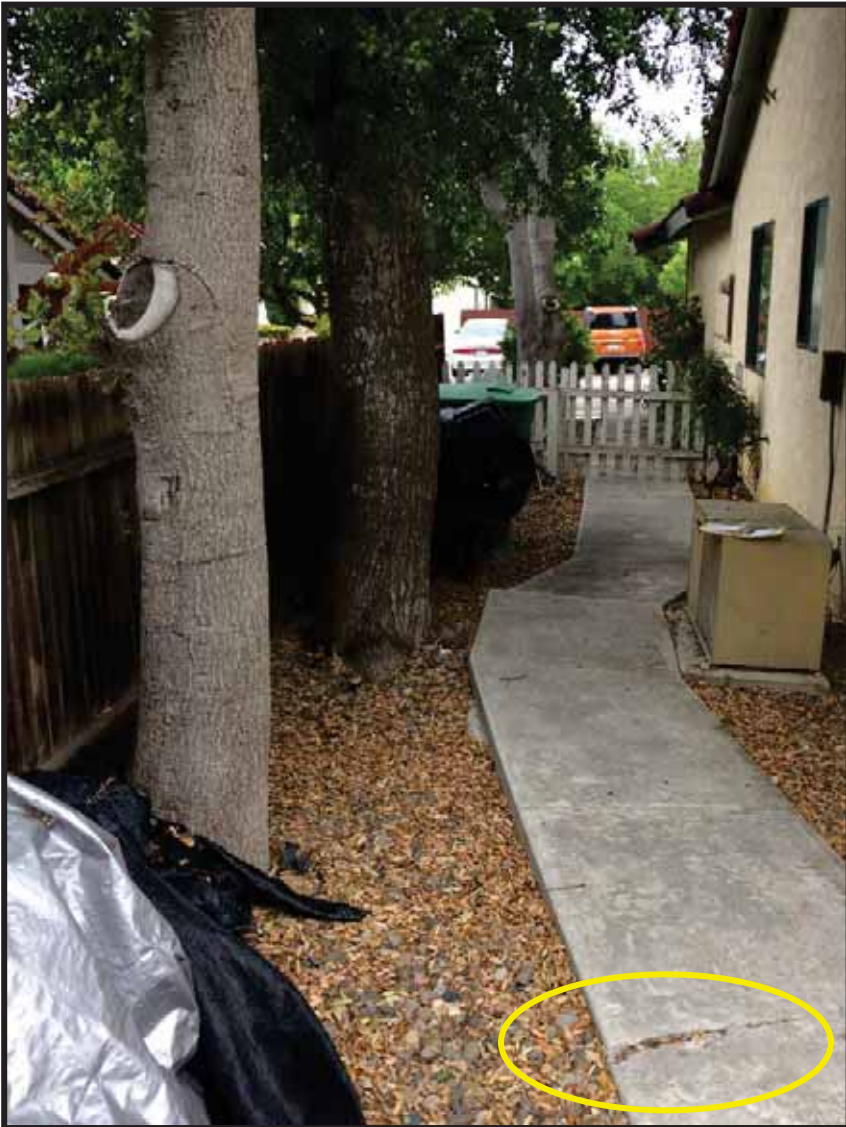
- Tree 3 has lifted the sidewalk approximately 3/4 inch. **(See Appendix A- Photo 6)**
- Tree 1 and 2 both have areas of included bark at major branch unions. **(See Appendix A- Photo 7&8)**

Photo 6- View of sidewalk uplifting next to Tree 3, indicated by yellow circle. Uplift is approximately  $\frac{3}{4}$ ".

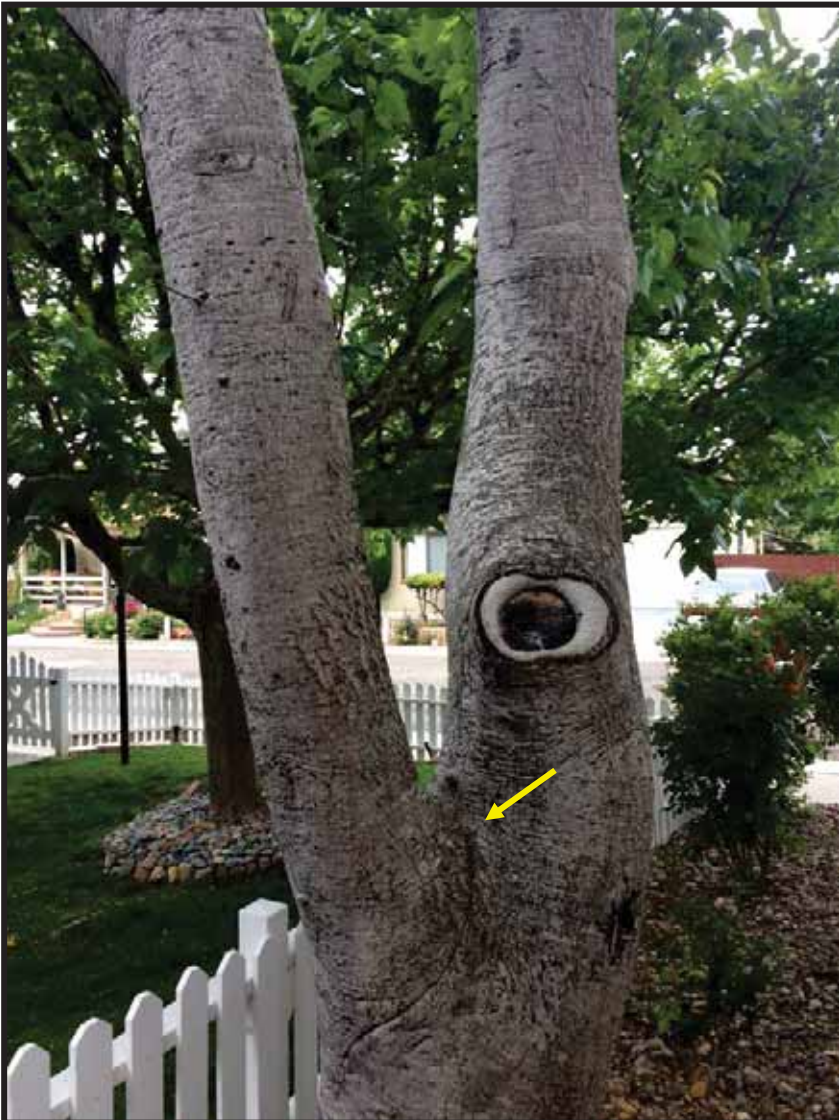
Even though the trees have been properly pruned and maintained in the past 30 years, there are still areas of included bark in trees 1 and 2. Included bark happens when two parts of the tree grow parallel to another but because of the bark trapped between them, have minimal structural connections (See Appendix A- Photos 7&8). These areas make these branches prone to failure. Removal of these branches would result in reducing the canopies between 30 and 50 percent. A reduction of the canopy by this amount puts undue stress on a tree and make is prone to disease.

Photo 7- Area of included bark in Tree 1, approximately 12" long.

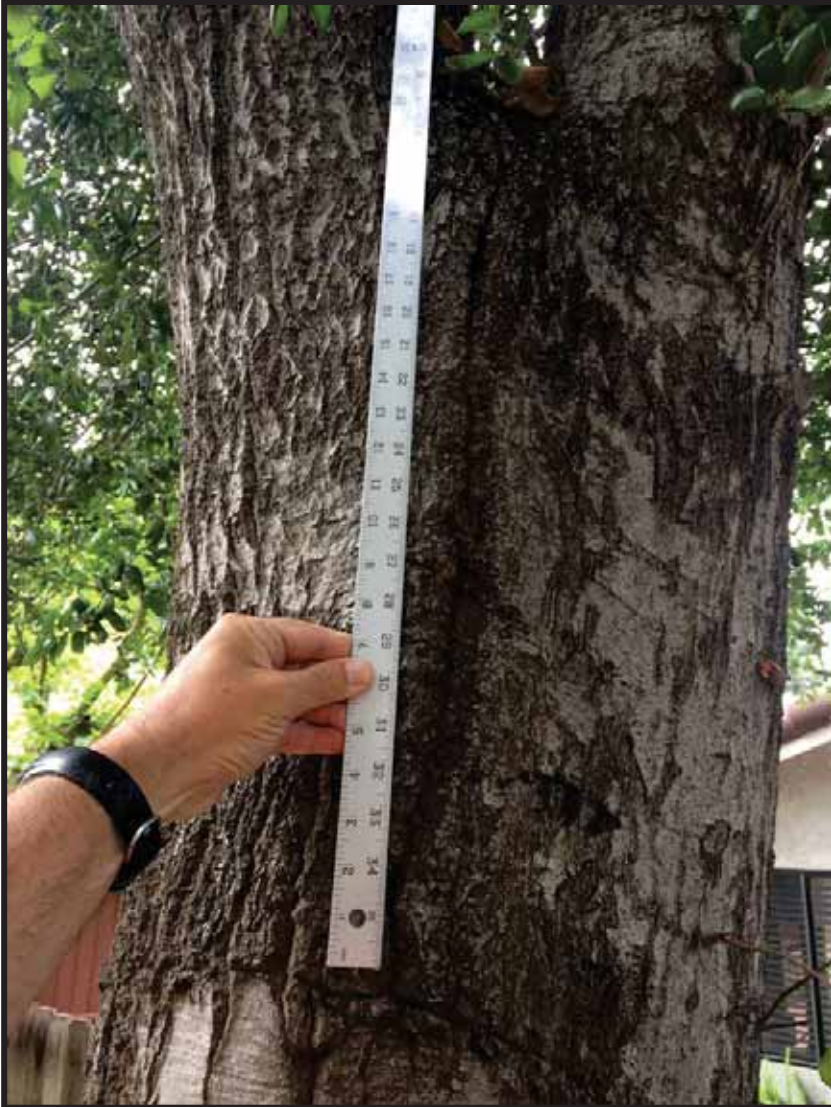
Photo 8- Area of Included bark Tree 2 – Approximately 24 inches long
