RESOLUTION NO. 14-027

A RESOLUTION OF THE CITY COUNCIL OF THE CITY OF PASO ROBLES
APPROVING THE REMOVAL OF PROPERTY LOCATED AT 1527 PARK STREET
FROM HISTORIC RESOURCES INVENTORY
(MACKLIN)

Subject: Single story unreinforced masonry (URM) brick residence located at 1527 Park St., Paso Robles.

Re: Structural observations of the existing building vertical and lateral force resisting system, as well as current material evaluation of supporting URM brick units.

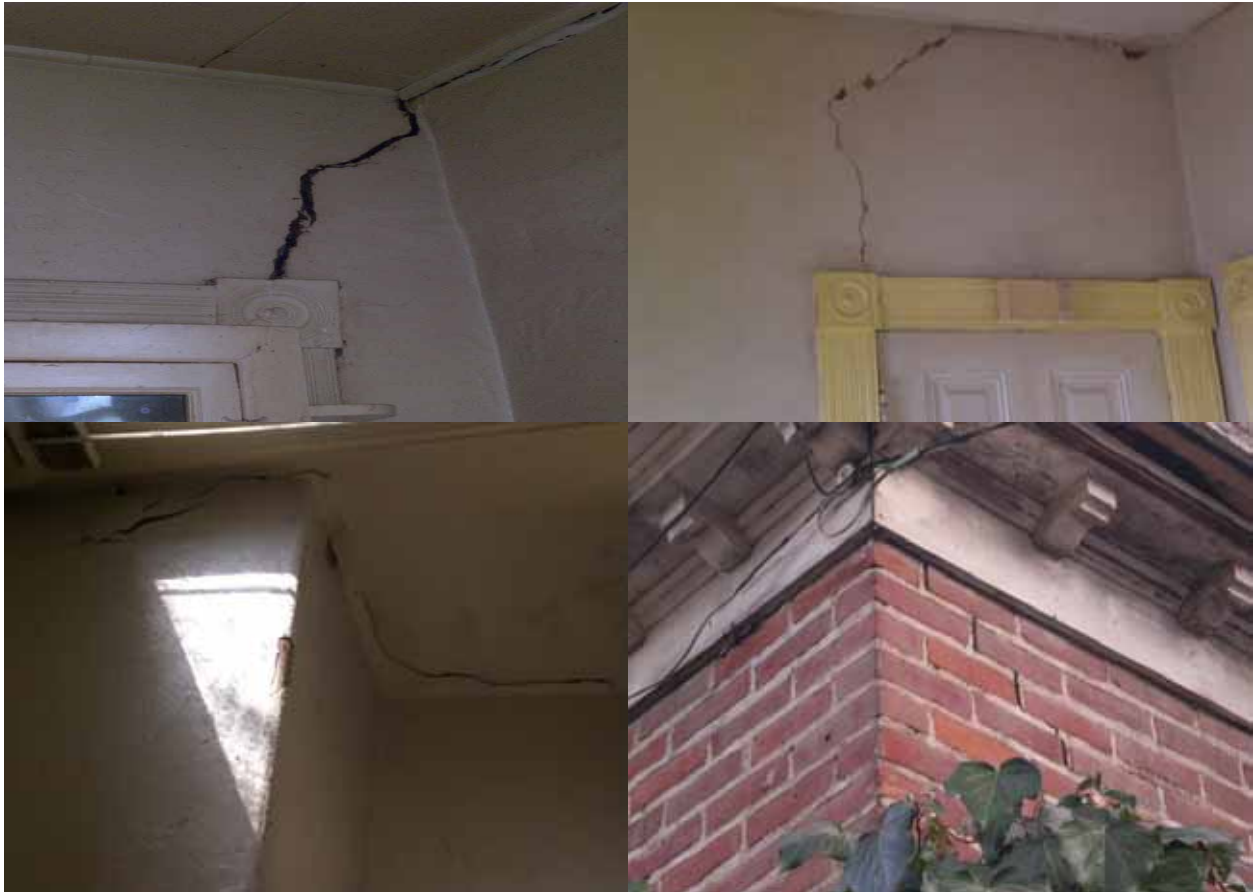
PICTURE GROUP #1

Initial observations reveal immediate concerns with the current condition of the exterior bearing (roof and ceiling supporting) URM walls. The (2) wythe walls ((2) layers of 2"x4"x8" red brick totaling 9" thick) have significant cracks extending through the full width of the wall at essentially every window and door opening (see picture group 1). These are clearly stress cracking which likely occurred during the 2003 San Simeon Earthquake, a major seismic event which significantly affected the entire downtown Paso Robles district. The cracks are "diagonal" at each corner of the window/door and extend away from the opening. These are indicative of shear overstress or "pier rocking" which occurs as the structure resists lateral forces. Furthermore, the cracks have "opened" or separated (see picture group 2) as to expose the internal portion of the (2) wythe URM wall to weather which has accelerated the deterioration of the bonding mortar and individual brick units. (Refer to discussion below for material evaluation). Supplemental diagonal cracking was also observed in several locations from the floor line down the supporting stem wall towards the bearing foundation (see picture group 3), as well as in the basement sidewalls.

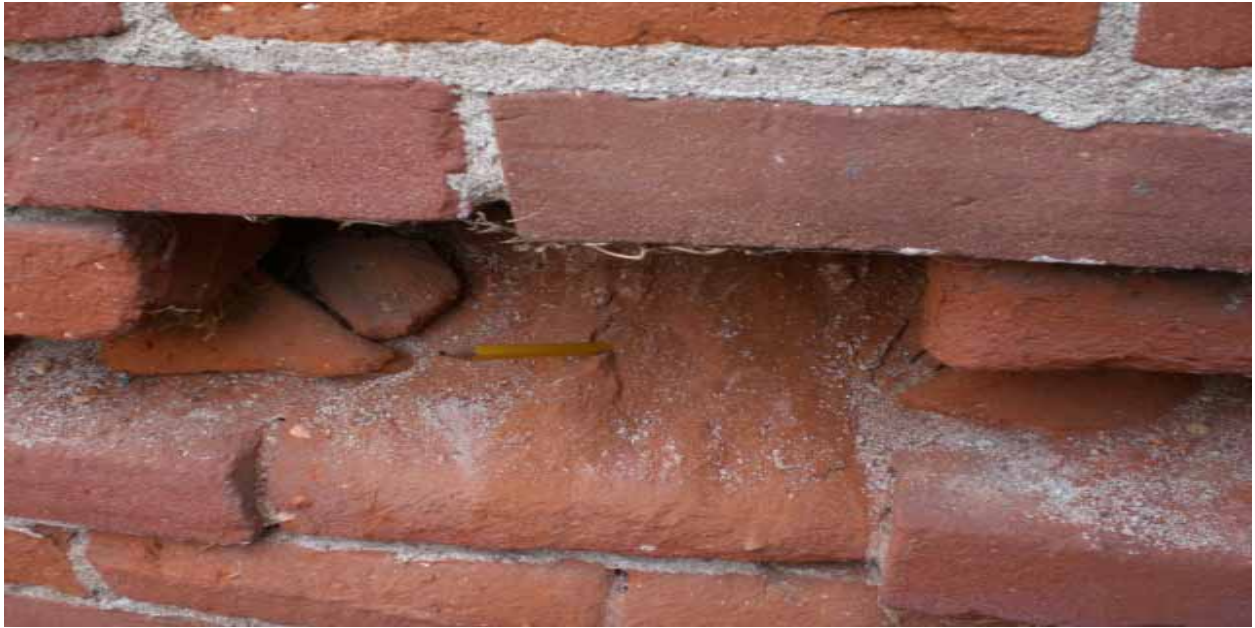
PICTURE GROUP #4

However, having identified and noted the wall cracking indicated above, of a more significant concern to our office and the ability to provide a proper seismic retrofit is the physical condition of the individual red bricks and bonding mortar (see picture group 4). There are several contributing factors to this structural deterioration which are briefly discussed below:

2. **Lack of minimum material standards for brick or mortar at the time of construction;** Due to the lack of regulatory agencies, minimum material specifications, or required stress requirements, the quality and strength of bricks and mortar can vary significantly within different areas of the same wall. The raw materials (clay, sand, lime, etc.) were locally provided with proportions and construction implementation provided by the builder. In this particular structure we found a majority (more than 50% surface area) of the exterior exposed bricks and mortar literally turning back into clay dust and sand (see photo group 4). A seismic retrofit relies on a majority of the brick units maintaining a minimum compression strength, although the deteriorated mortar is allowed to be removed and replaced up to a depth of 1 ½" (this process is called 'pointing'), this repair cannot be provided with such significant deterioration of the existing wall prism.

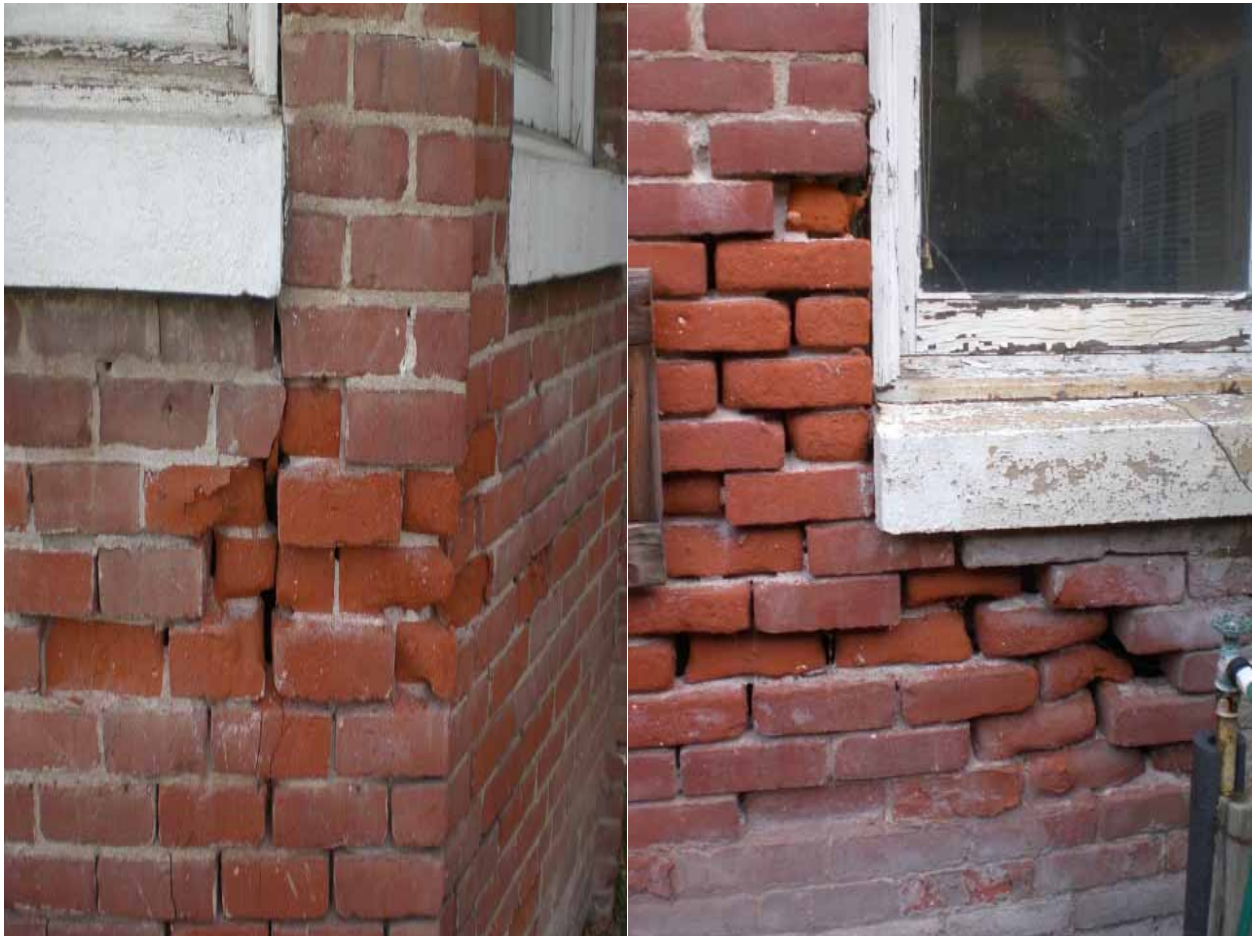
PICTURE GROUP #5

1. **The age of the mortar and brick materials;** The residence was constructed over 100 years ago and the exterior is exposed brick without paint or plaster. As such, the mortar and brick have been significantly weathered and weakened due to the constant temperature cycles and exposure to rain and freezing. The mortar can be removed from between the bricks simply by scrapping the joint with a finger, and the exterior surface of the bricks has deteriorated and individual bricks now have rounded edges rather than the original rectangle shape (see picture group 5).
