RESOLUTION NO. 17-049

A RESOLUTION OF THE CITY COUNCIL OF THE CITY OF PASO ROBLES
AUTHORIZING THE REMOVAL OF ONE 11-INCH DIAMETER BLUE OAK TREE
AT 801 EXPERIMENTAL STATION ROAD (OTR 17-007)
(MBK HOMES – BLUE OAK APARTMENTS)

Re: Oak Tree Removal, Blue Oaks Apartments Experimental Station, Paso Robles

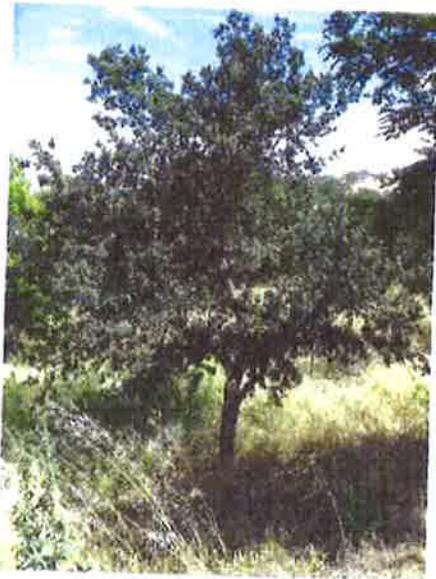
Photo 23. Tree 76, young tree east of mature tree 75, 2004 condition.

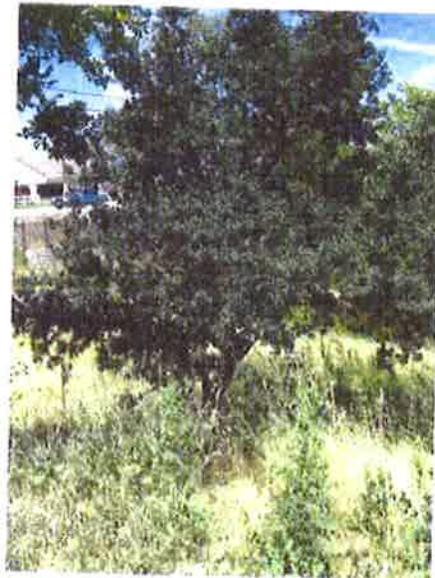
Photo 24. Tree 77, young tree east of mature tree 75, 2004 condition.

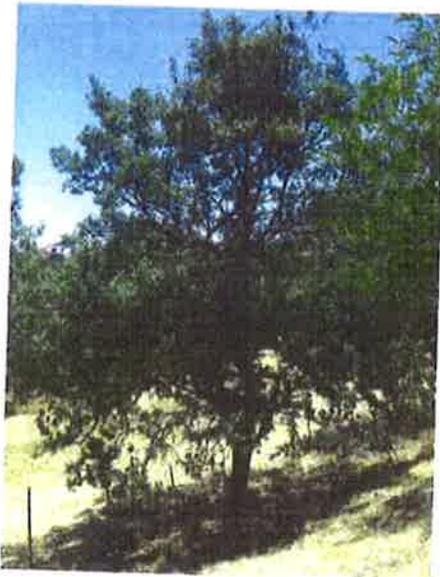
The second issue involves tree #76. The tree was listed as "fair" with a 63% health rating in the original arborist report prepared by Mike Bova of Davey Resource Group through Althouse and Meade. Mike Bova is a city council approved certified arborist. The tree's location would eventually be growing through a deck attached to the new home. In addition, the over-excavation for the support column for the home would necessitate completely removing the tree. There is also a storm drain planned within the critical root zone. Per the original arborist report completed by Davey, it states, "proposed foundation is partially within CRZ" which was basically incorrect. The fact is the over-excavation for the foundation completely eliminates the tree. Staff also told me they did not notice or missed seeing the tree in the plans. Our initial plan was to remove the hazard tree (#74) and slide the home 10 feet west to allow for the column over-excavation and saving the tree (#76). This included making lot line adjustments to two properties which the owner was prepared to do. The other problem was the deck construction. The tree was planned to grow through the deck which in itself is not a problem. However, future pruning and training the tree to grow next to a three story building could have proved challenging although it can be done. The foundation of the

Photo 25. Tree 76, 2012 condition.

Therefore, we are requesting to remove a multiple trunk blue oak (tree #76), 11 inches in diameter and replace it with (2) 36" box oak trees that would be planted on site. The diameter of a 36" box tree is usually close to 5-6 inches. This would equal a 100% diameter replacement for the inches removed. Their survival would still be subject to the seven year guarantee spelled out in the original arborist report.

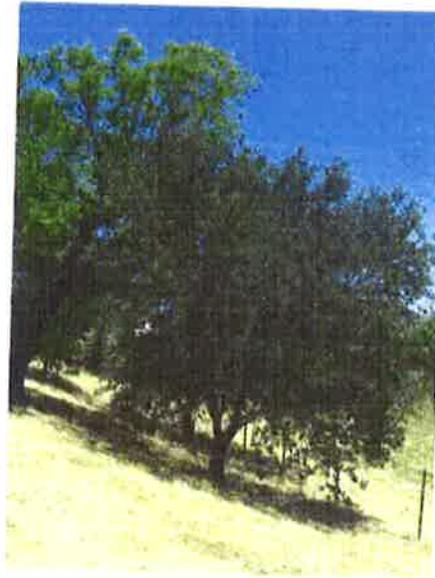
Photo 26. Tree 77, 2012 condition.

Tree 76 is also shown behind tree 77 in photo 26.
