RESOLUTION NO. 17-050

A RESOLUTION OF THE CITY COUNCIL OF THE CITY OF PASO ROBLES  
AUTHORIZING THE REMOVAL OF ONE 38" VALLEY OAK TREE  
AT 515 21<sup>ST</sup> STREET  
(OTR 17-005 / LINDA THORNDYKE) APN: 008-221-006

Exhibit A: Arborist Report

**Re:** Tree Risk Assessment for Linda Thorndyke 515 21<sup>st</sup> Street in Paso Robles, CA

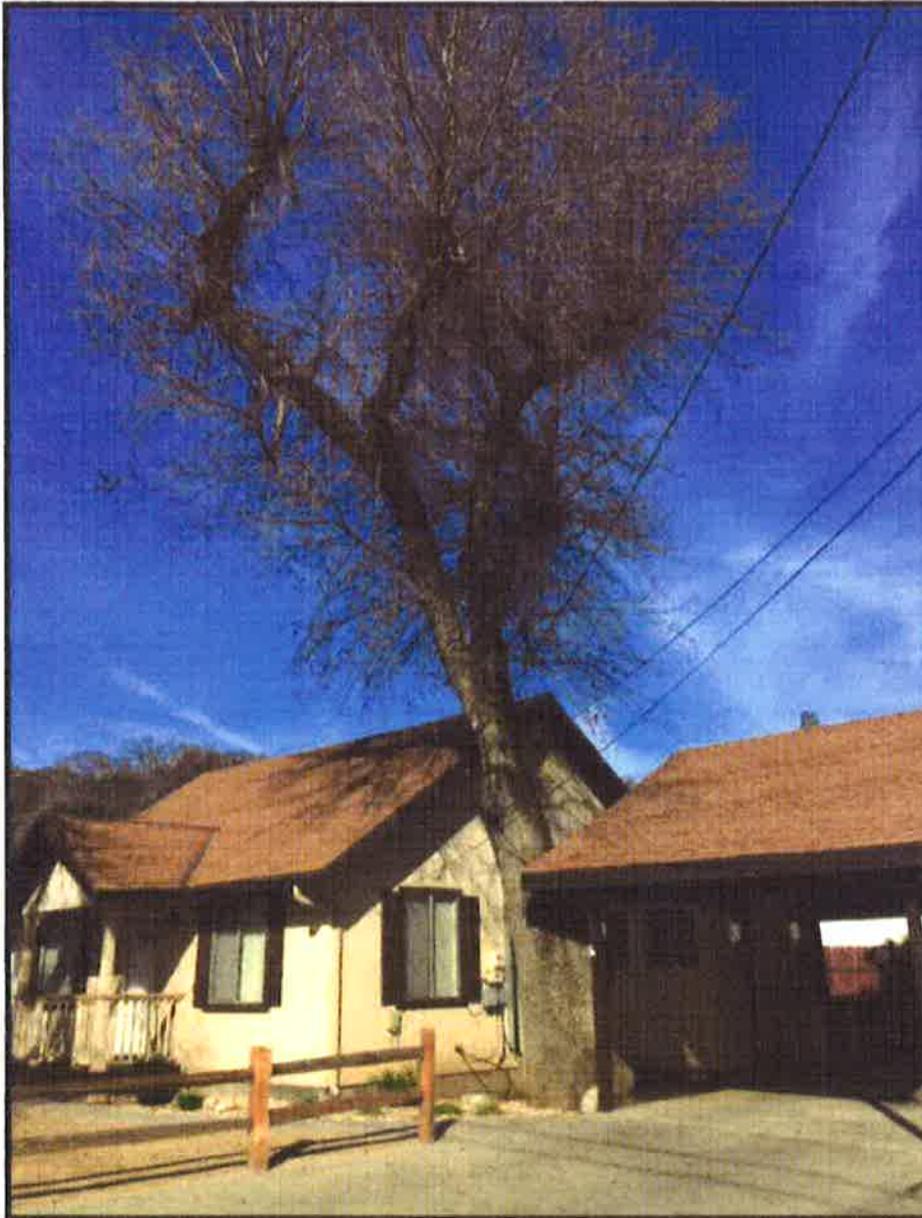
- The tree is a single stem measuring 38 inches in diameter at breast height (DBH), measured at 4.5 feet above ground level. The tree height is approximately 50 feet tall with a crown spread of approximately 40 feet. **See Appendix A- Photo1**

- The tree has a 30 degree lean west toward the home. **See Appendix A- Photos 1&4**
- The tree has been topped in the past and no lateral branches are left. Only epicormic re-sprouts are forming the canopy. **See Appendix A- Photo 5**

**Photo 1-** Full view of tree from street and southeast side of home

**Recommendation:** I recommend full removal of this tree.

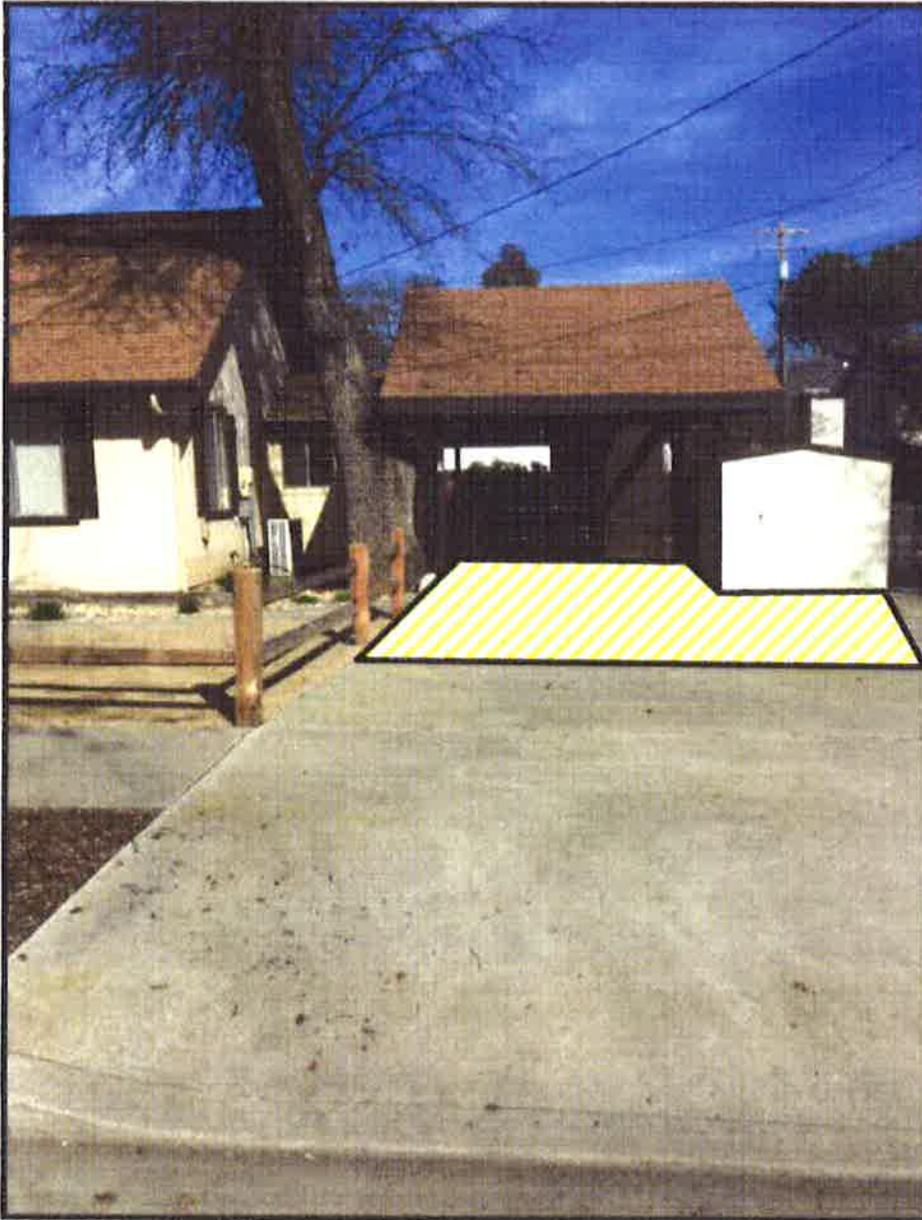
- The critical root zone (CRZ) has had been covered approximately 50% by a cement driveway and parking area. Another 30% of the CRZ is covered by the footprint of the house. Open yard area for root growth is approximately 20%. **See Appendix A- Photos2&3**

Up to 80% of the CRZ of this tree is covered by cement and the footprint of the house. The driveway and parking pad for the carport appears to have been reconstructed since the house was built in the mid 1940's. Because of these construction activities, grading and soil movement occurred. Roots were potentially damaged and the original grade of the soil around the tree was raised at least 12 inches. When soil depth is changed and soil is placed against the trunk of a tree, the stem can suffocate and begin to decay. Often times structural roots rot over many years due to the suffocation. Secondary or adventitious roots form to feed the tree but provide no structural support and make the tree prone to failure.

**Photo 2-** View of paved and restricted CRZ highlighted in yellow hash marks. House footprint also contributes to restricted root-space.

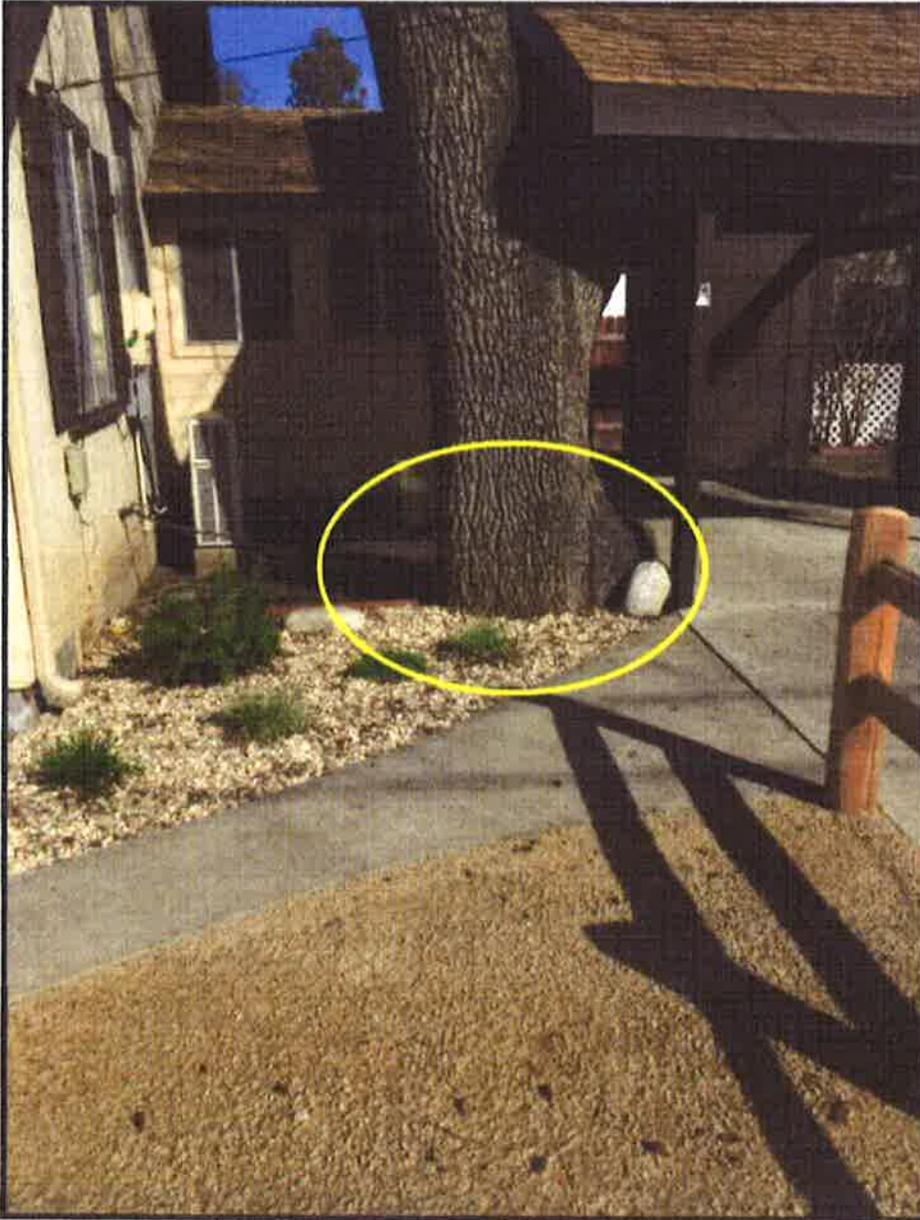
- The tree is located 5.5 feet east of the foundation of the house and the root crown is making contact with the cement parking pad of the carport. **See Appendix A- Photos 3**

- The root crow has been buried below grade at least 12 inches. **See Appendix A- Photos 3**
- A large branch has been removed from the lower trunk of the tree on the north side. The wound created by the cut is approximately 18 inches X 24 inches and is showing signs of decay. **See Appendix A- Photo 4**

**Photo3-** Close-up of grade buried root crown and restricted root space.

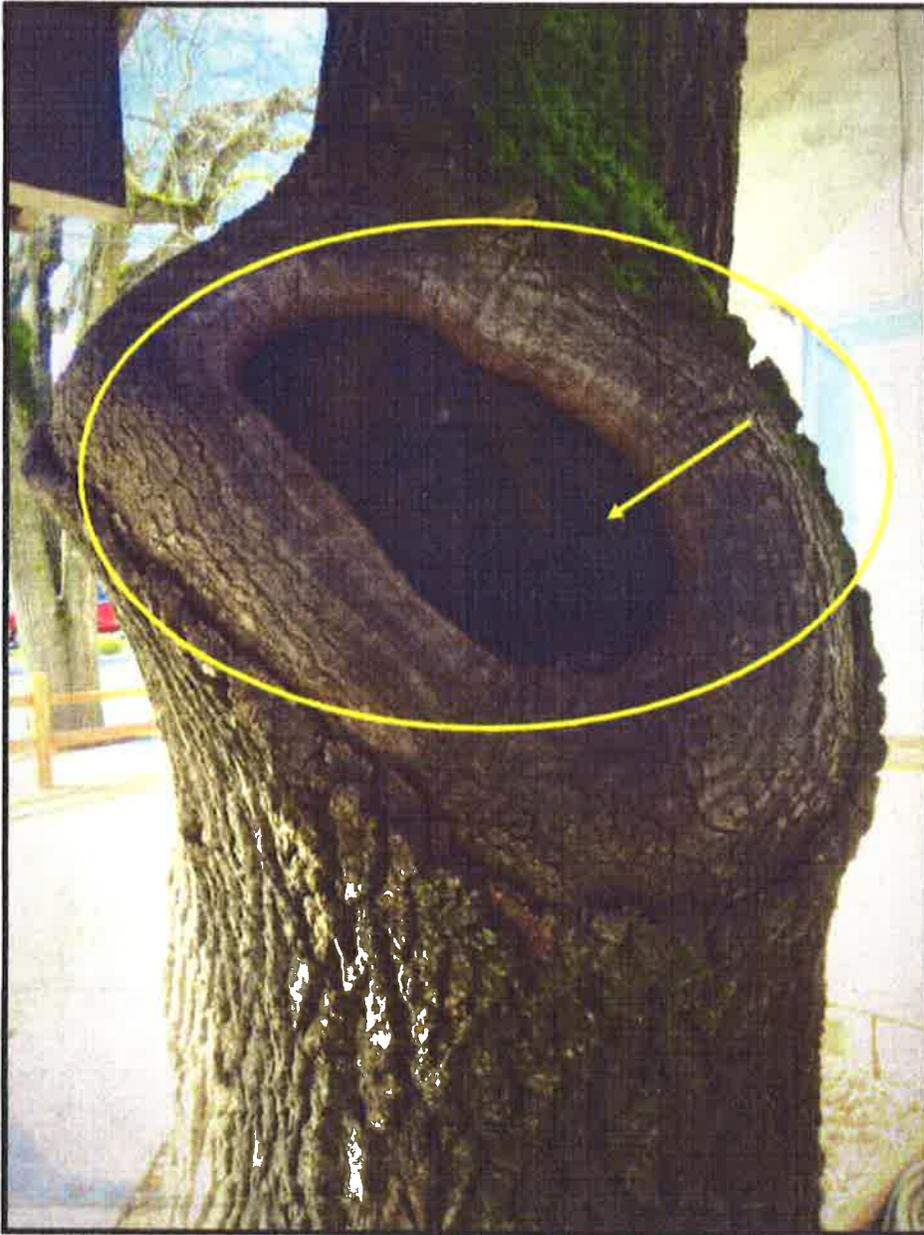
A large branch was removed from the north side of the tree 10 or more years ago. It is located approximately 6 feet above ground. The original diameter of the branch was approximately 36 inches. The open wound that remains is approximately 18 inches x 24 inches. The wound is callusing over, however decay has begun to form. It is not likely that the wound will seal over before decay advances significantly into the stem of the tree. The main stem of the tree above the wound has a lean of approximately 30 degrees to the west and over the house. The length of the stem above the wound is approximately 45 feet. The weak area of the stem with the large wound and decay combined with the lean and height of the stem make the possibility of stem failure at the wound point somewhat likely.

**Photo 4-** Close-up of large wound on north side of tree. Arrow indicates formation of decay.

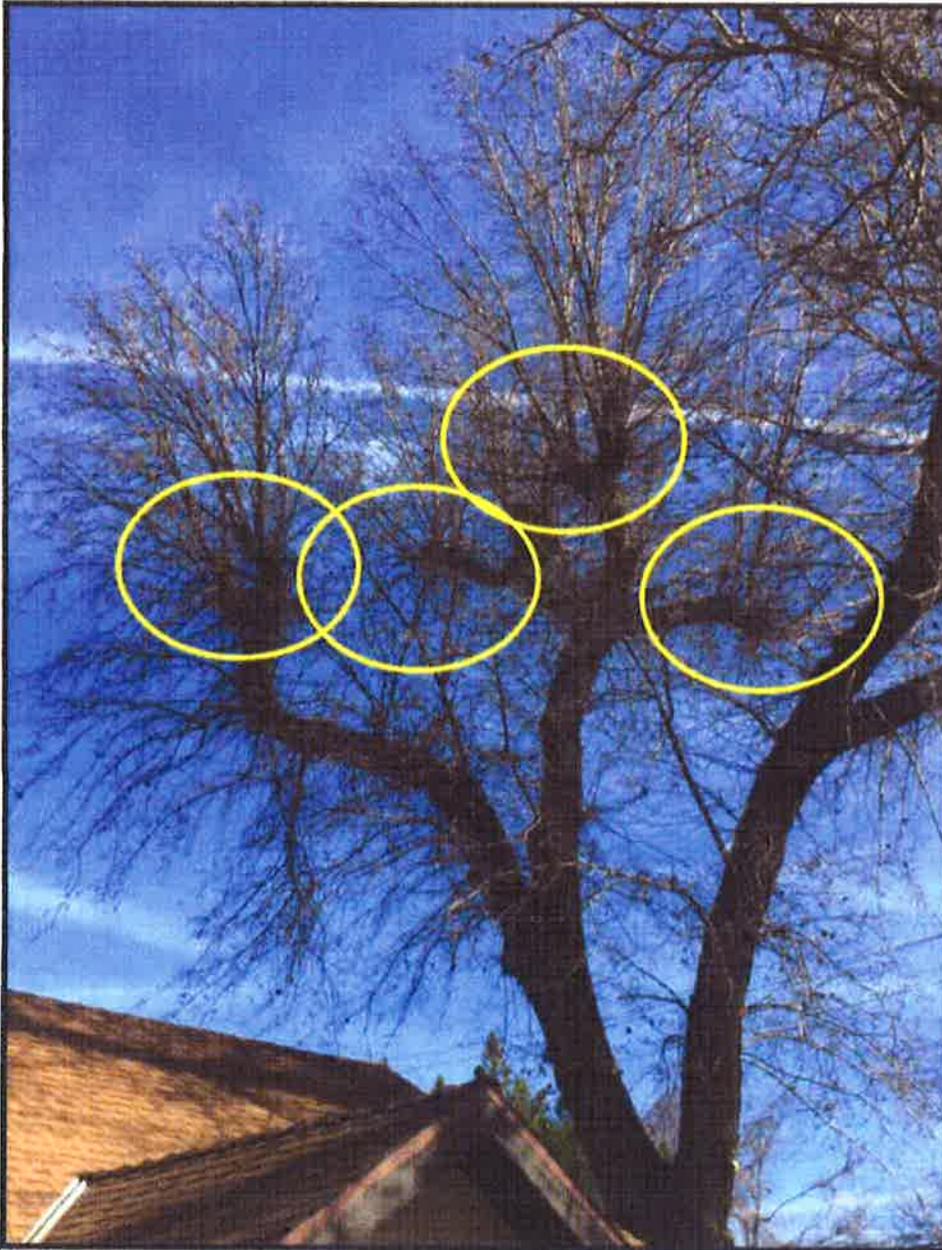
This tree has been topped significantly in the past. By my estimation of the re-growth, the work occurred in the last 10 years. Most of the lateral branches were removed leaving only 3 main scaffolds and some stubbed secondary branches. As a response to topping, epicormic shoots or "suckers" have re-grown from the topping points. Epicormic shoots originate from beneath the surface of the bark and are typically weakly attached to the parent branches. As these shoots gain height and diameter, they tend to fail during wind events.

Photo 5- Epicormic shoots growing from topping points.
