RESOLUTION NO. 17-087

A RESOLUTION OF THE CITY COUNCIL OF THE CITY OF PASO ROBLES
AUTHORIZING THE REMOVAL OF ONE 10.5-INCH DIAMETER BLUE OAK TREE
AT 188 VIA MAGNOLIA – LOT 15 TRACT 2620 (OTR 17-009 -MICHAEL HARROD)

SUBJECT: OAK TREE EVALUATIONS
188 VIA MAGNOLIA
PASO ROBLES, CA

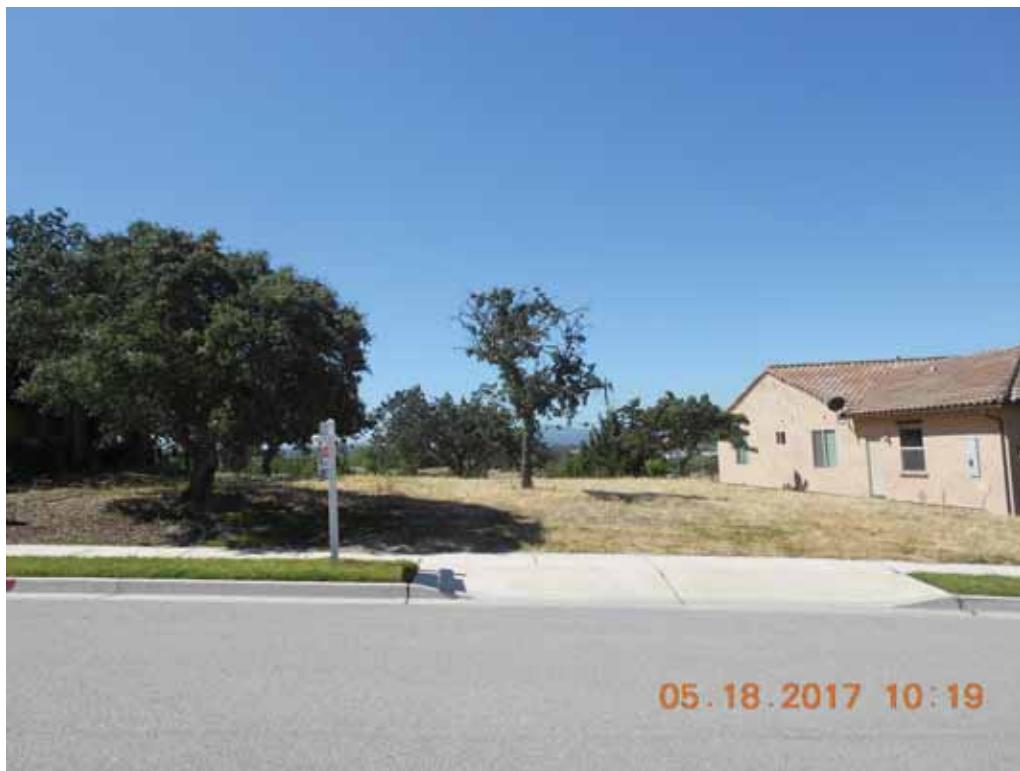
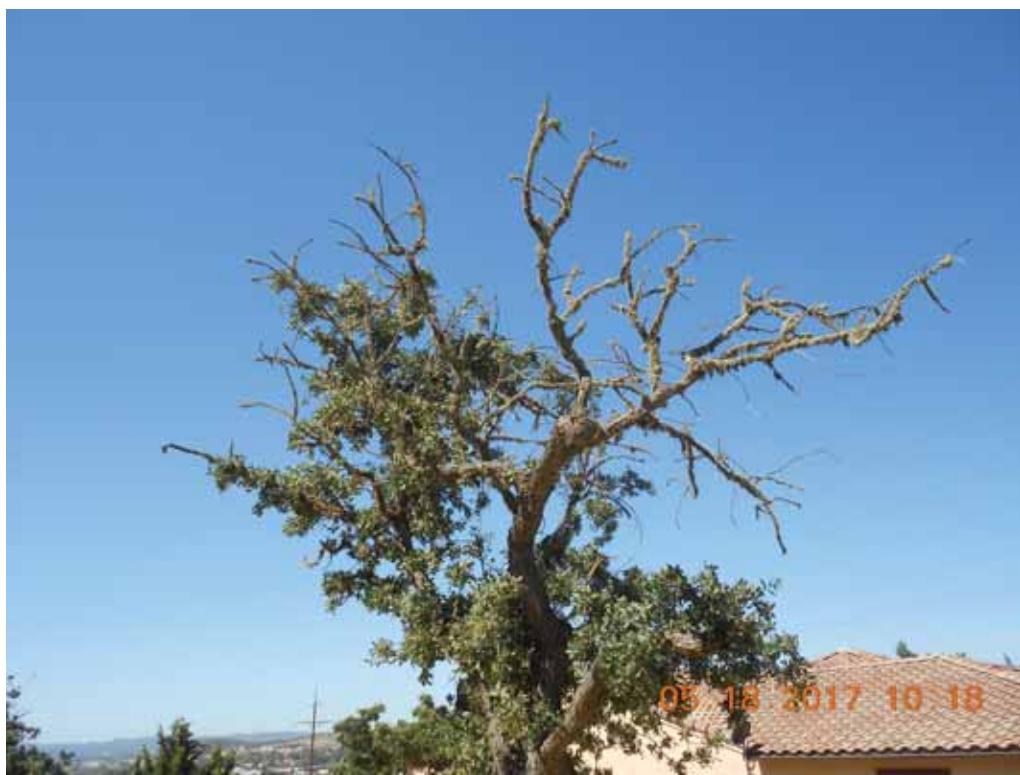
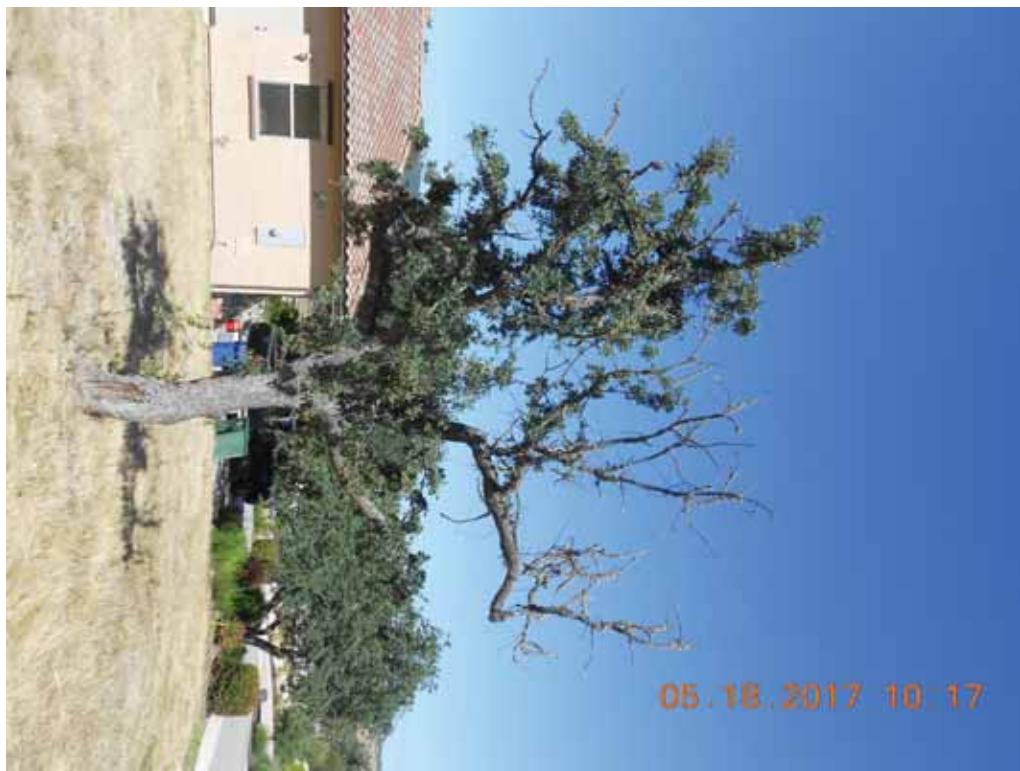
Tree #1 – BLUE OAK [see figures 1, 2 & 3]

The Blue Oak tree (*Quercus douglasii*) #1 is located on an empty lot in a residential subdivision. There is approximately one-half to two-thirds dead branches. Excessive sucker growth is the only green foliate growth. Sign of prior branch breakage are evident. Bark near the root ball has evidence of prior injury with no evidence of healing.

Tree #1 (described above) is clearly in severe declining health. The foliage evident is merely succor growth and will not sustain the tree for long. Comparing the health of the subject tree to others on the lot clearly indicate that the tree will not survive another summer with no precipitation. As the tree continues to decay, there is a potential for total failure in a short period of time.

The health of the tree will not be improved by any measures. The potential for additional limb failure and/or total tree failure is extremely high. This tree should be removed and replaced with a compatible native species.

Based on the overall health of the tree, it is recommended that it be removed and replaced elsewhere on the lot by another native tree with a stronger potential for survival.
