RESOLUTION NO. 18-024

A RESOLUTION OF THE CITY COUNCIL OF THE CITY OF PASO ROBLES  
AUTHORIZING THE REMOVAL OF ONE OAK TREE AT 3230 RIVERSIDE AVENUE  
(OTR 18-002 / HASTINGS) APN 008-051-027

## Oak Tree Impact Report

**Project Name:** Building Expansion 3230 Riverside Avenue

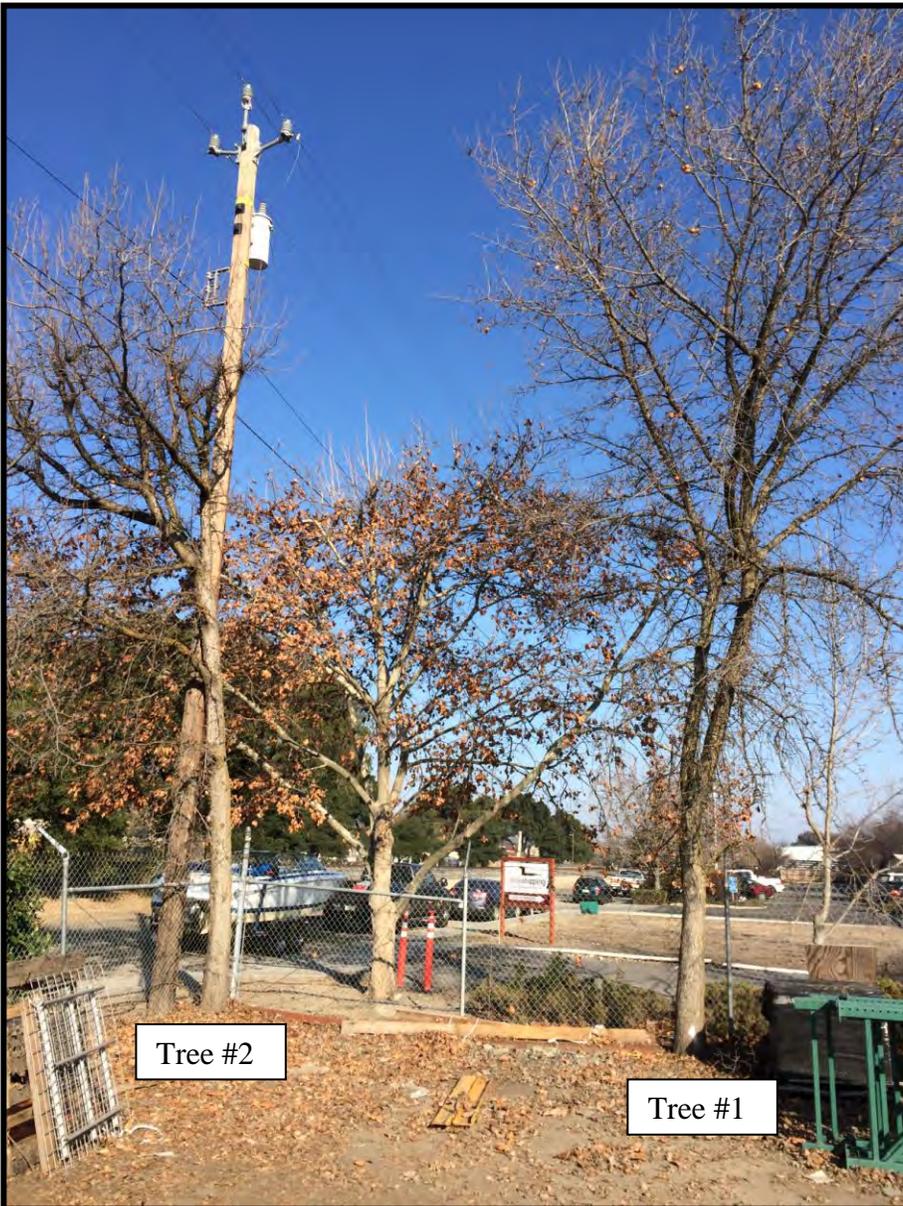
The trees appeared to be a “volunteers” that came up naturally rather than being part of a planned landscape. In general the trees were in fair condition and showed some mild drought stress indicated by some dead, pencil sized, twigs in the canopy. The structure of tree #1 was also in fair condition. Tree # 2 had been pruned by PG&E for utility clearance; therefore I rated its structure as poor.

Photo 1- Tree locations on site.

Tree # 1 is within the proposed building addition footprint and will need to be removed. Tree #2 is located outside the proposed building addition footprint and can be retained but will require tree protection during all phases of construction.

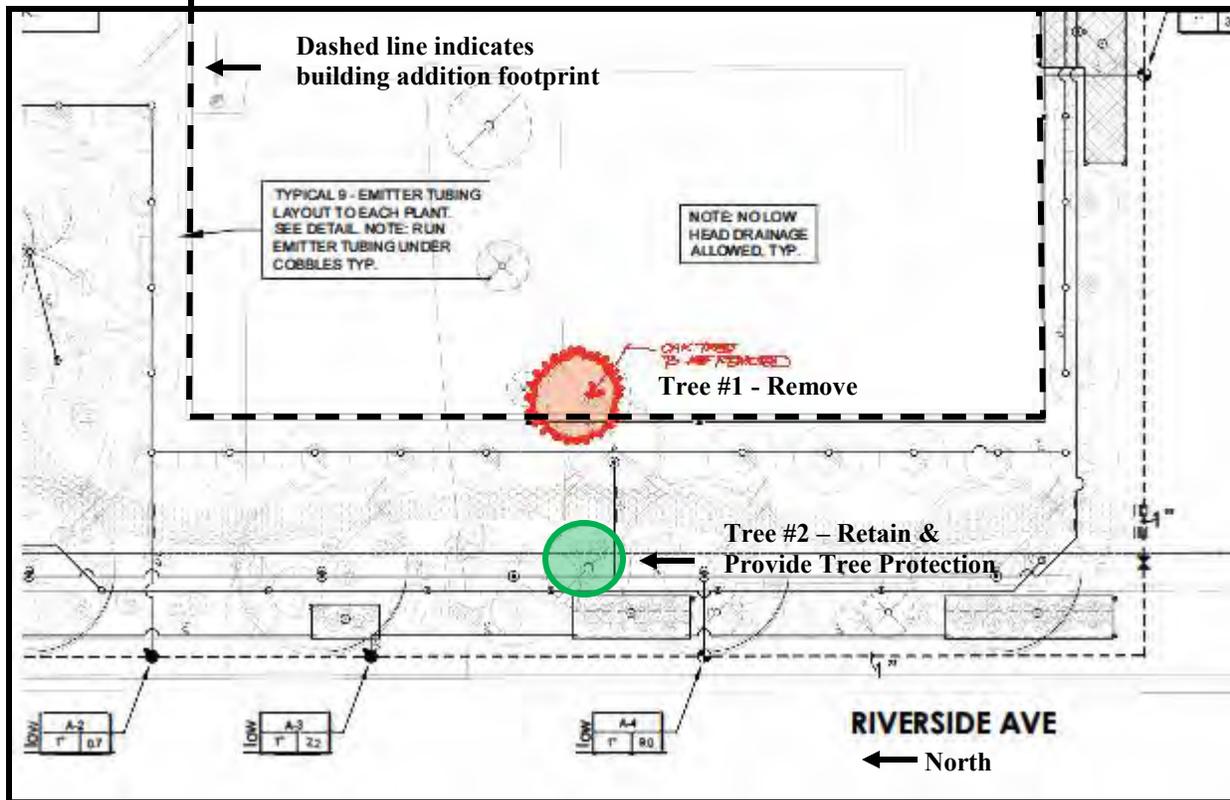
## Appendix B- Site Diagrams

I noted two (2) Valley oaks within and adjacent to the proposed building footprint. I attached metal tags to the base of the trees and assigned numbers to each. The tree numbers I assigned correlate with tree #1 and #2 noted in Appendix B- Site Diagrams. Tree #1 was growing at the north fenceline in part of a storage area in the parking lot for the existing building. Tree #2 was located beside an electrical utility pole at the northwest corner of the same storage area as tree #1.

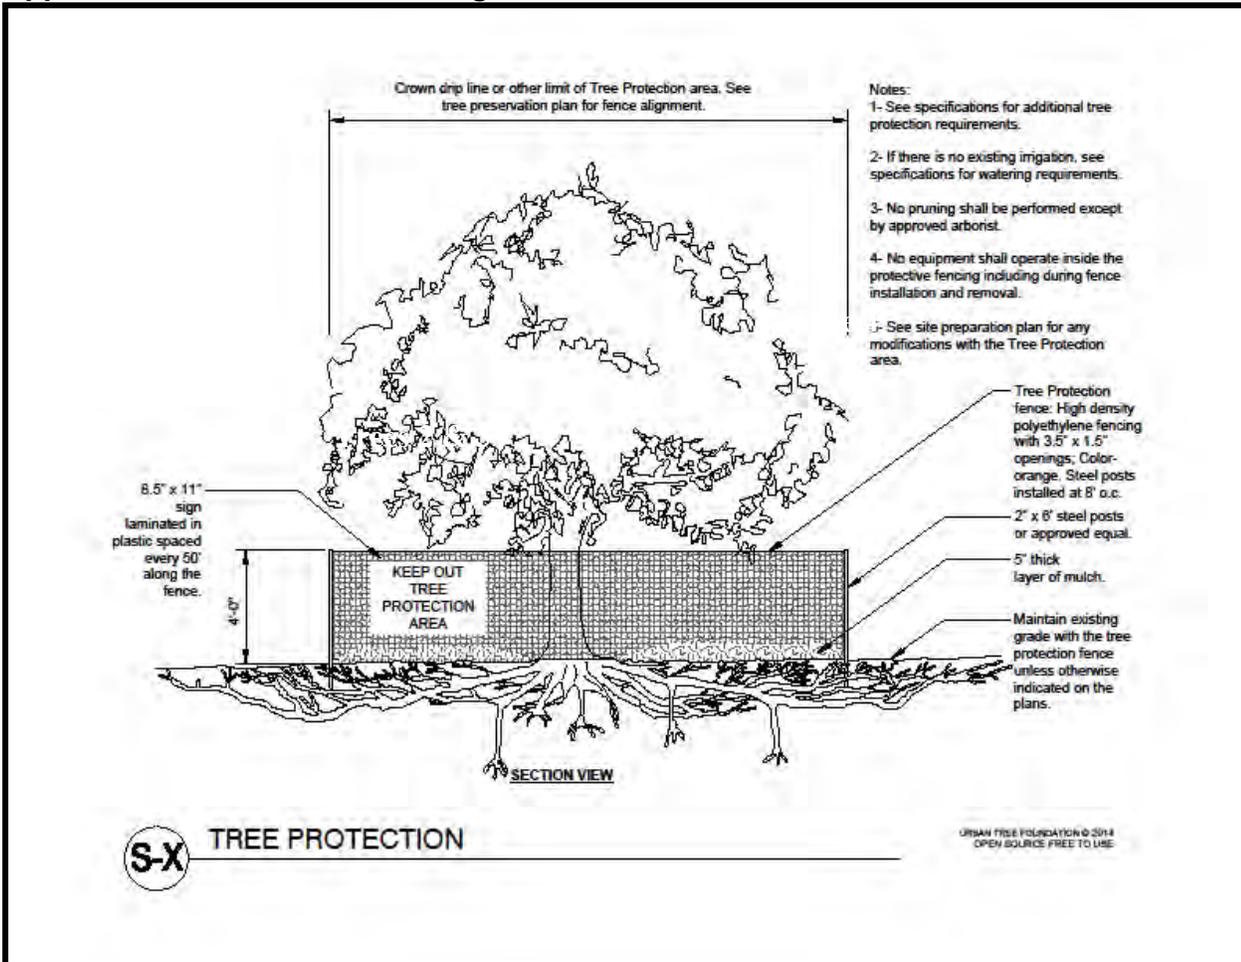
## Appendix C- Tree Protection Diagram

Tree #2 although poorly located adjacent to a utility pole, can be retained if the **\*critical root zone (CRZ)** is protected during construction activities. In order to protect the CRZ, a **\*tree protection zone (TPZ)** should be established and tree protection fencing installed at the limits of the TPZ.

- **Tree Protection During Construction-** The tree protection shall be provided during the entire time construction activities occur. A TPZ shall be established and maintained to ensure roots remain undamaged. A critical root zone or CRZ is an area equal to 1-foot radius from the base of the tree's trunk for each 1 inch of the tree's diameter at 4.5 feet above grade or DSH. Example: By multiplying a tree diameter of 24 inches by 1, the radius of root protection would be 24 feet from the trunk. At that distance the tree protection fencing would be installed around the perimeter of the tree. In this case of tree #2, the tree was 11 inches in diameter so a radius extending out 11 feet from the trunk of the tree will be the limit of the TPZ.

- **Tree Protection Fencing-** Tree protection fencing is required to be in place for the duration of the construction project. The fencing should be 4 feet tall and made of orange, high density, polyethylene with 3.5" x 1.5" openings. It should be installed on steel posts 8 feet on center and tightly stretched to prevent sagging. Weatherproof tree protection signs shall be placed on the fencing and remain in place until completion of the project. See Appendix C - Tree Protection Diagram.
