TO: James L. App, City Manager
FROM: Ronald Whisenand, Community Development Director
SUBJECT: Highway 101 Median Barrier Project Recommendations
DATE: June 2, 2009

The City of El Paso de Robles Highway 101 Median Barrier Project

Paso Robles Median Barrier Project

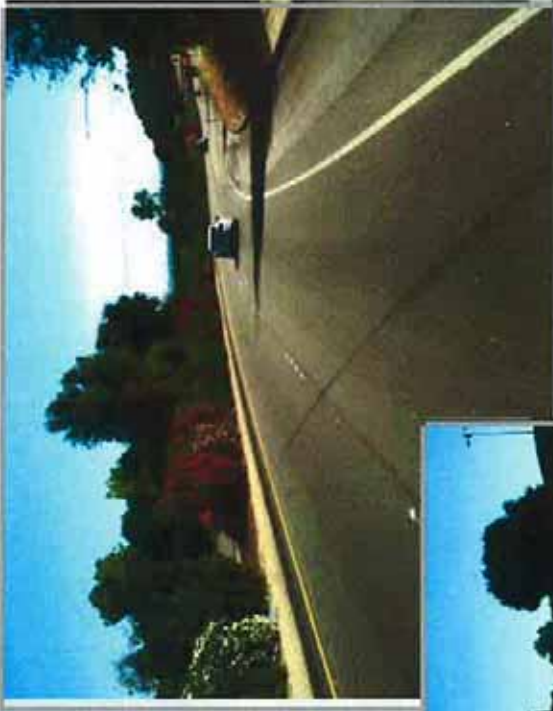
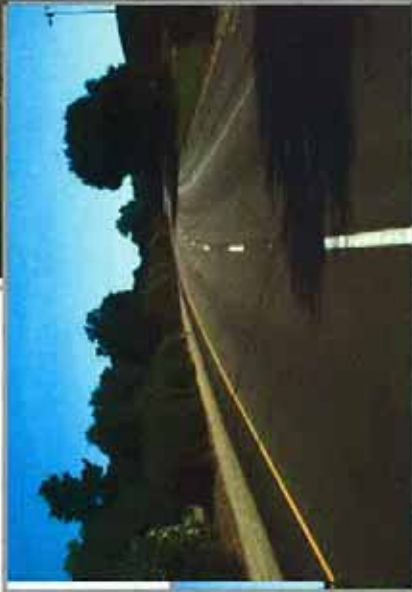
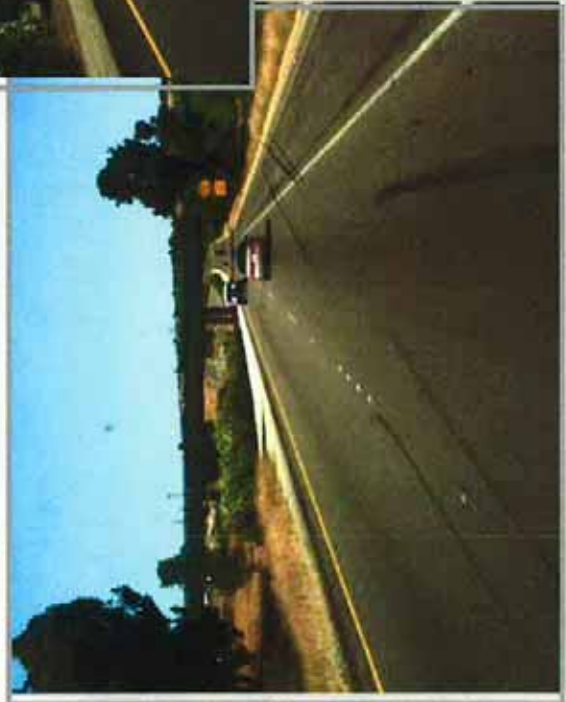
Paso Robles (Highway 101) Median Barrier

- 4-lane freeway
- Traffic volumes 37,000-44,000 vehicles per day (2007 estimate)
- Warrant: Median Barrier “Volume/Median Width”
- Median Width is 46 feet in this area

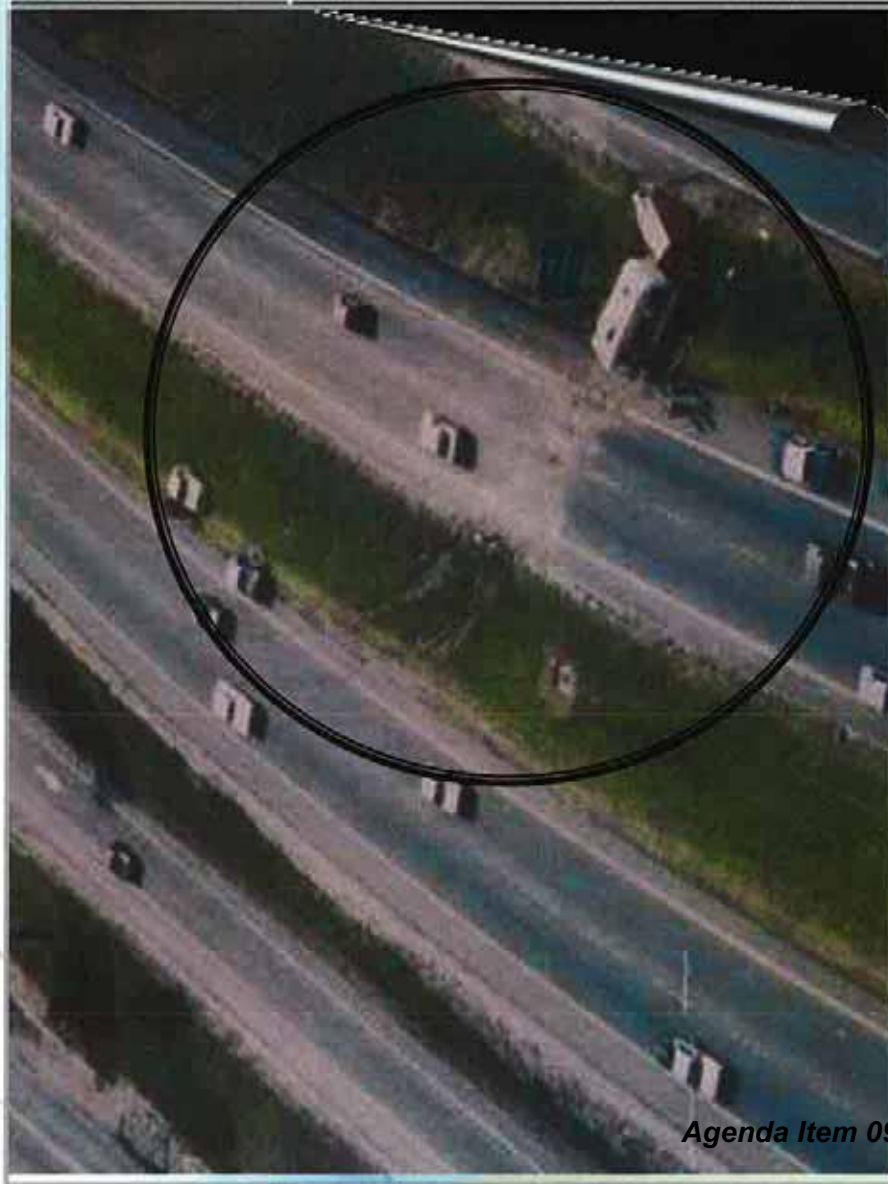
Cross-Median Errant Vehicles

- Cross-median collisions severely impact unsuspecting motorists
- Errant Vehicles can also impact those working in the median or along the shoulder

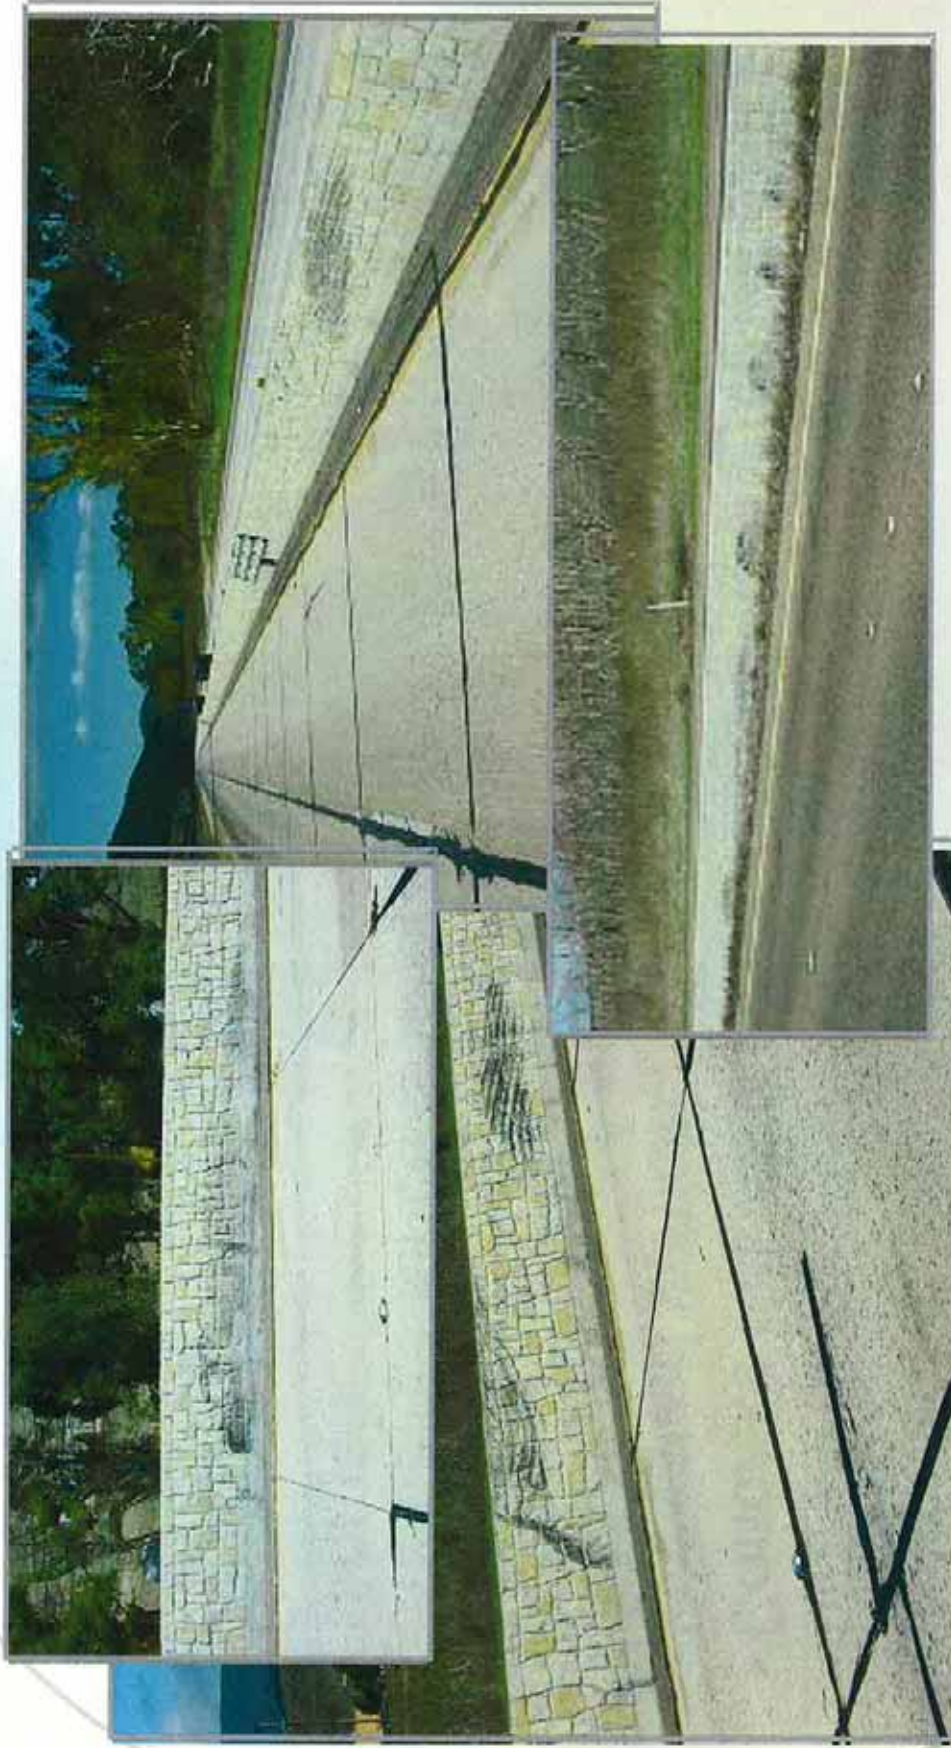
Median “Hits” – with Concrete Barrier

Concrete Median “hits” require little or no maintenance

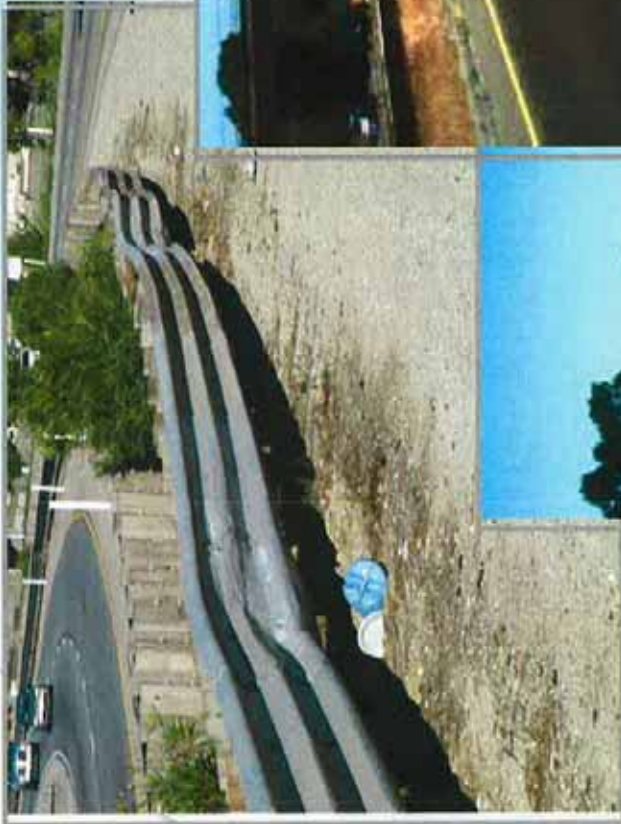
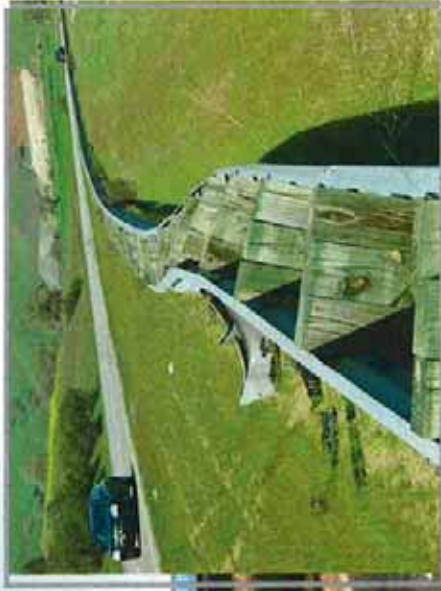
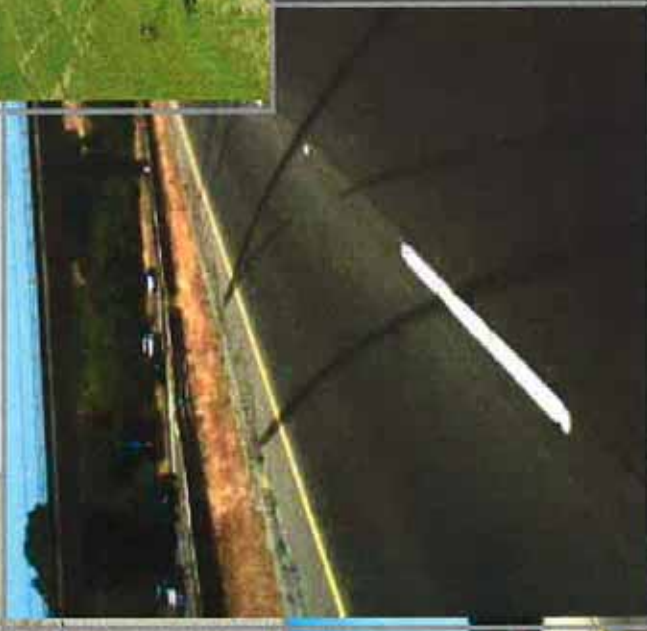
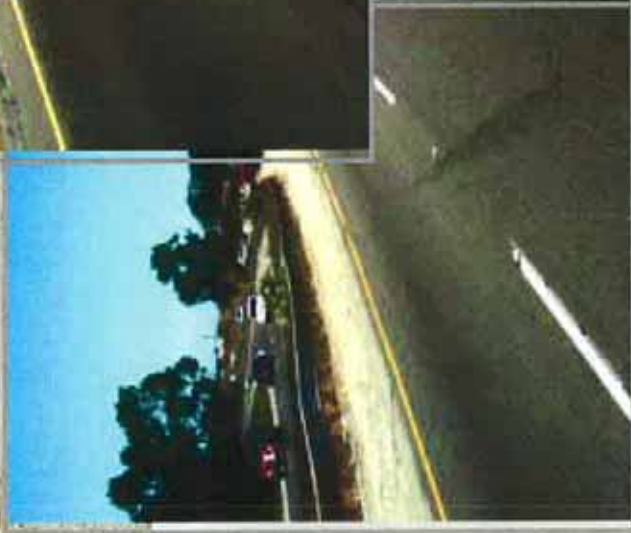
Median "Hits" – Metal Beam Barrier

Metal Beam
requires
lane closures
to repair,
which delays
motorists

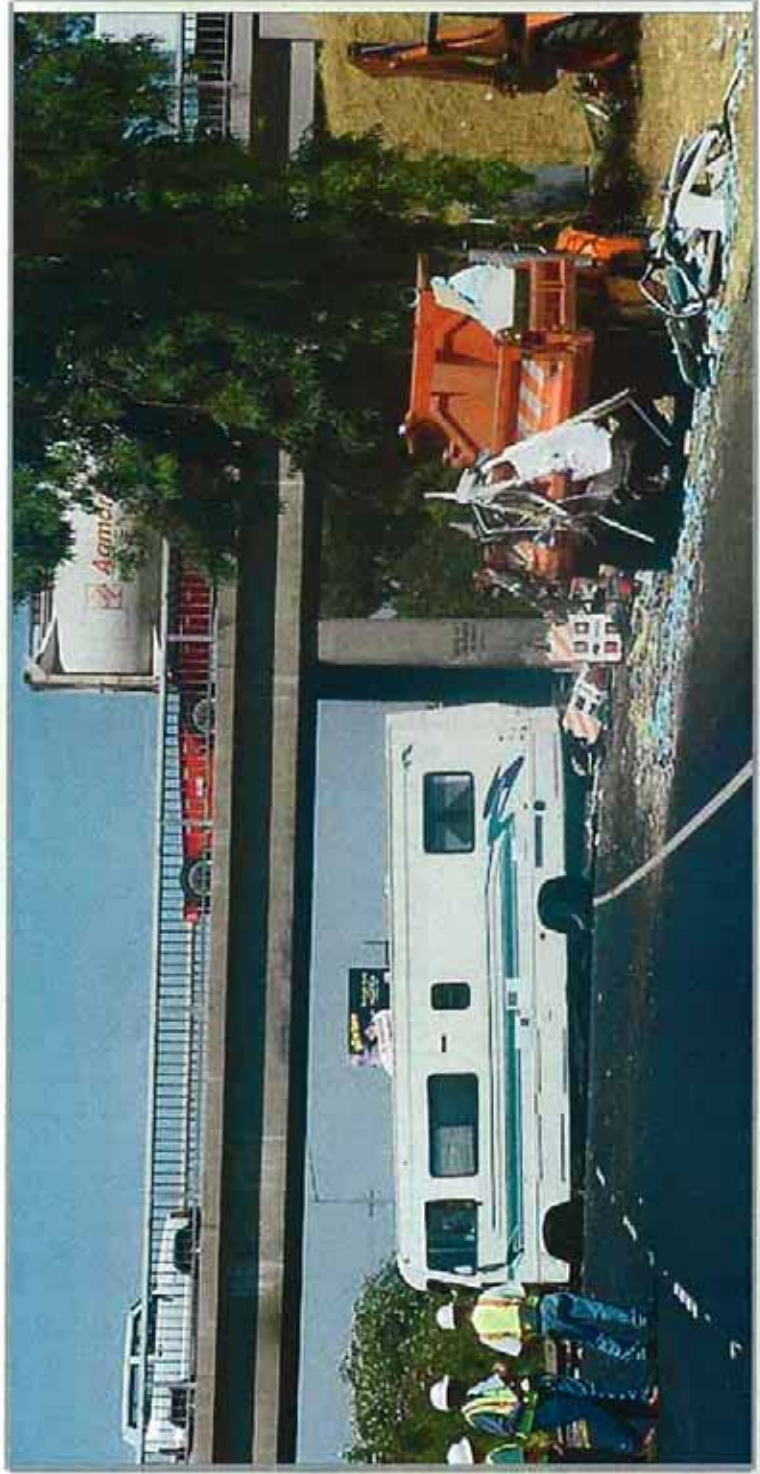
Caltrans Experience

- RV driver dosed off
- Caltrans crew repairing guardrail
- Caltrans worker jumped to safety at the last minute

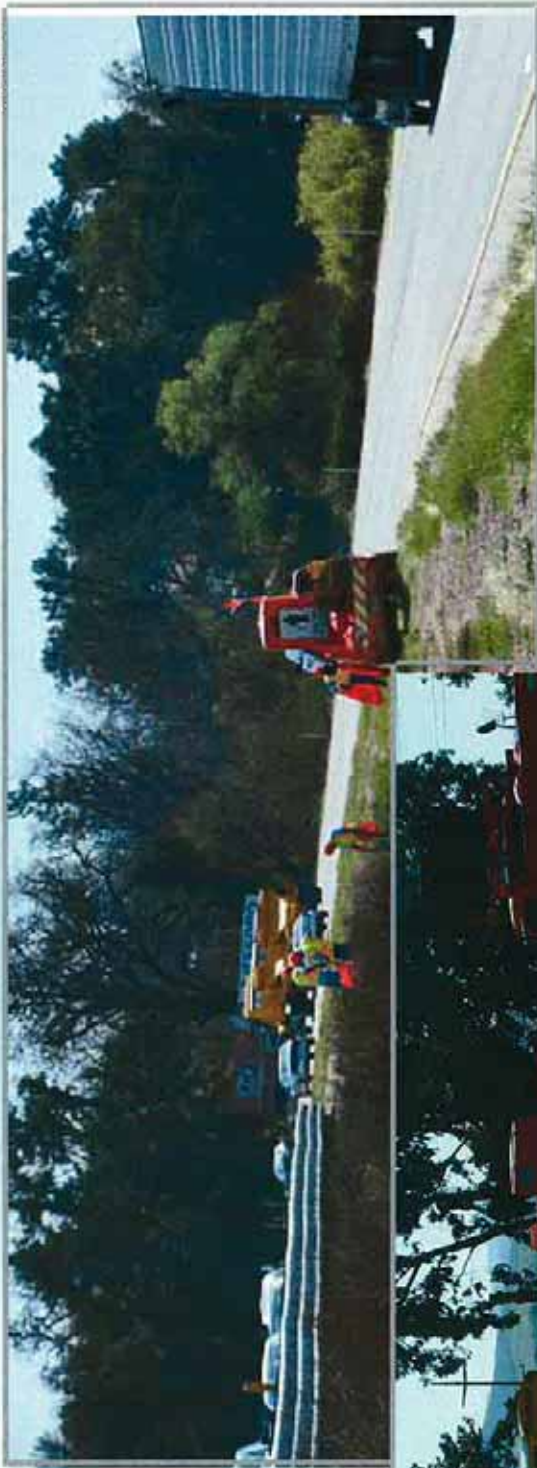
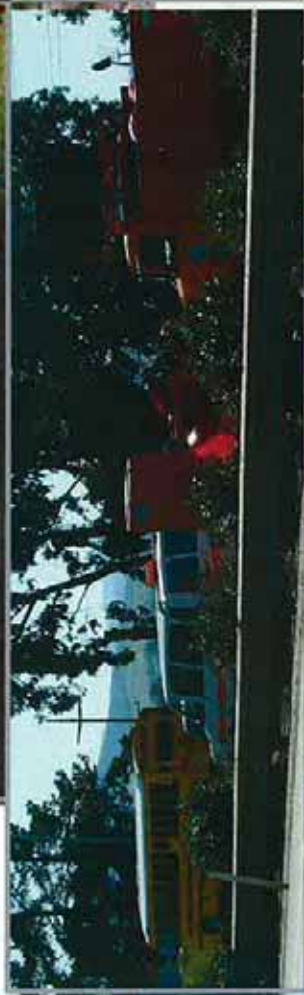
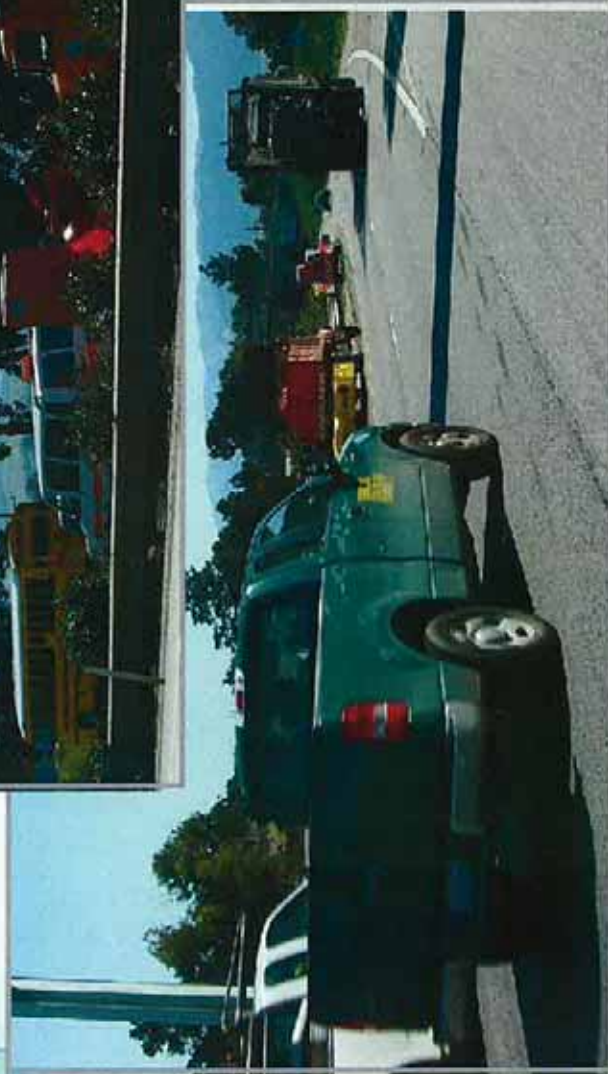
Worker Safety – Litter Pick Up

- Workers on foot
- litter pick up in wide median
 - little to protect from errant vehicle

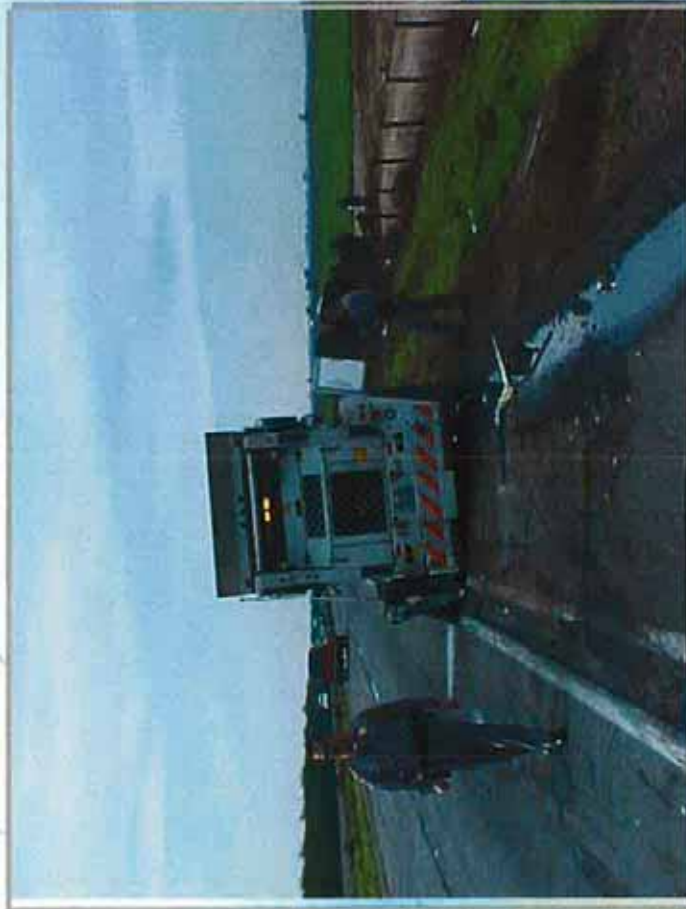
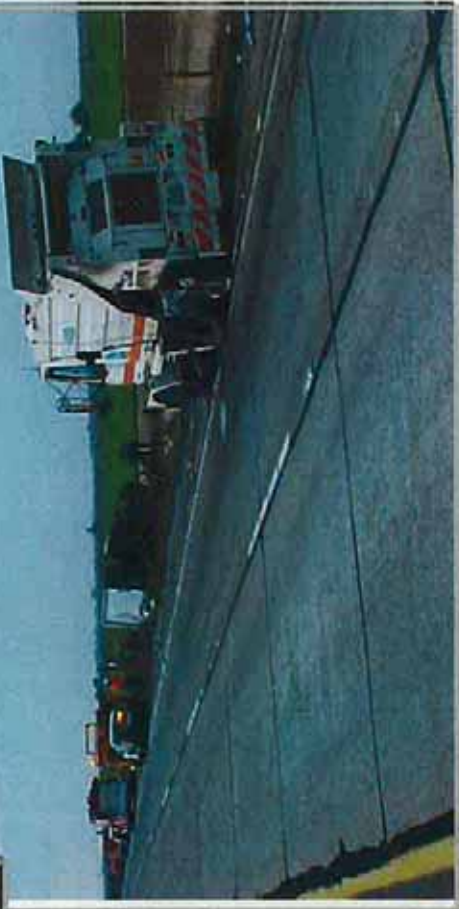
Work Zone Incident – Sweeping

- Sweeper truck vs. errant vehicle
- Caltrans sweeper struck while sweeping shoulder
- Worker has better chance for safety in vehicle than on foot

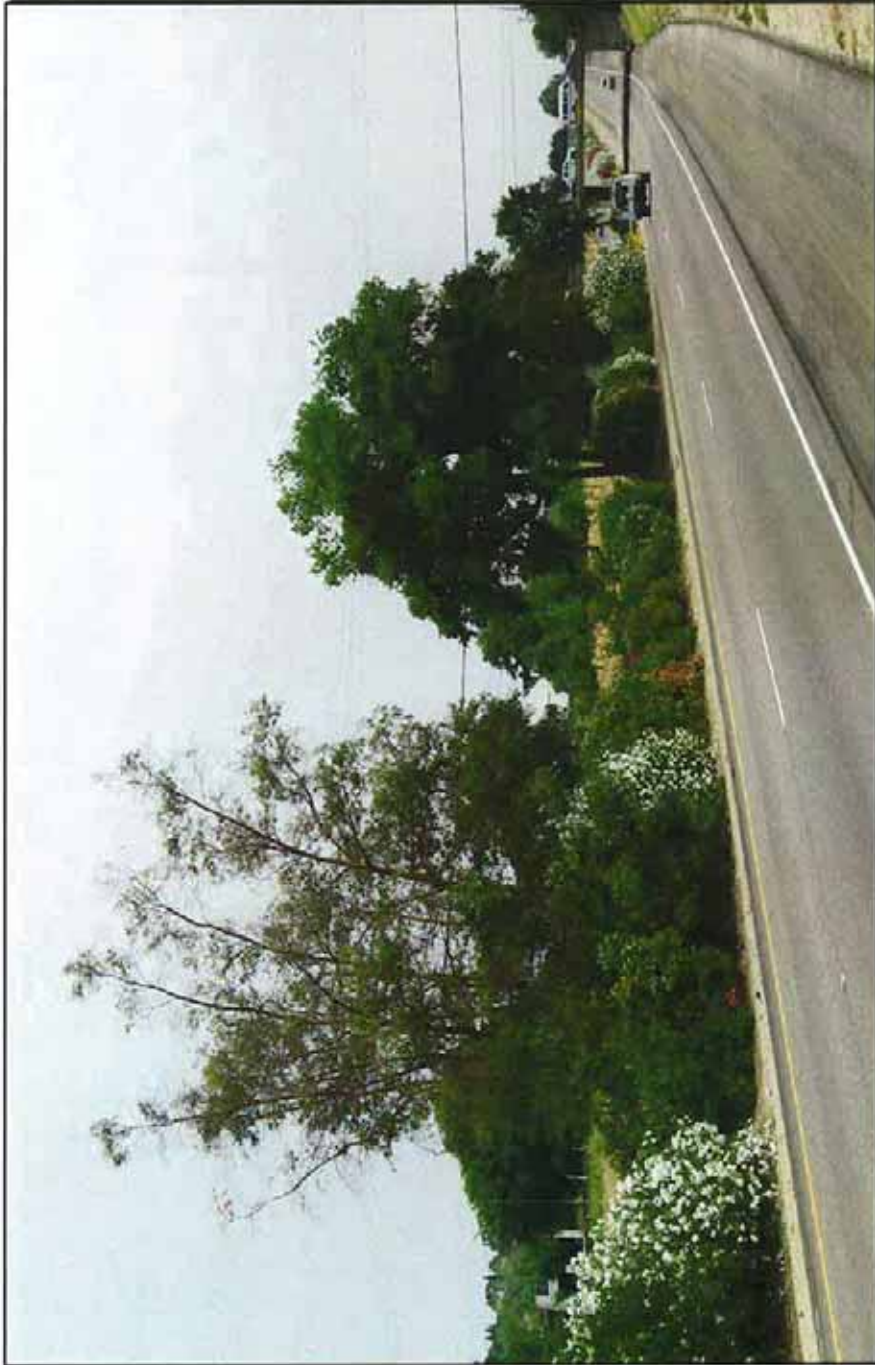
EXISTING VIEW
OBSERVER VIEWPOINT 1
From southbound Highway 101 approximately
200 feet north of the 13th Street Bridge
Figure 2

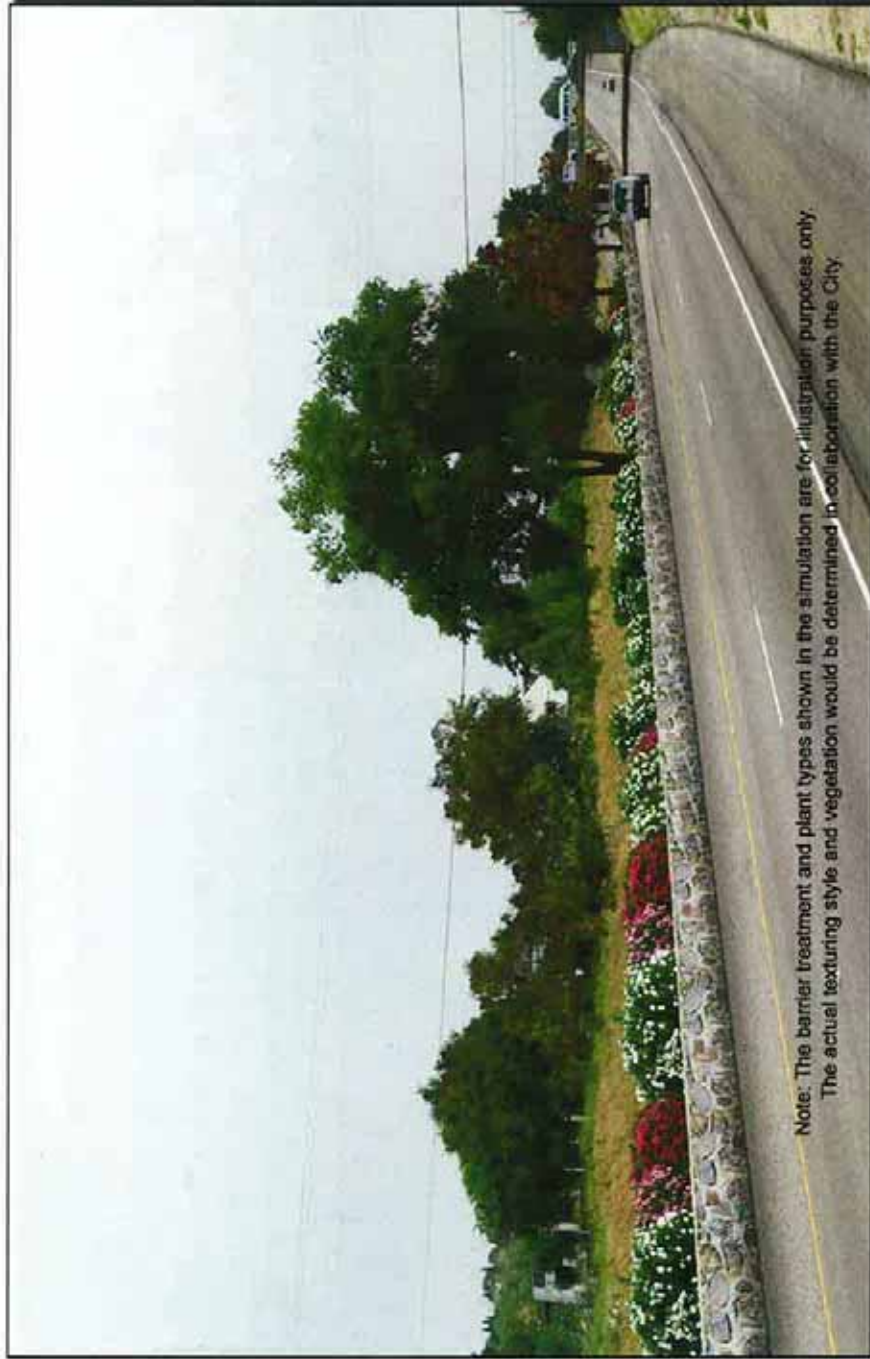
Figure 3

VIEW OF THE PROPOSED PROJECT
OBSERVER VIEWPOINT 1
From southbound Highway 101 approximately
200 feet north of the 13th Street Bridge
