SUBJECT: APCD Comments Regarding the Paso Robles Motorcoach Resort GPA,  
PD08-001 Project Referral. (PD/CUP 08-001)

Exhibit C  
APCD Letter  
GPA 09-001, RZ 09-001, PD 08-001  
CUP 08-001 & PRAL 07-0293  
(PR Motorcoach)

This traffic and circulation study contains an analysis of the affect of the Paso Robles Motorcoach Resort (PRMCR) on the Golden Hill Road corridor. The City process will include a General Plan Amendment (GPA), Zone Change and a Conditional Use Permit (CUP). The Project covers an area of 160.5 acres in three parcels. The parcel sizes are: Parcel 1 - 36 acres; Parcel 2 - 79.9 acres; and Parcel 3 - 44.6 acres. All three parcels are designated as AG/Airport Overlay in the current General Plan and are zoned RA. These parcels are located in the Paso Robles Airport Planning Area (Zones 3 & 5), regulated by the Airport Land Use Plan (ALUP). Residential units are not allowed in this area per the ALUP, thus the current RA zoning should be changed to AG. The project evaluation and consistency with the General Plan will be based upon the assumption that the AG zoning is in place. The Golden Hill Retail Center (GHRC) Traffic and Circulation report (Near-Term Cumulative) alo

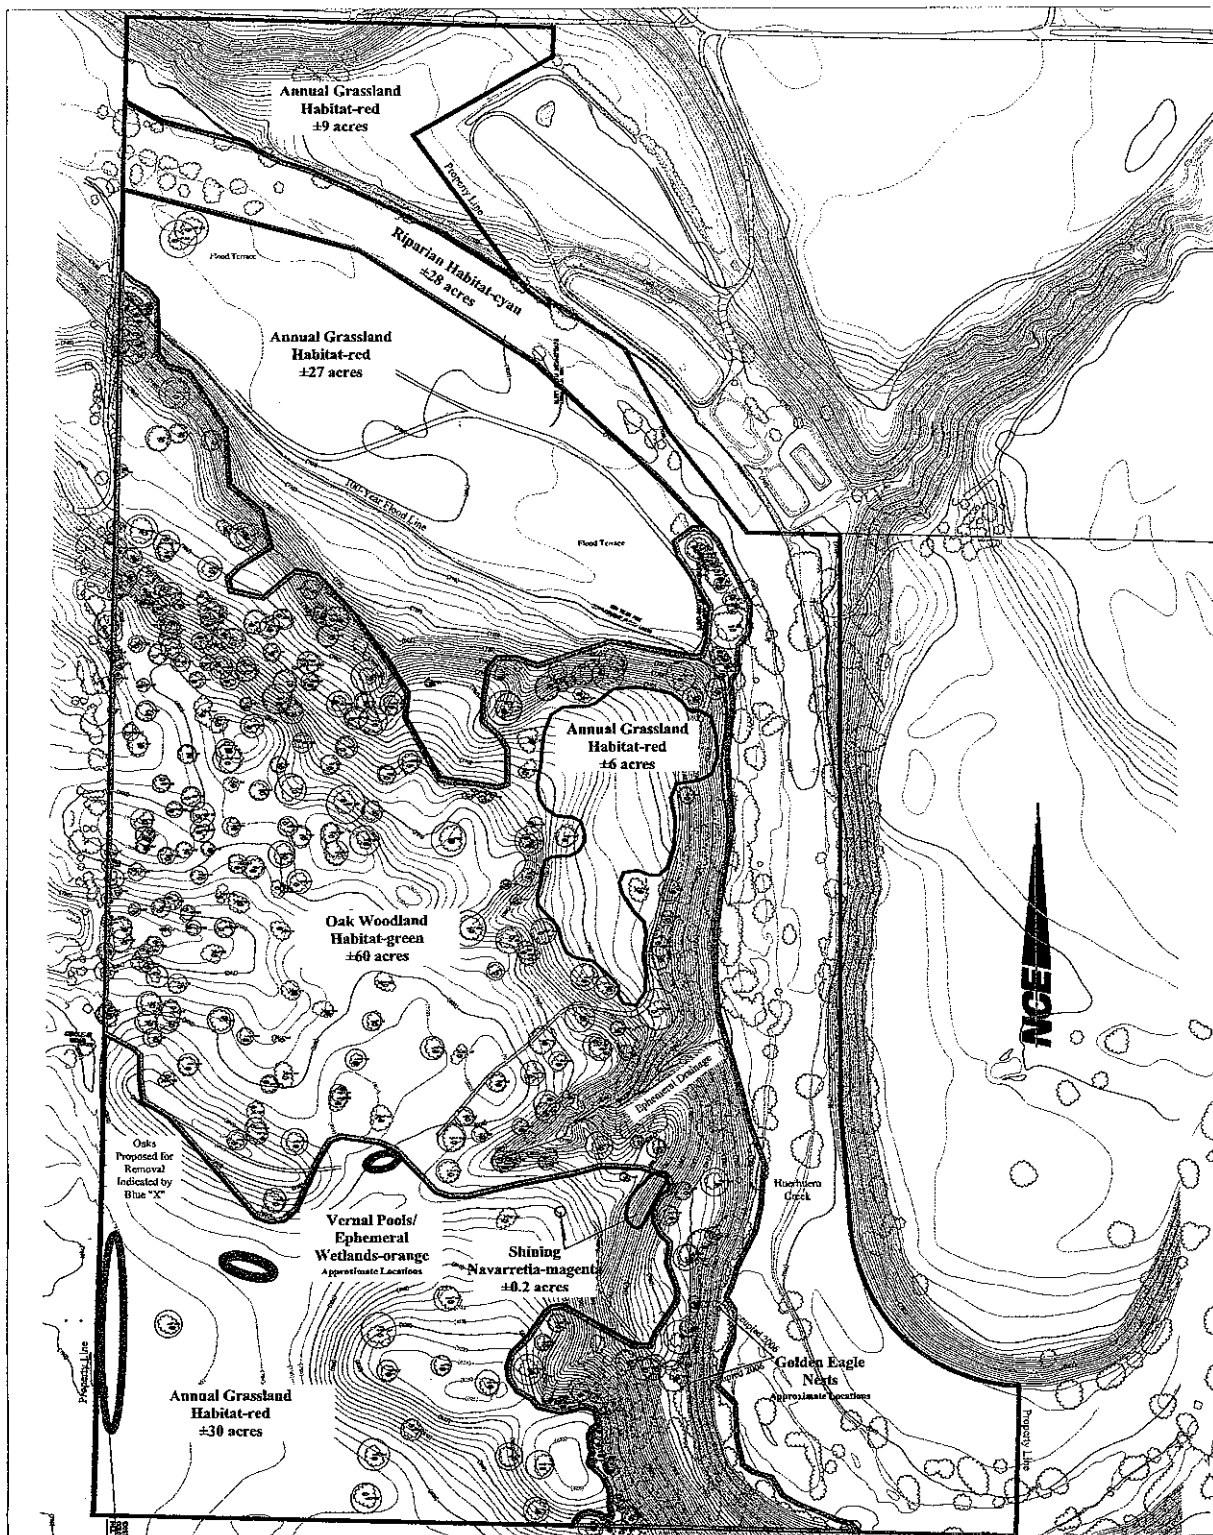
Paso Robles  
 Motorcoach Resort  
 APN 025-435-005, -006, -007

## Biological Resource Map

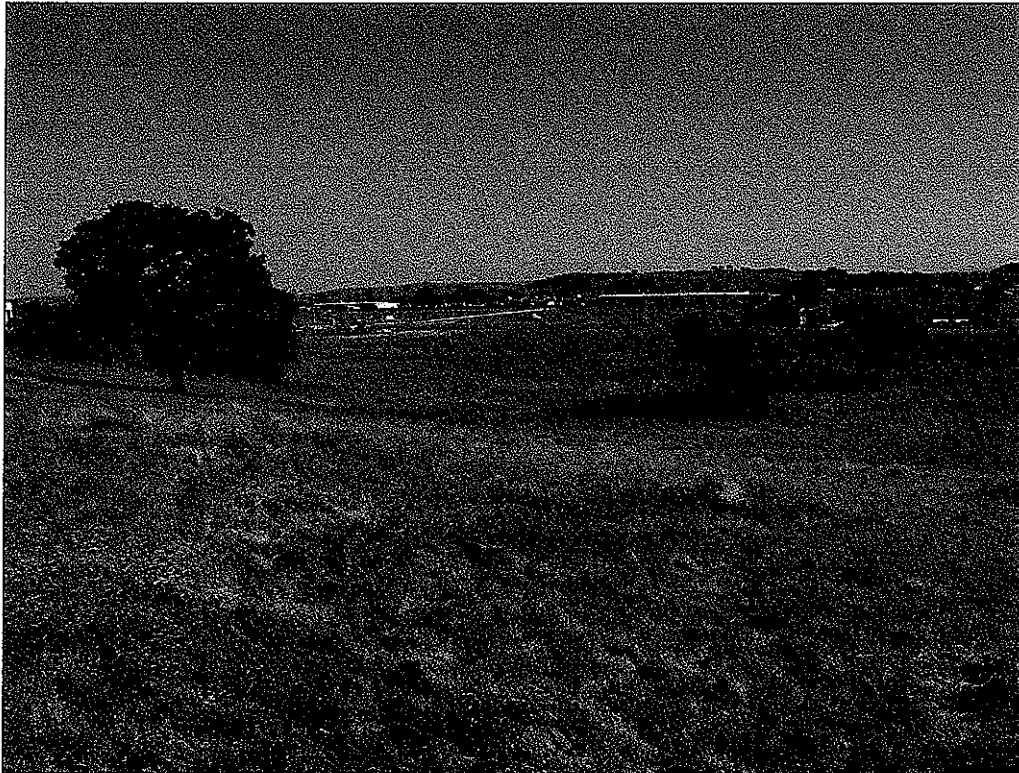
Photo 1. Grassland with occasional scattered oak trees occupies a large portion of the property. View southwest at south end of the property, May 2006.

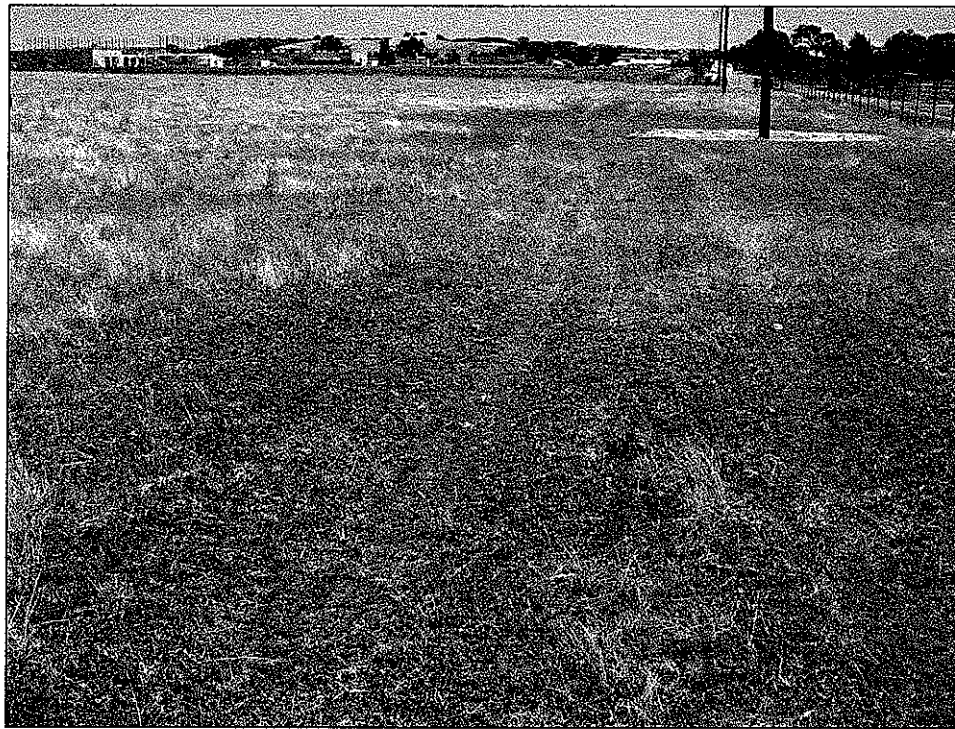
Photo 5. Isolated seasonal wetlands occur in small patches along the western property boundary. Photo taken May 24, 2006.

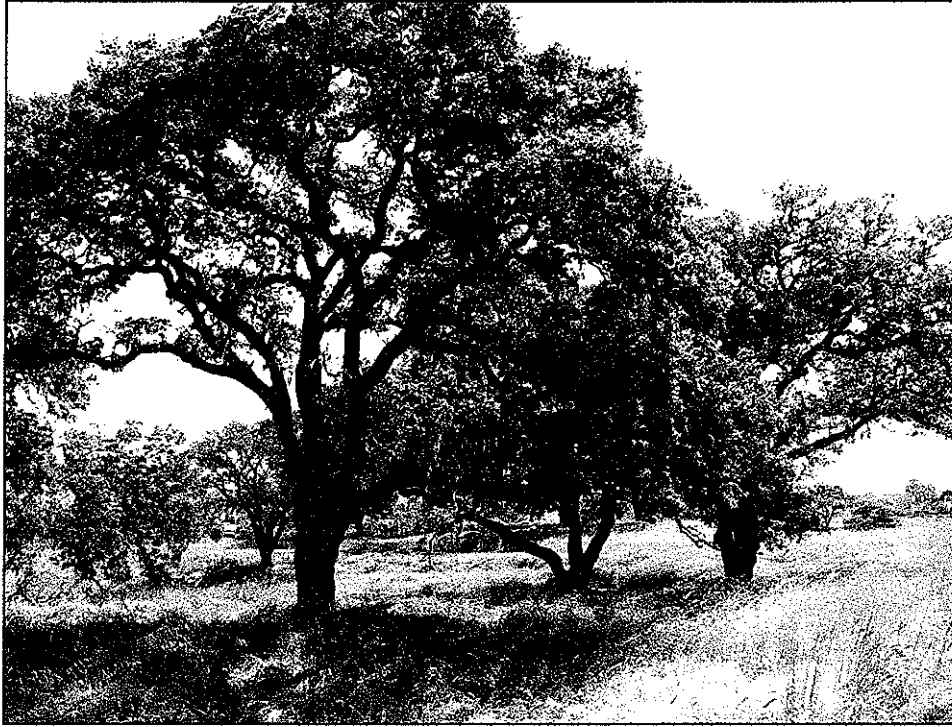
Photo 6. Many mature blue oaks and occasional valley oaks occur on the property in oak woodland and grassland habitats. Photo taken May 4, 2006.

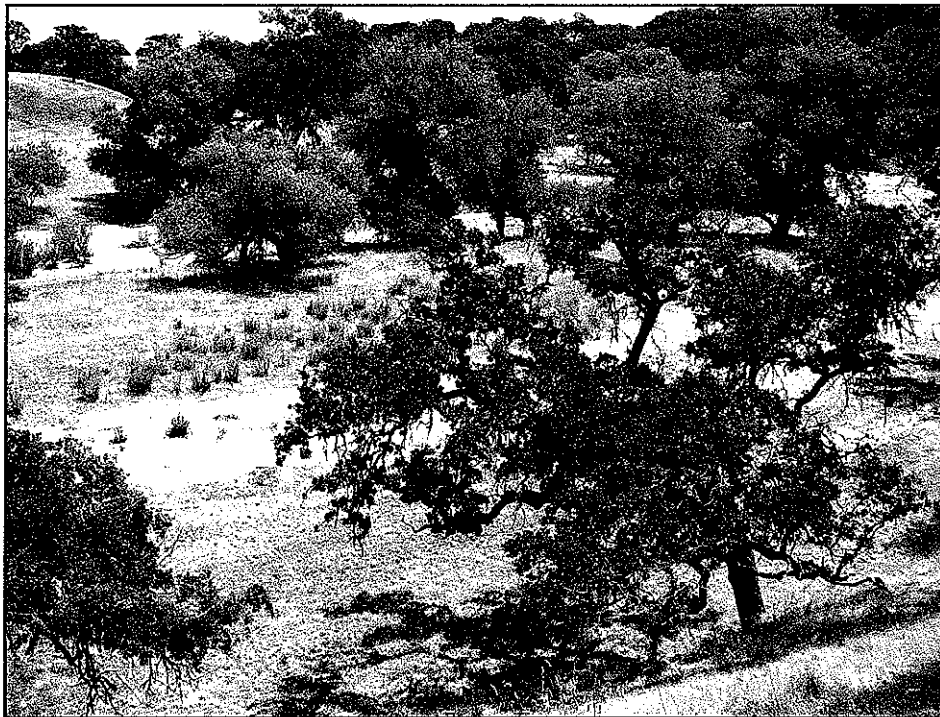
Photo 7. Riparian habitat along Huerhuero Creek includes a mixture of oak trees, riparian trees, riparian shrubs, and herbaceous vegetation.

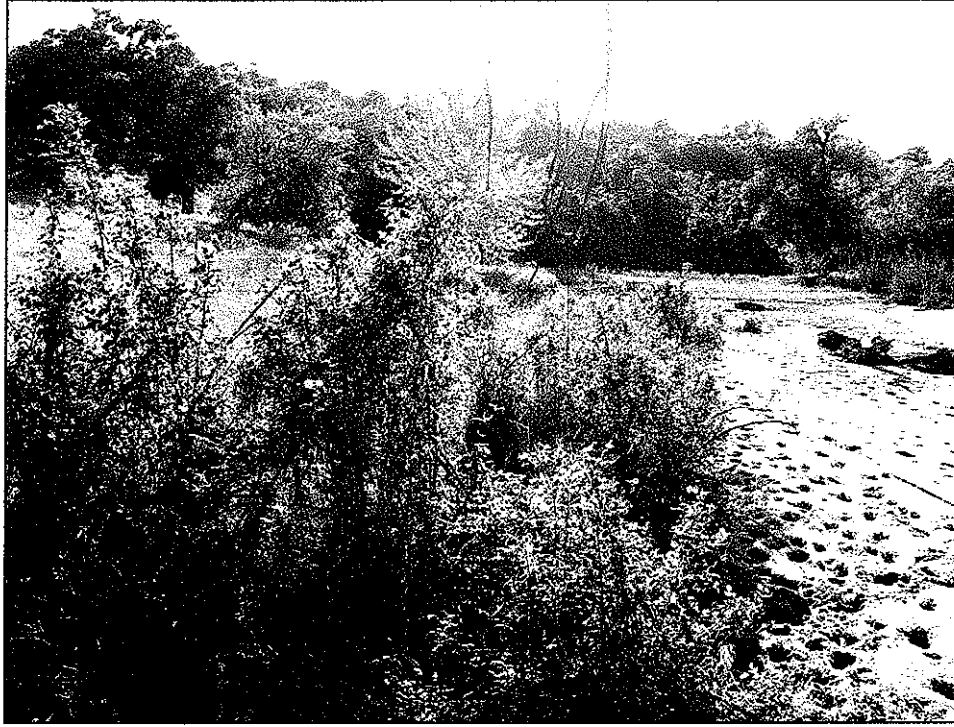
Photo 8. California wild rose thickets occur in patches along the banks of Huerhuero Creek.

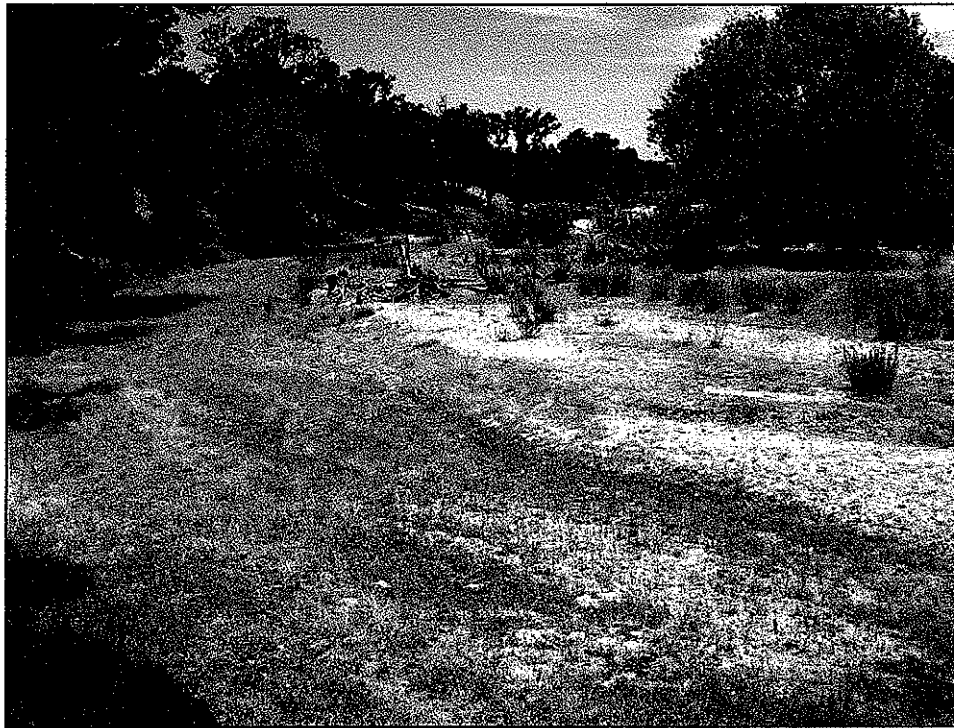
Photo 9. Some portions of the streambed support herbaceous vegetation. Smaller shrubs occur on sandbars, while large shrubs and trees are dominant on banks and stream terraces.

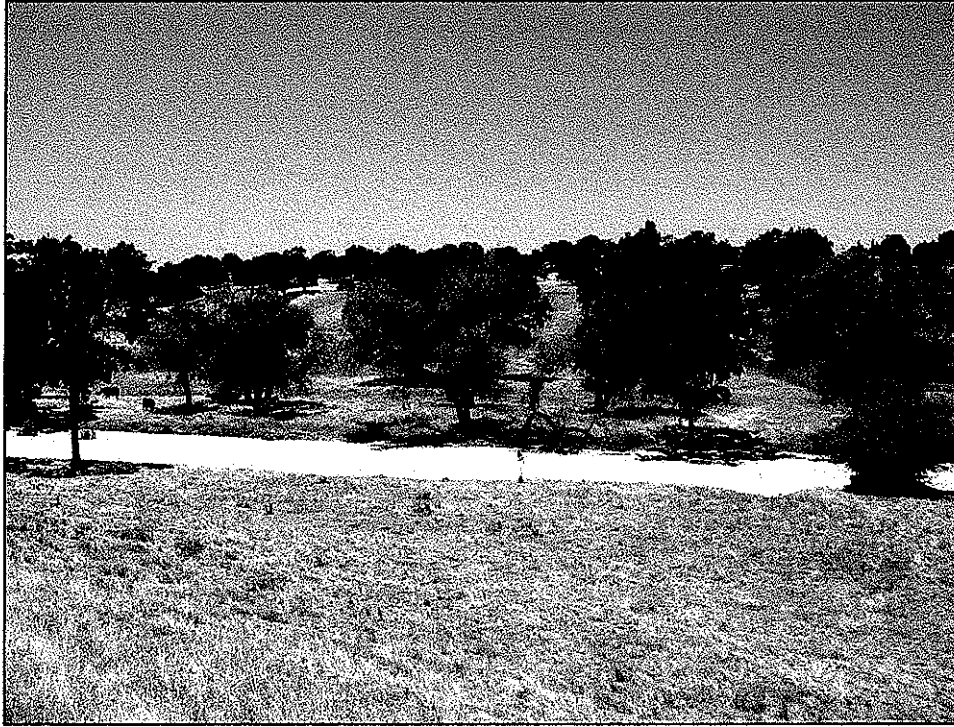
Photo 10. Scattered mature cottonwoods and valley oaks are present on the stream banks. Annual grasses dominate occasional open areas of the riparian corridor.

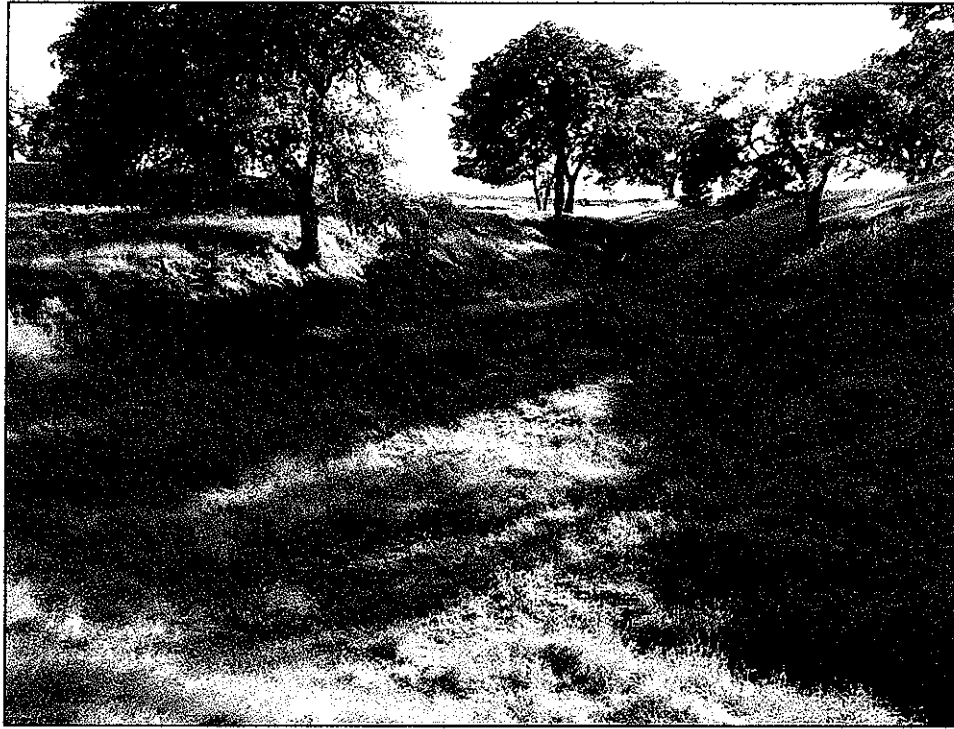
Photo 12. View west of the lower end of the ephemeral drainage just before its confluence with Huerhuero Creek.

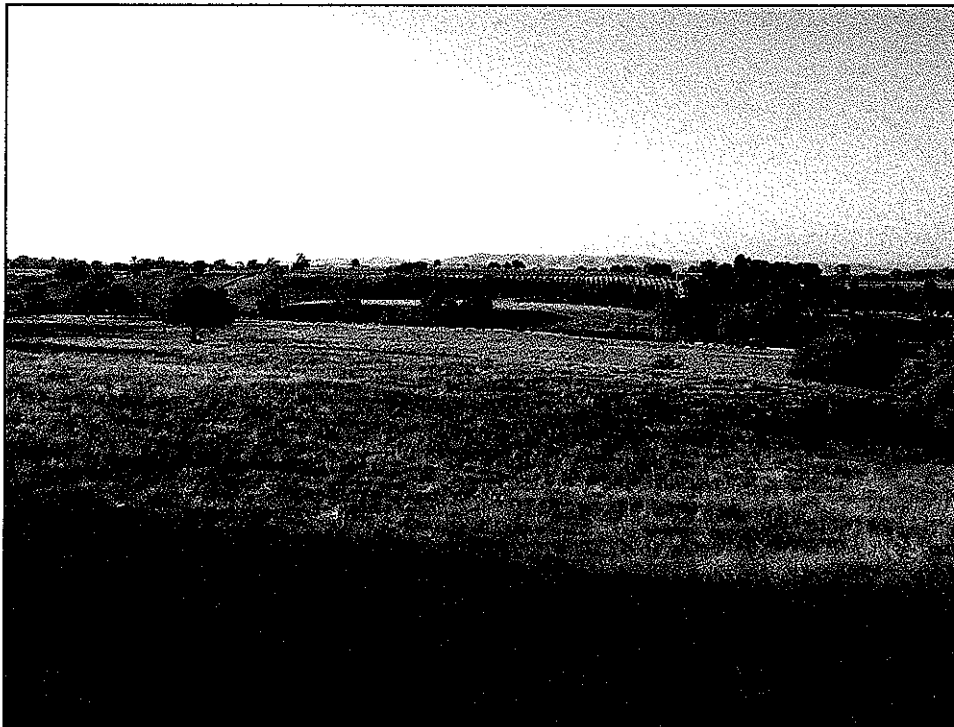
Photo 13. Grassland habitat occurs on the floodplain and low terraces adjacent to Huerhuero Creek at the north end of the property. View northeast.

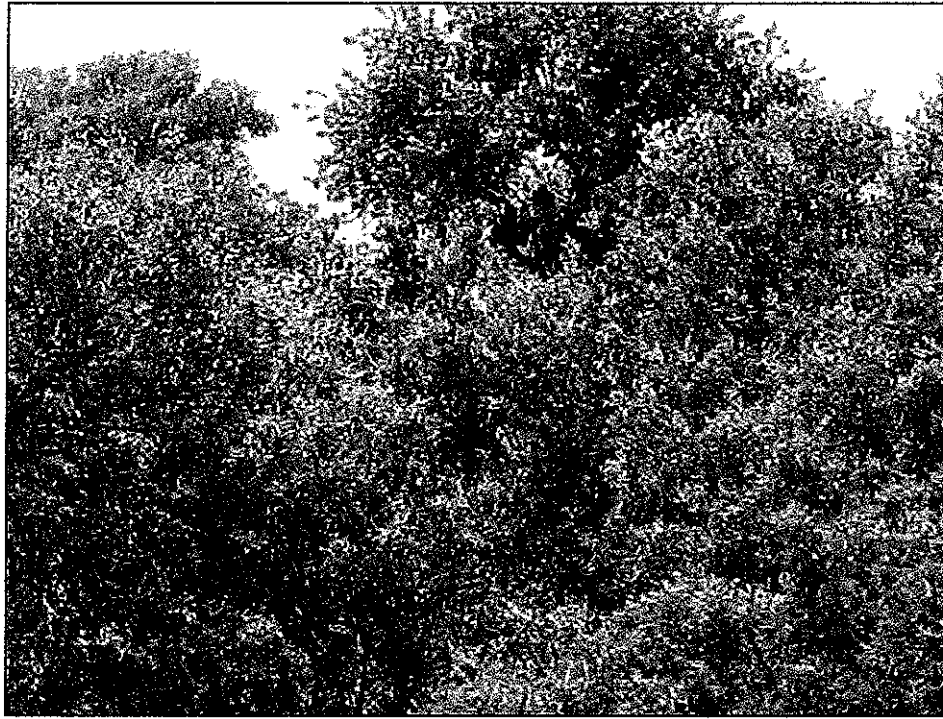
Photo 14. An occupied golden eagle nest was found on the property in 2006, in a blue oak tree along Huerhuero Creek.

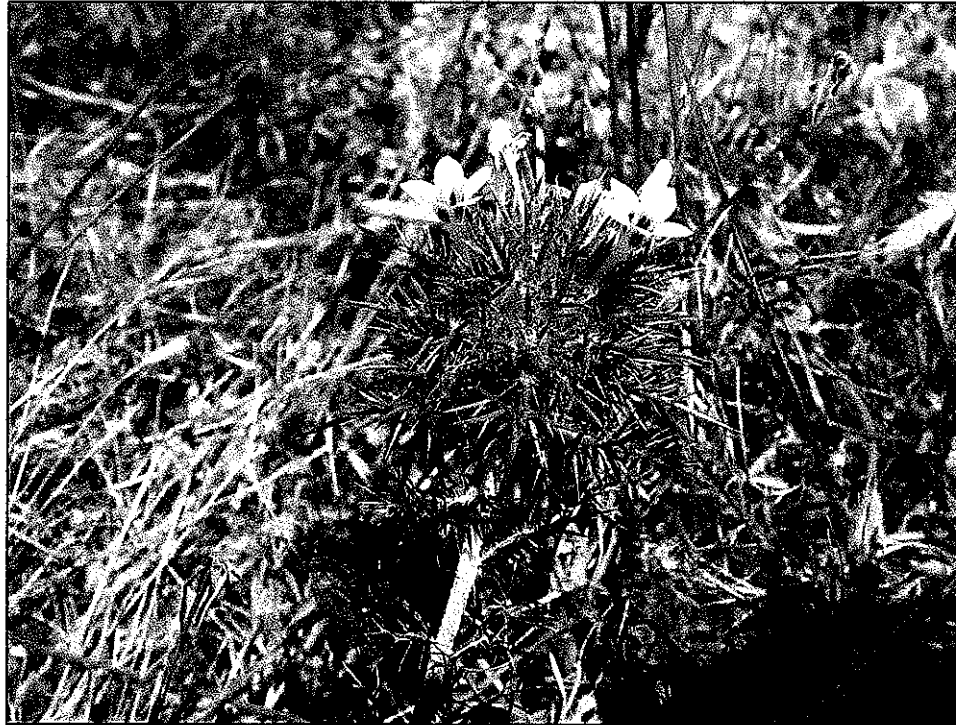
Photo 15. Shining navarretia (*Navarretia nigelliformis* ssp. *radians*), a CNPS List 1B.2 species, was mapped in two locations on the property.

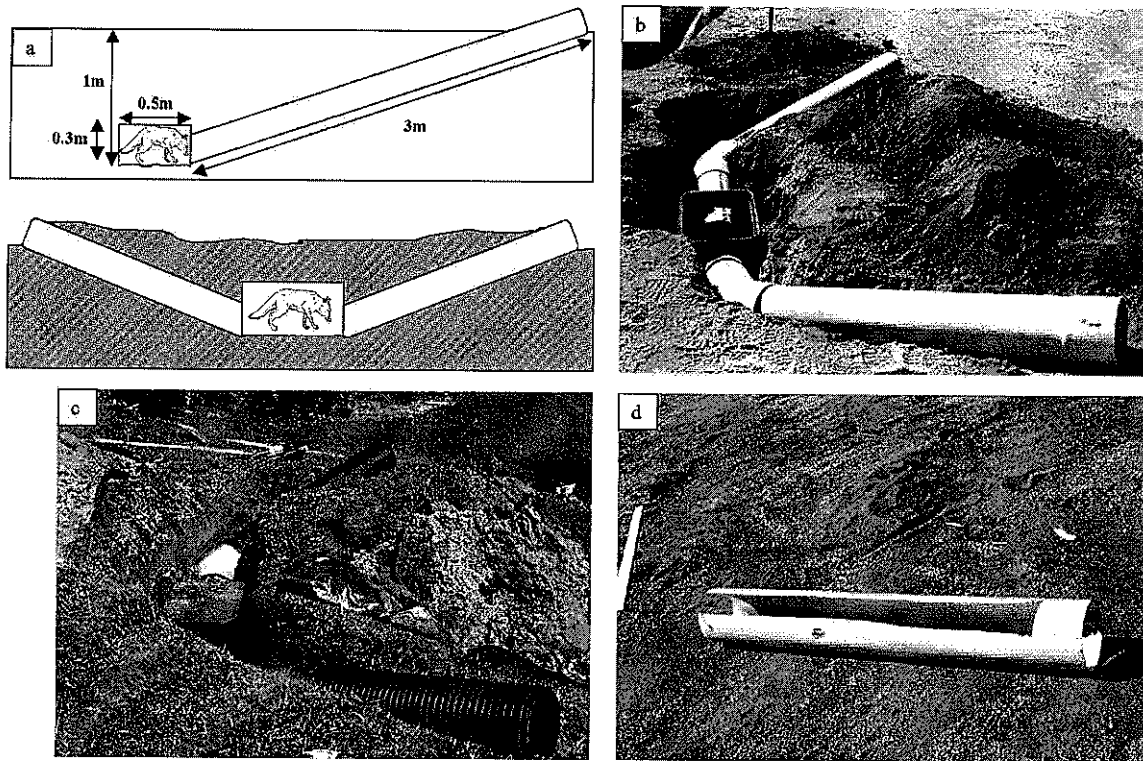
Figure 1. Artificial subterranean dens for San Joaquin kit fox at Bakersfield, CA. a) Artificial den schematic. b) PVC two-entrance chamber den under construction. c) High-density polyethylene two-entrance den. d) PVC tunnel with floor removed longitudinally.

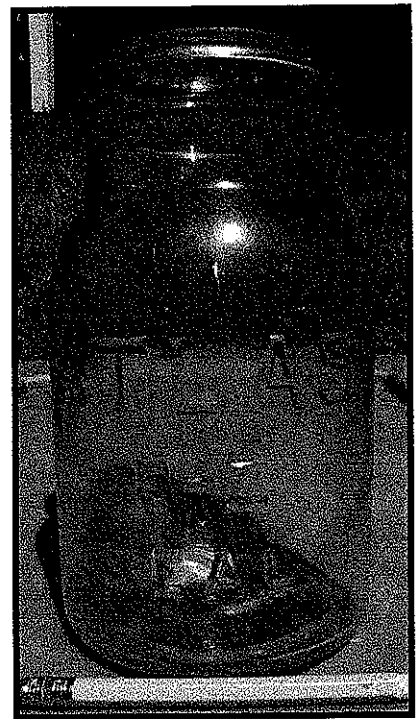
Historic materials encountered consisted of isolated artifacts and features representing general ranching activity during the past 50 to 100 years. These included an Atlas E-Z Seal jar discovered in the Huerhuero Creek sands at the north end of the project area. This jar was likely transported downstream during winter runoff from a historic trash deposit somewhere upstream of the project area. The Atlas jar was manufactured by the Hazel-Atlas Glass Co. The "E-Z SEAL" logo was in use from 1896 to 1964 (Toulouse 1971:241).

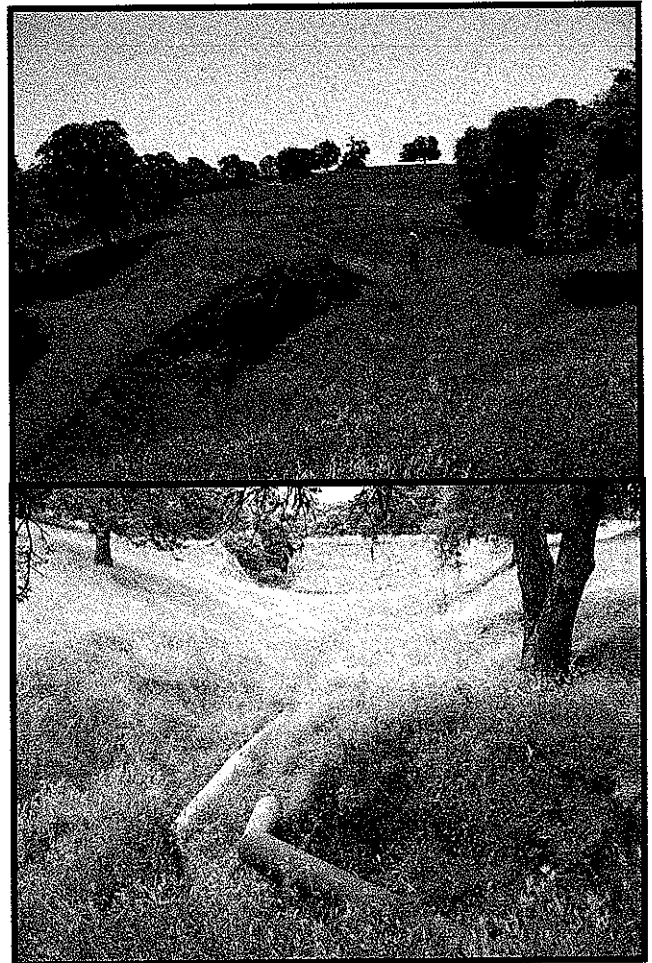
Historic features encountered were all located in the southern ½ of the project area. These included a blown out earthen dam with welded and riveted iron pipe that both supplied water to the reservoir and acted as a spillway. Near the southern end of the dam were several pieces of milled lumber, some of which contained square nails.

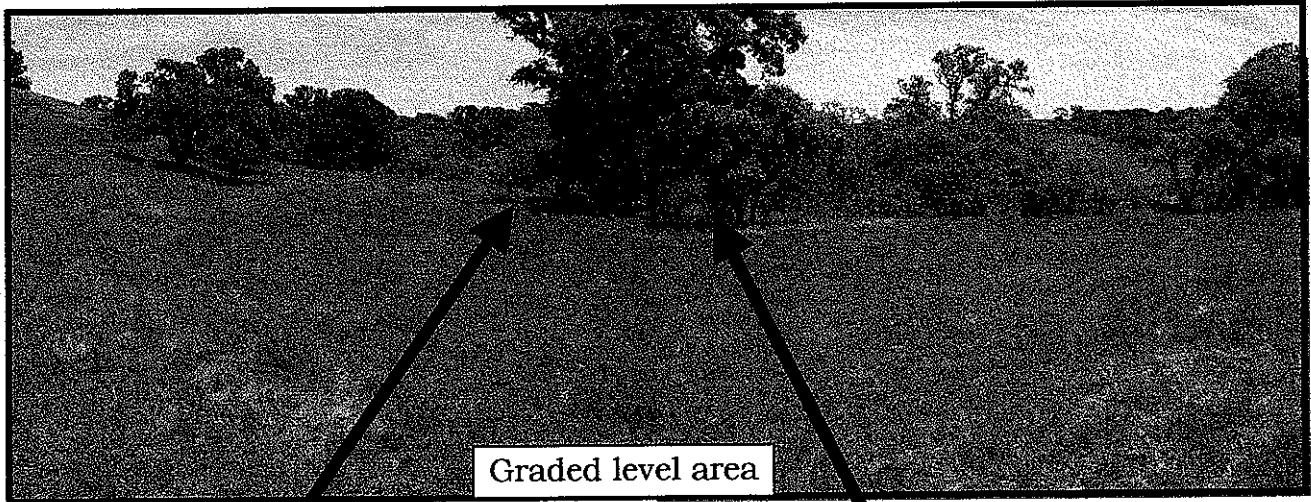
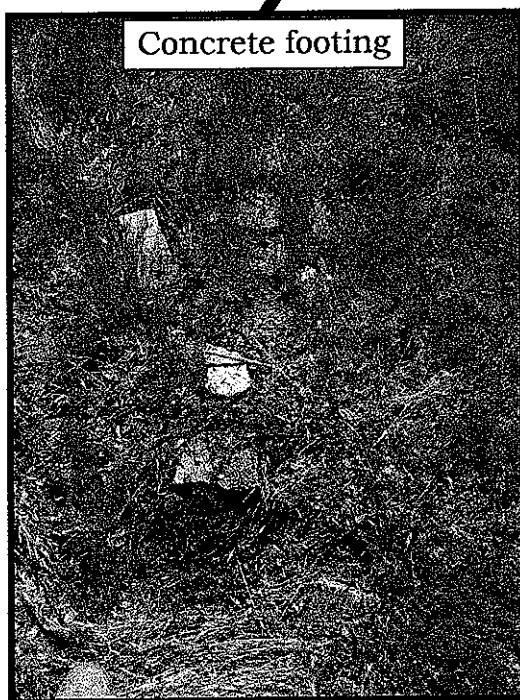
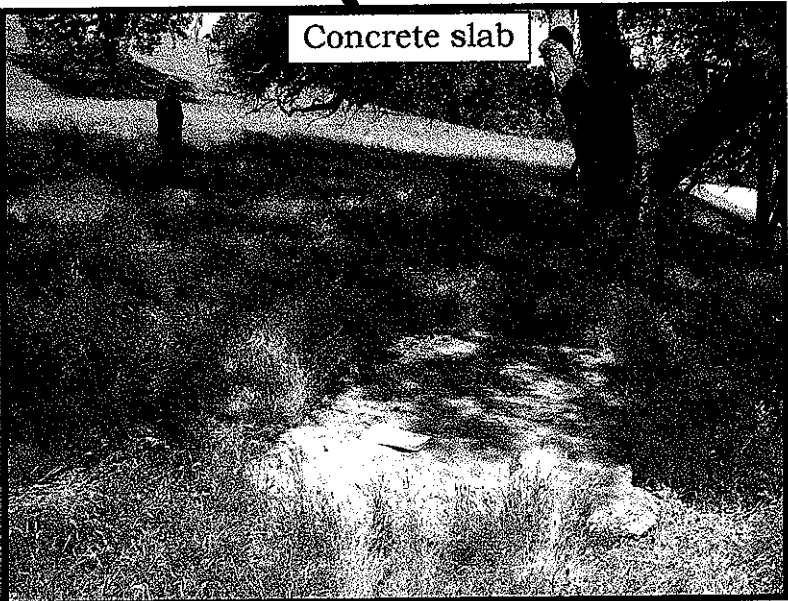
A graded flat area on a natural bench overlooking Huerhuero Creek was discovered. Within the leveled area were a concrete slab, what appeared to be the end of a concrete footing and various small pieces of milled wood and metal. The slab was ~12 x 5 feet in size and oriented north-south. It was situated at UTM coordinate 712490E/3948106N. The footing was also oriented north-south and was located at UTM 712483E/3948123N. It is likely that the footing once supported a small barn.

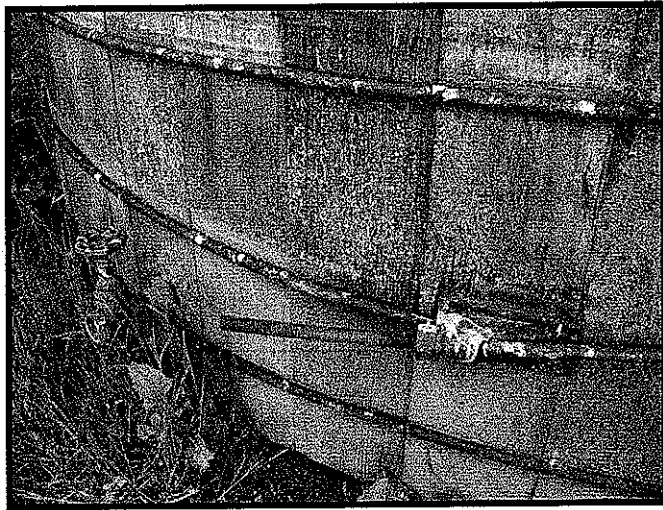
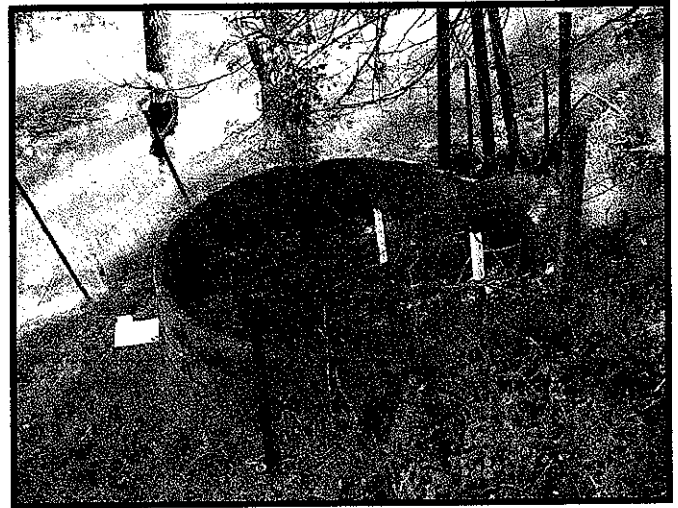
Down slope (east) from the southern-most end of the level bench was a redwood watering trough. The trough was ~10 feet in diameter, ~3.5 feet deep, and situated just above the bed of Huerhuero Creek (at UTM 712502E/3947991N).

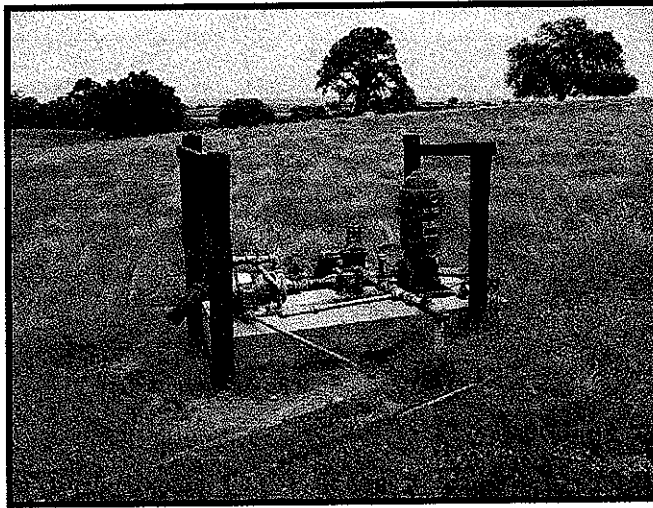
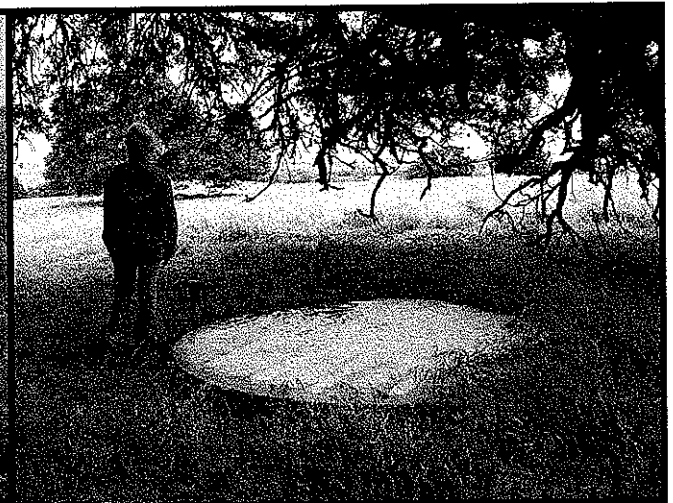
More recent features included a circular concrete footing for a water tank located on a hill within the southern portion of the project area. Just north of this was a wellhead with pump and power supply. The southwestern corner of the project area had evidence of recent farming (most likely grain production).
