**SUBJECT: CERTIFICATE OF APPROPRIATENESS 11-001
(DERBY WINE ESTATES) APN: 009-268-003 & 004**

Derby Winery Estates

Tower (Cupola) Rehabilitation Plan

A photo documentary, dimensional analysis and reconstruction study for the rehabilitation of the existing "cupola" tower feature of the existing historical Farmer's Alliance Building, and future Derby Winery Estates Facility, at 525 Riverside Drive, Paso Robles, California, 93446

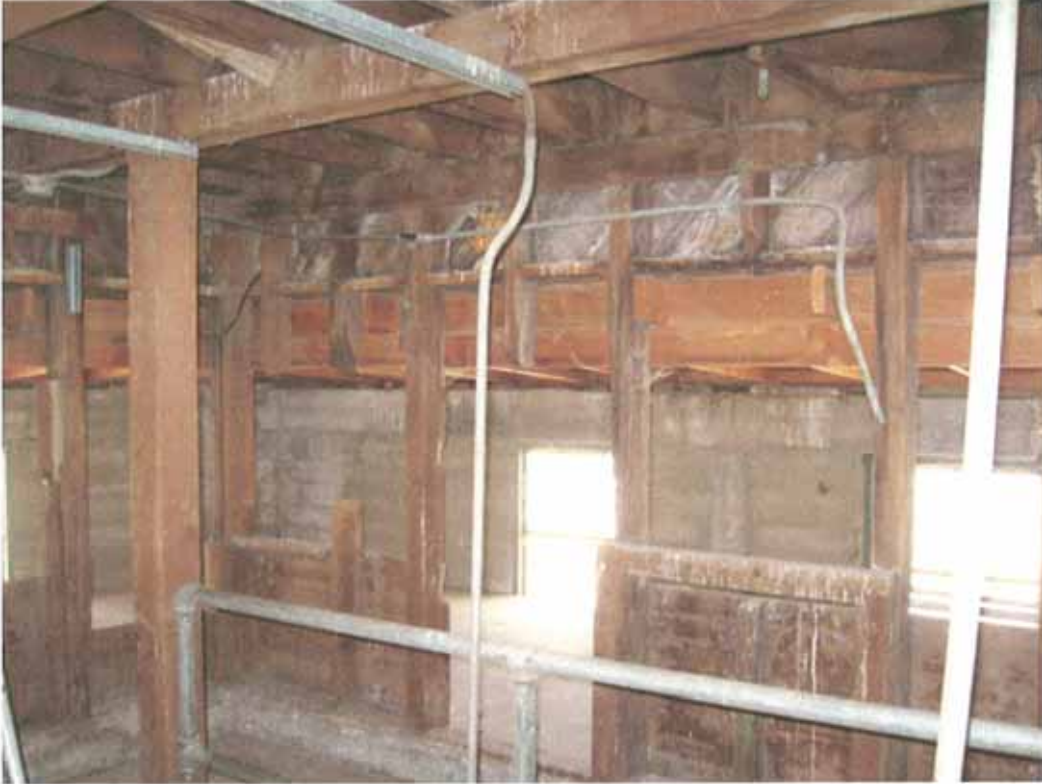
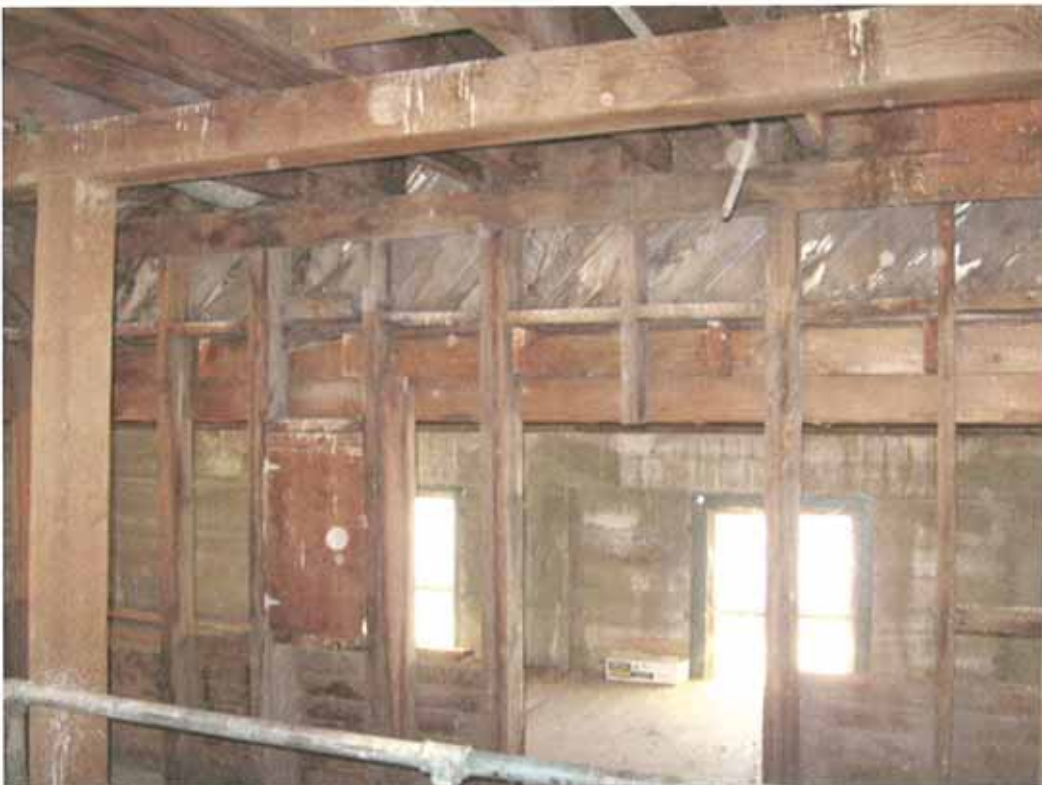
Since the Planned Development approval, detailed onsite observations and inspections have been conducted in order to evaluate the existing conditions in preparation for structural analysis and construction methods necessary to preserve the tower. These observations and inspections revealed the tower's existing condition that included a combination of termite damage, wet/dry rot, structural failure and long-term deterioration. Additionally, the existing construction within the cupola was poorly executed with prior structural modifications and resulting damage to the structural integrity of the walls. This primarily due to modifications presumably done by the Farmers Alliance organization to allow the almond bins to be used for grain bins that further contributed to the deterioration of the structure. In addition, the structural integrity of the cupola has been compromised because the existing stucco and lath material becoming separated from the wall framing, thus eliminating the anchoring and shear value of the stucco cover. Additional work, assumed to have been done when the cellular company antennae were introduced to the walls of the cupola structure, could have resulted in improper flashing installation, water intrusion and damaged wall framing. The rebuild approach would correct these deficiencies and better the situation from a health and public safety perspective, and would preserve the structural integrity in the event of an earthquake, hard and driving rain and/or elevated wind loads.

Interior photos of Cupola structure at just below roof framing at top of tower with the existing window openings:

In order to retain the cupola features, and maintain the adequate structural integrity, it will be necessary to replace most of the existing structural and architectural features and components. This would include the upper cupola walls, roof and support framing. Due to the existing level of deterioration, and to conform to the secretaries standards, it will be necessary to replace all distinctive exterior features, structural components and architectural characteristics in a manner that will match the existing, old design, color, texture and materials.

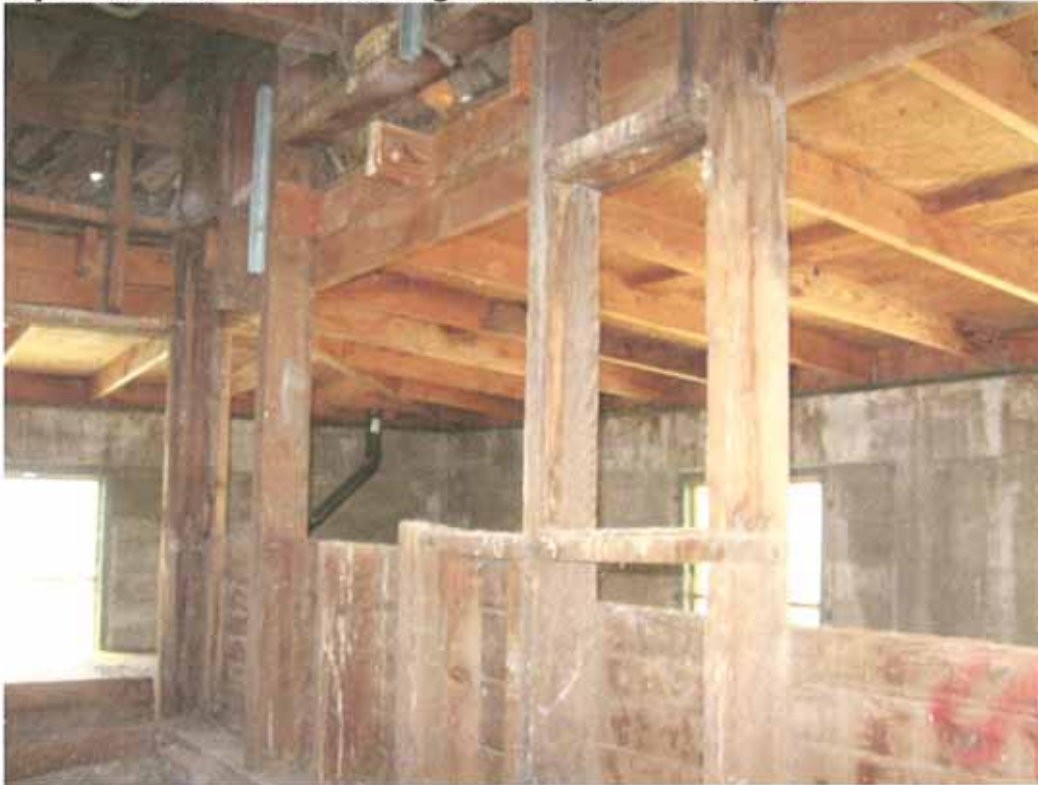
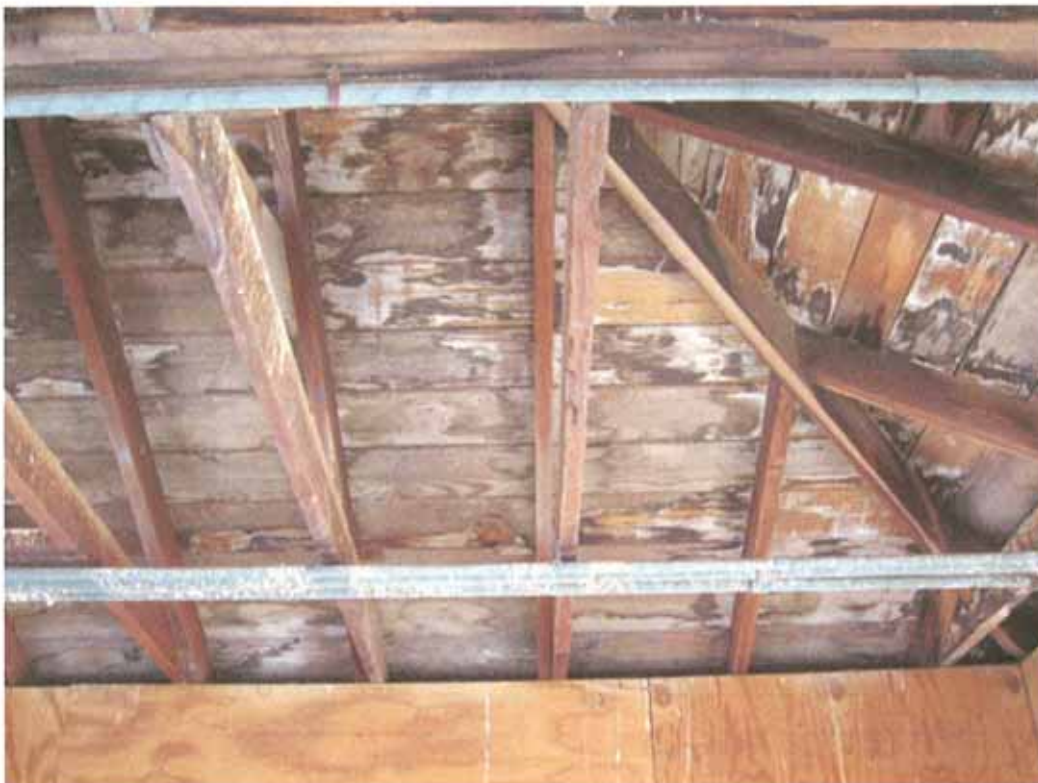
Interior photos of Cupola structure at just below roof framing at top of tower and roof framing at the top of the Cupola:

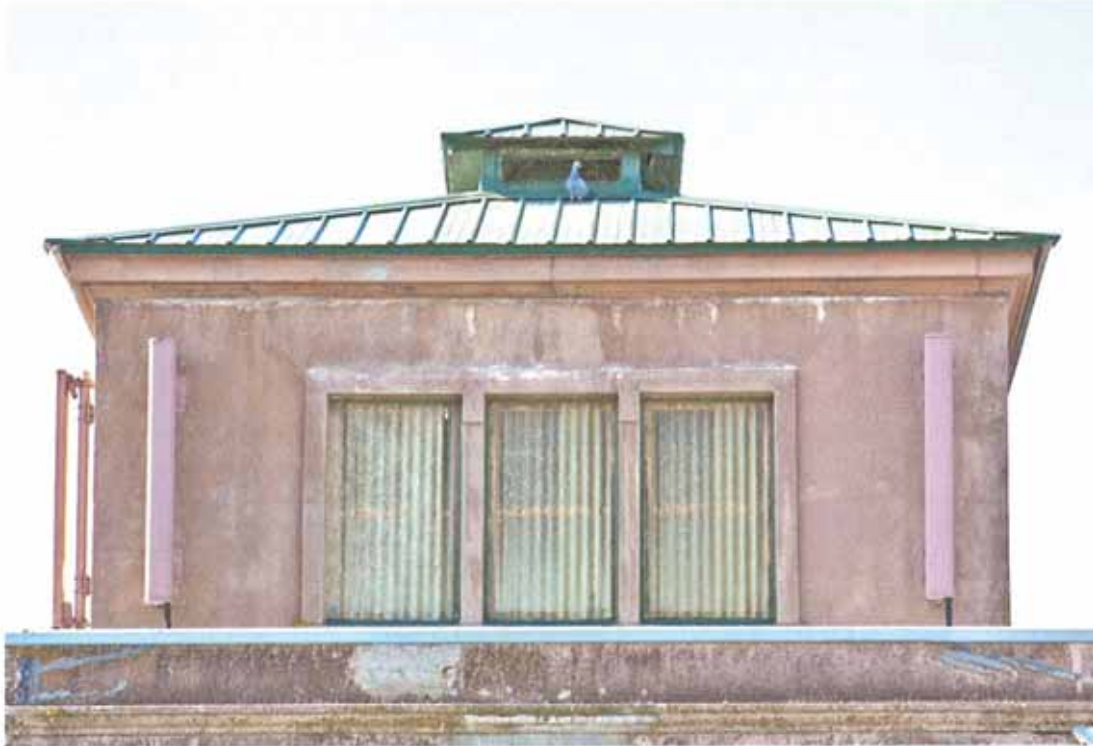
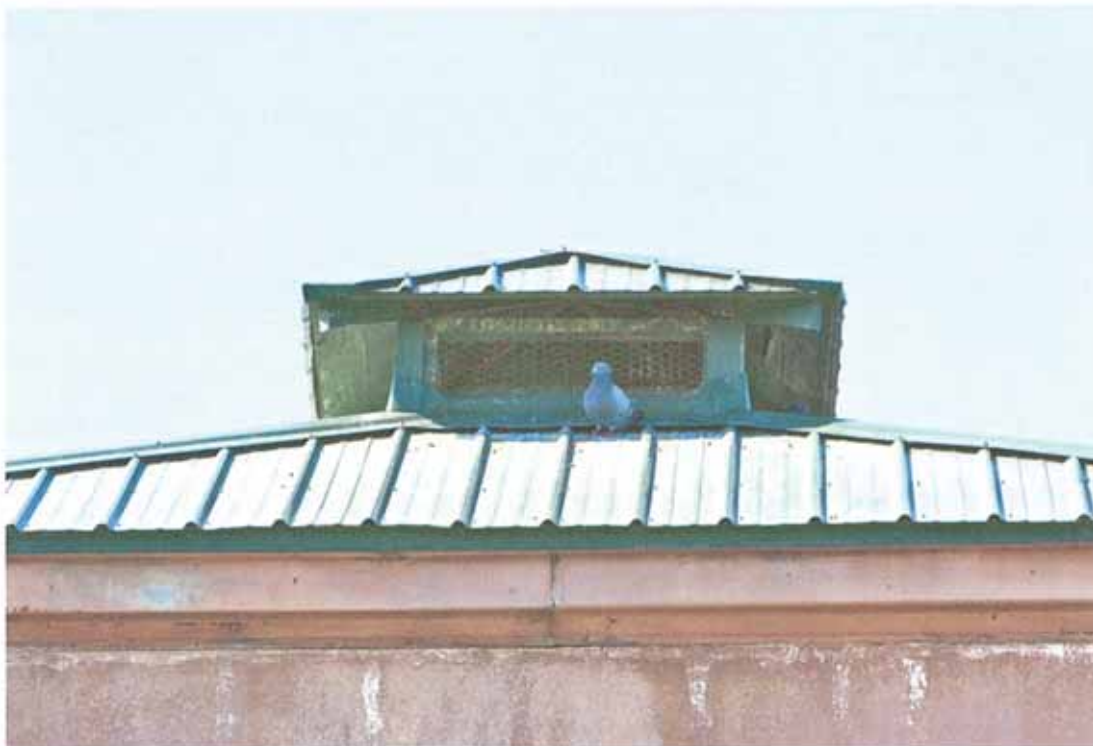
Exterior photos of Cupola structure at North/South Elevation:

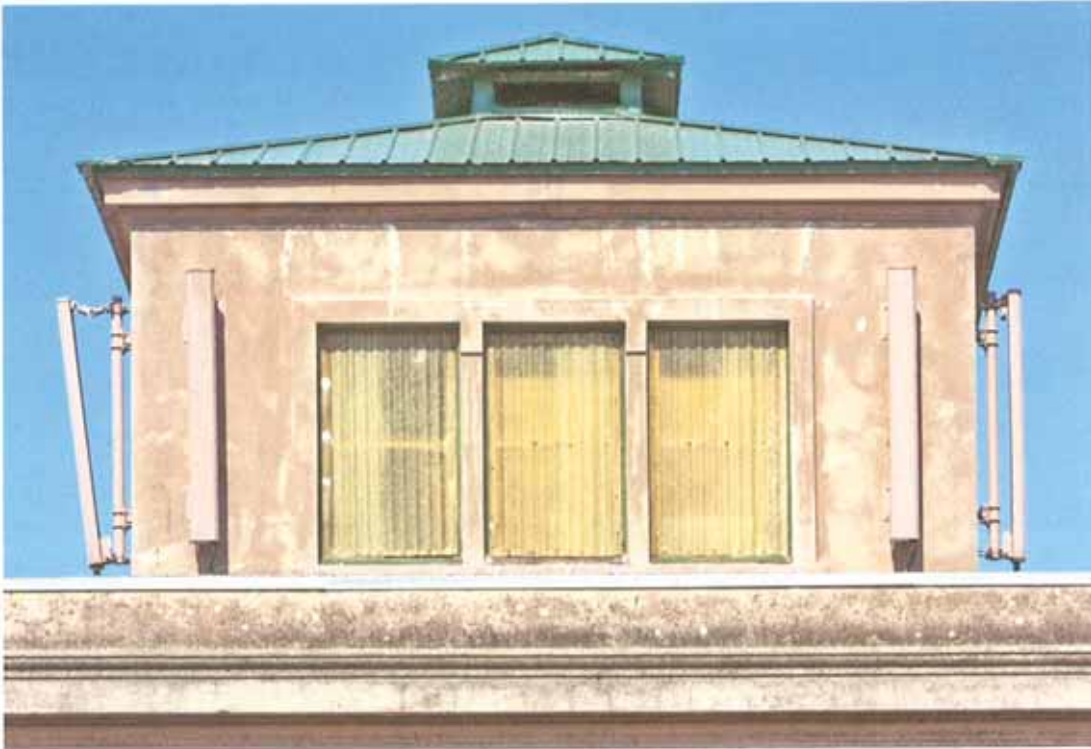
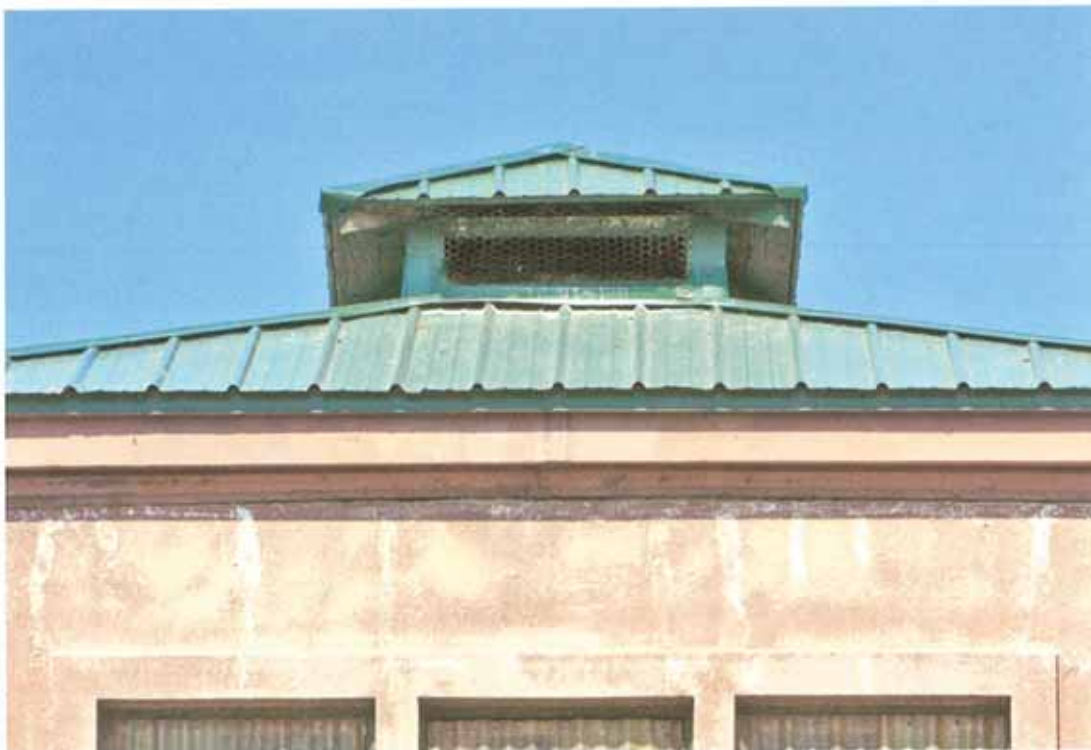
Exterior photos of Cupola structure at East/West Elevation:

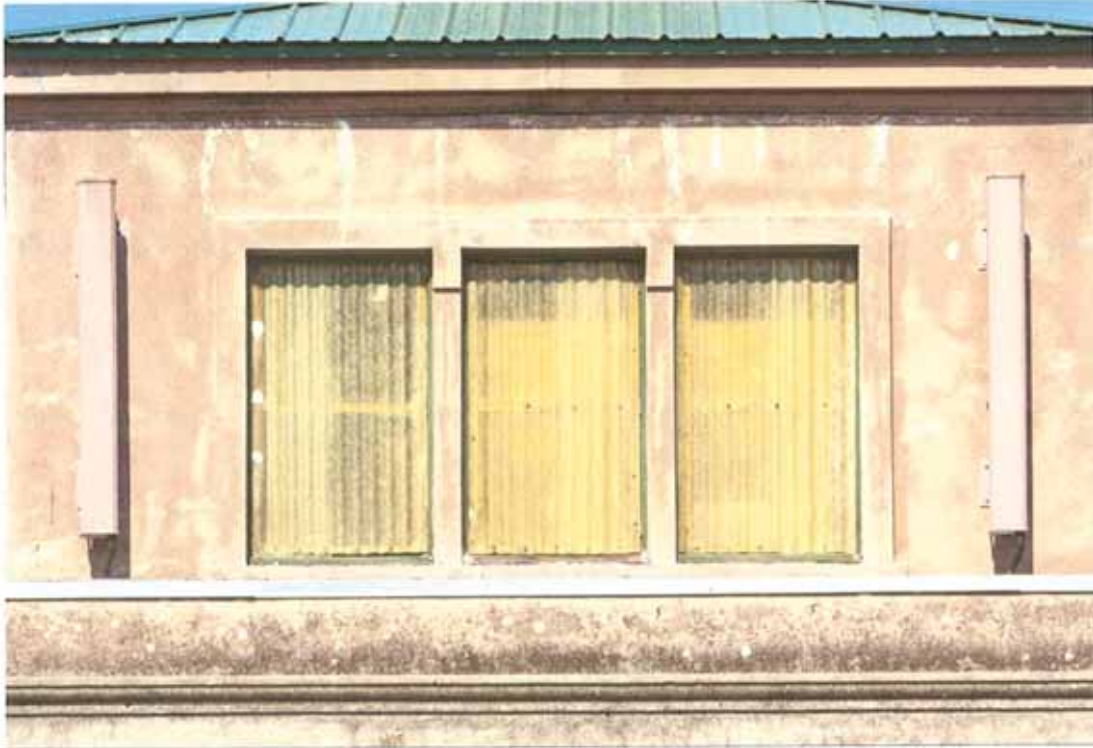
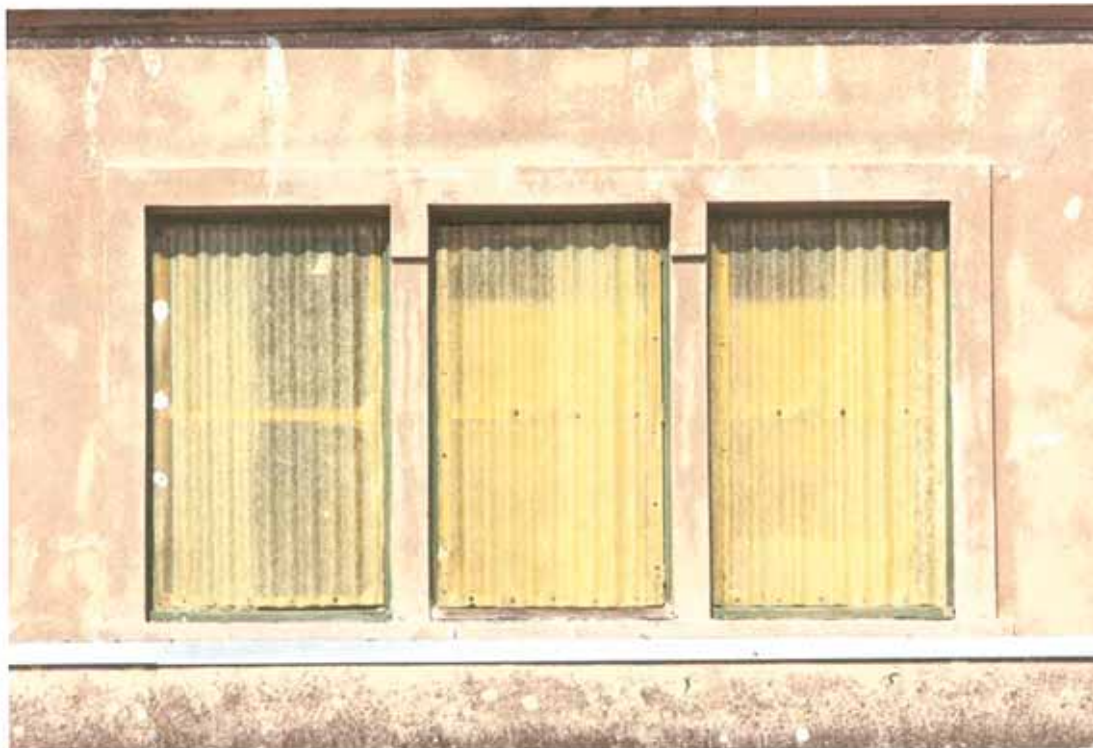
Exterior photos of Cupola window array and window trim arrangement:

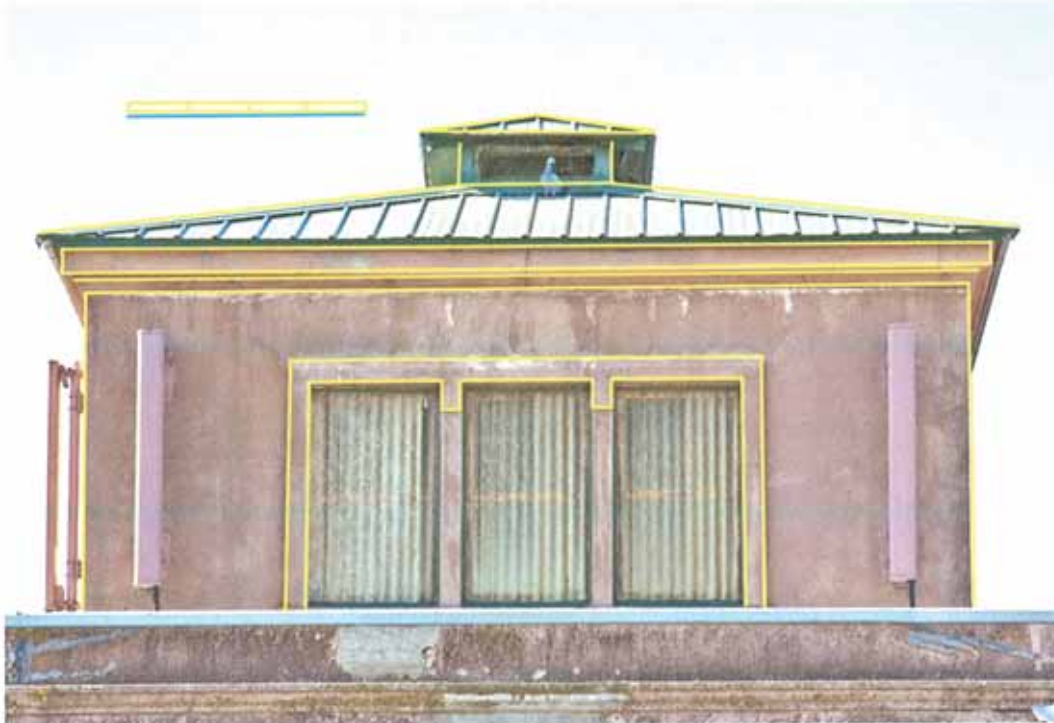
Exterior photograph with computer-line overlay to generate “true” size and dimensional analysis.

Photographic exterior elevations of the cupola were taken and overlaid with a scaled frame of reference to generate an accurate depiction of the actual features, sizes, lengths and heights. The computer can determine the length of the line based on a given frame of reference scale, inputted to the CAD system for true and correct measurement. In this case the windows were measured as the “as-built” frame of reference scale. As a line is drawn over the actual component, a scaled reading is generated for the redraw of the elevation as an architectural exterior elevation (refer to following elevations and sections for this representation).

Additionally, field measurements were taken to verify trim depths, overhangs and other horizontal or vertical characteristics of the structure. Some minor demolition and investigative work was also conducted to verify thicknesses, fastening and attachment of finishes, trim and some structural aspects of the existing framing.

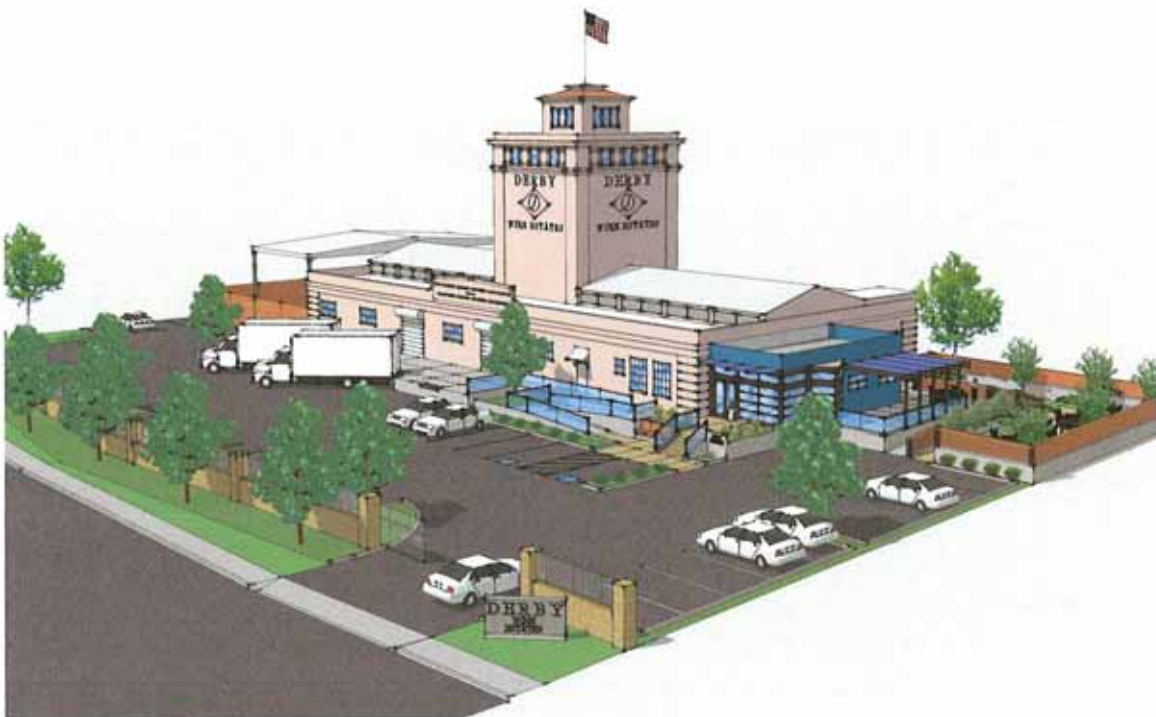
The final and complete end product will be the true and replicated cupola structure, rebuilt in accordance to the accepted and required guidelines set forth for historical rehabilitation and restoration.

Computer rendering of final and proposed project
