**SUBJECT: REQUEST TO REMOVE ONE OAK TREE - 1612 OAK STREET (STEVENS)**

To: City of Paso Robles  
From: Chip Tamagni, A & T Arborists  
Re: Hazard Oak at 1612 Oak Street  
CC: Calvin and Sara Stevens, Owners

**Review of Quercus agrifolia**

**Second Opinion**

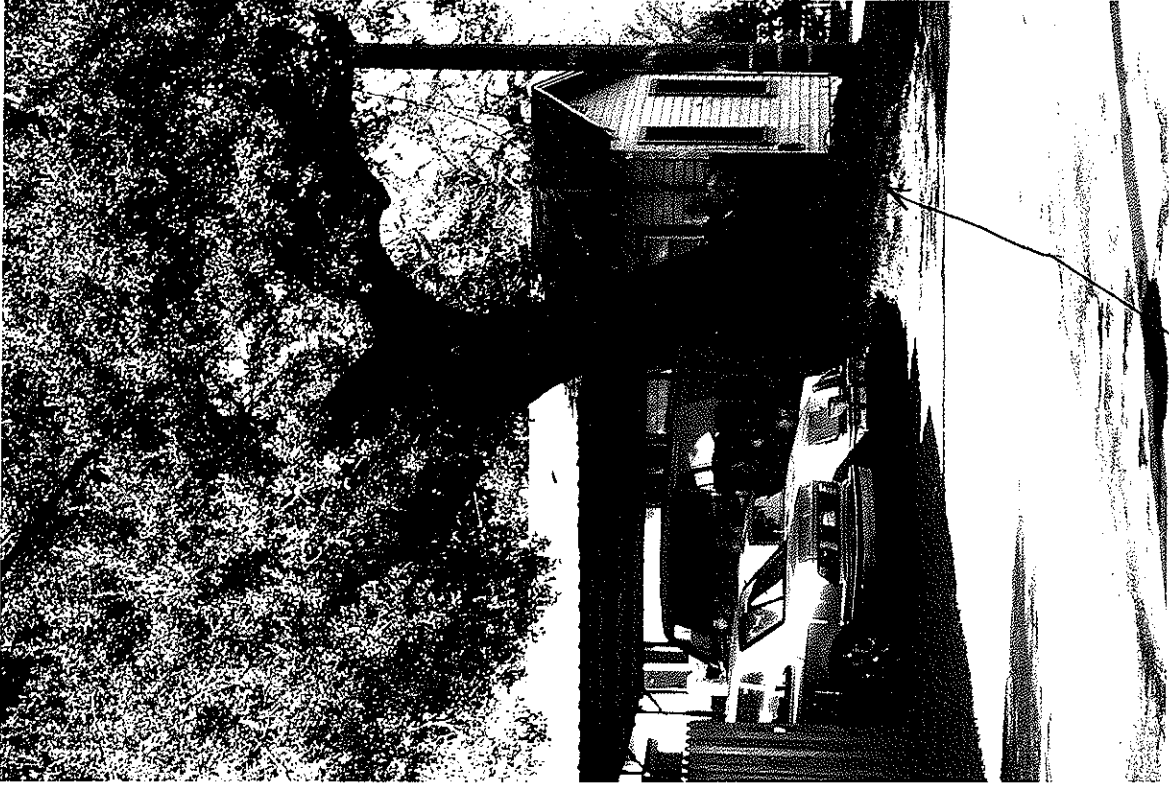
Suspect root rot: ☒ N Mushroom/bracket present: ☒ N ID: \_\_\_\_\_  
 Exposed roots: ☐ severe ☒ moderate ☐ low Undetermined: ☐ severe ☐ moderate ☒ low  
 Root pruned: \_\_\_\_\_ distance from trunk Root area affected: \_\_\_\_\_ Buttress wounded: ☐ Y ☒ N When: \_\_\_\_\_  
 Restricted root area: ☐ severe ☒ moderate ☐ low Potential for root failure: ☒ severe ☐ moderate ☐ low  
 LEAN: 20° deg. from vertical ☒ natural ☐ unnatural ☐ self-corrected Soil heaving: ☒ Y ☐ N  
 Decay in plane of lean: ☐ Y ☒ N Roots broken: ☐ Y ☒ N Soil cracking: ☐ Y ☒ N  
 Compounding factors: Recent movement, increased lean Lean severity: ☒ severe ☐ moderate ☐ low

Exposed  
Roots

The lean is currently so excessive, pruning will not abate the hazard.
