TO: JAMES L. APP, CITY MANAGER
FROM: ROBERT A. LATA, COMMUNITY DEVELOPMENT DIRECTOR
SUBJECT: REQUEST TO REMOVE ONE OAK TREE – 2503 STARLING DR.
(ROGER & PATRICIA GREENE)
DATE: MARCH 1, 2005

A RESOLUTION OF THE CITY COUNCIL OF THE CITY OF PASO ROBLES
AUTHORIZING THE REMOVAL OF ONE OAK TREE AT 2503 STARLING DRIVE
(ROGER & PATRICIA GREENE)

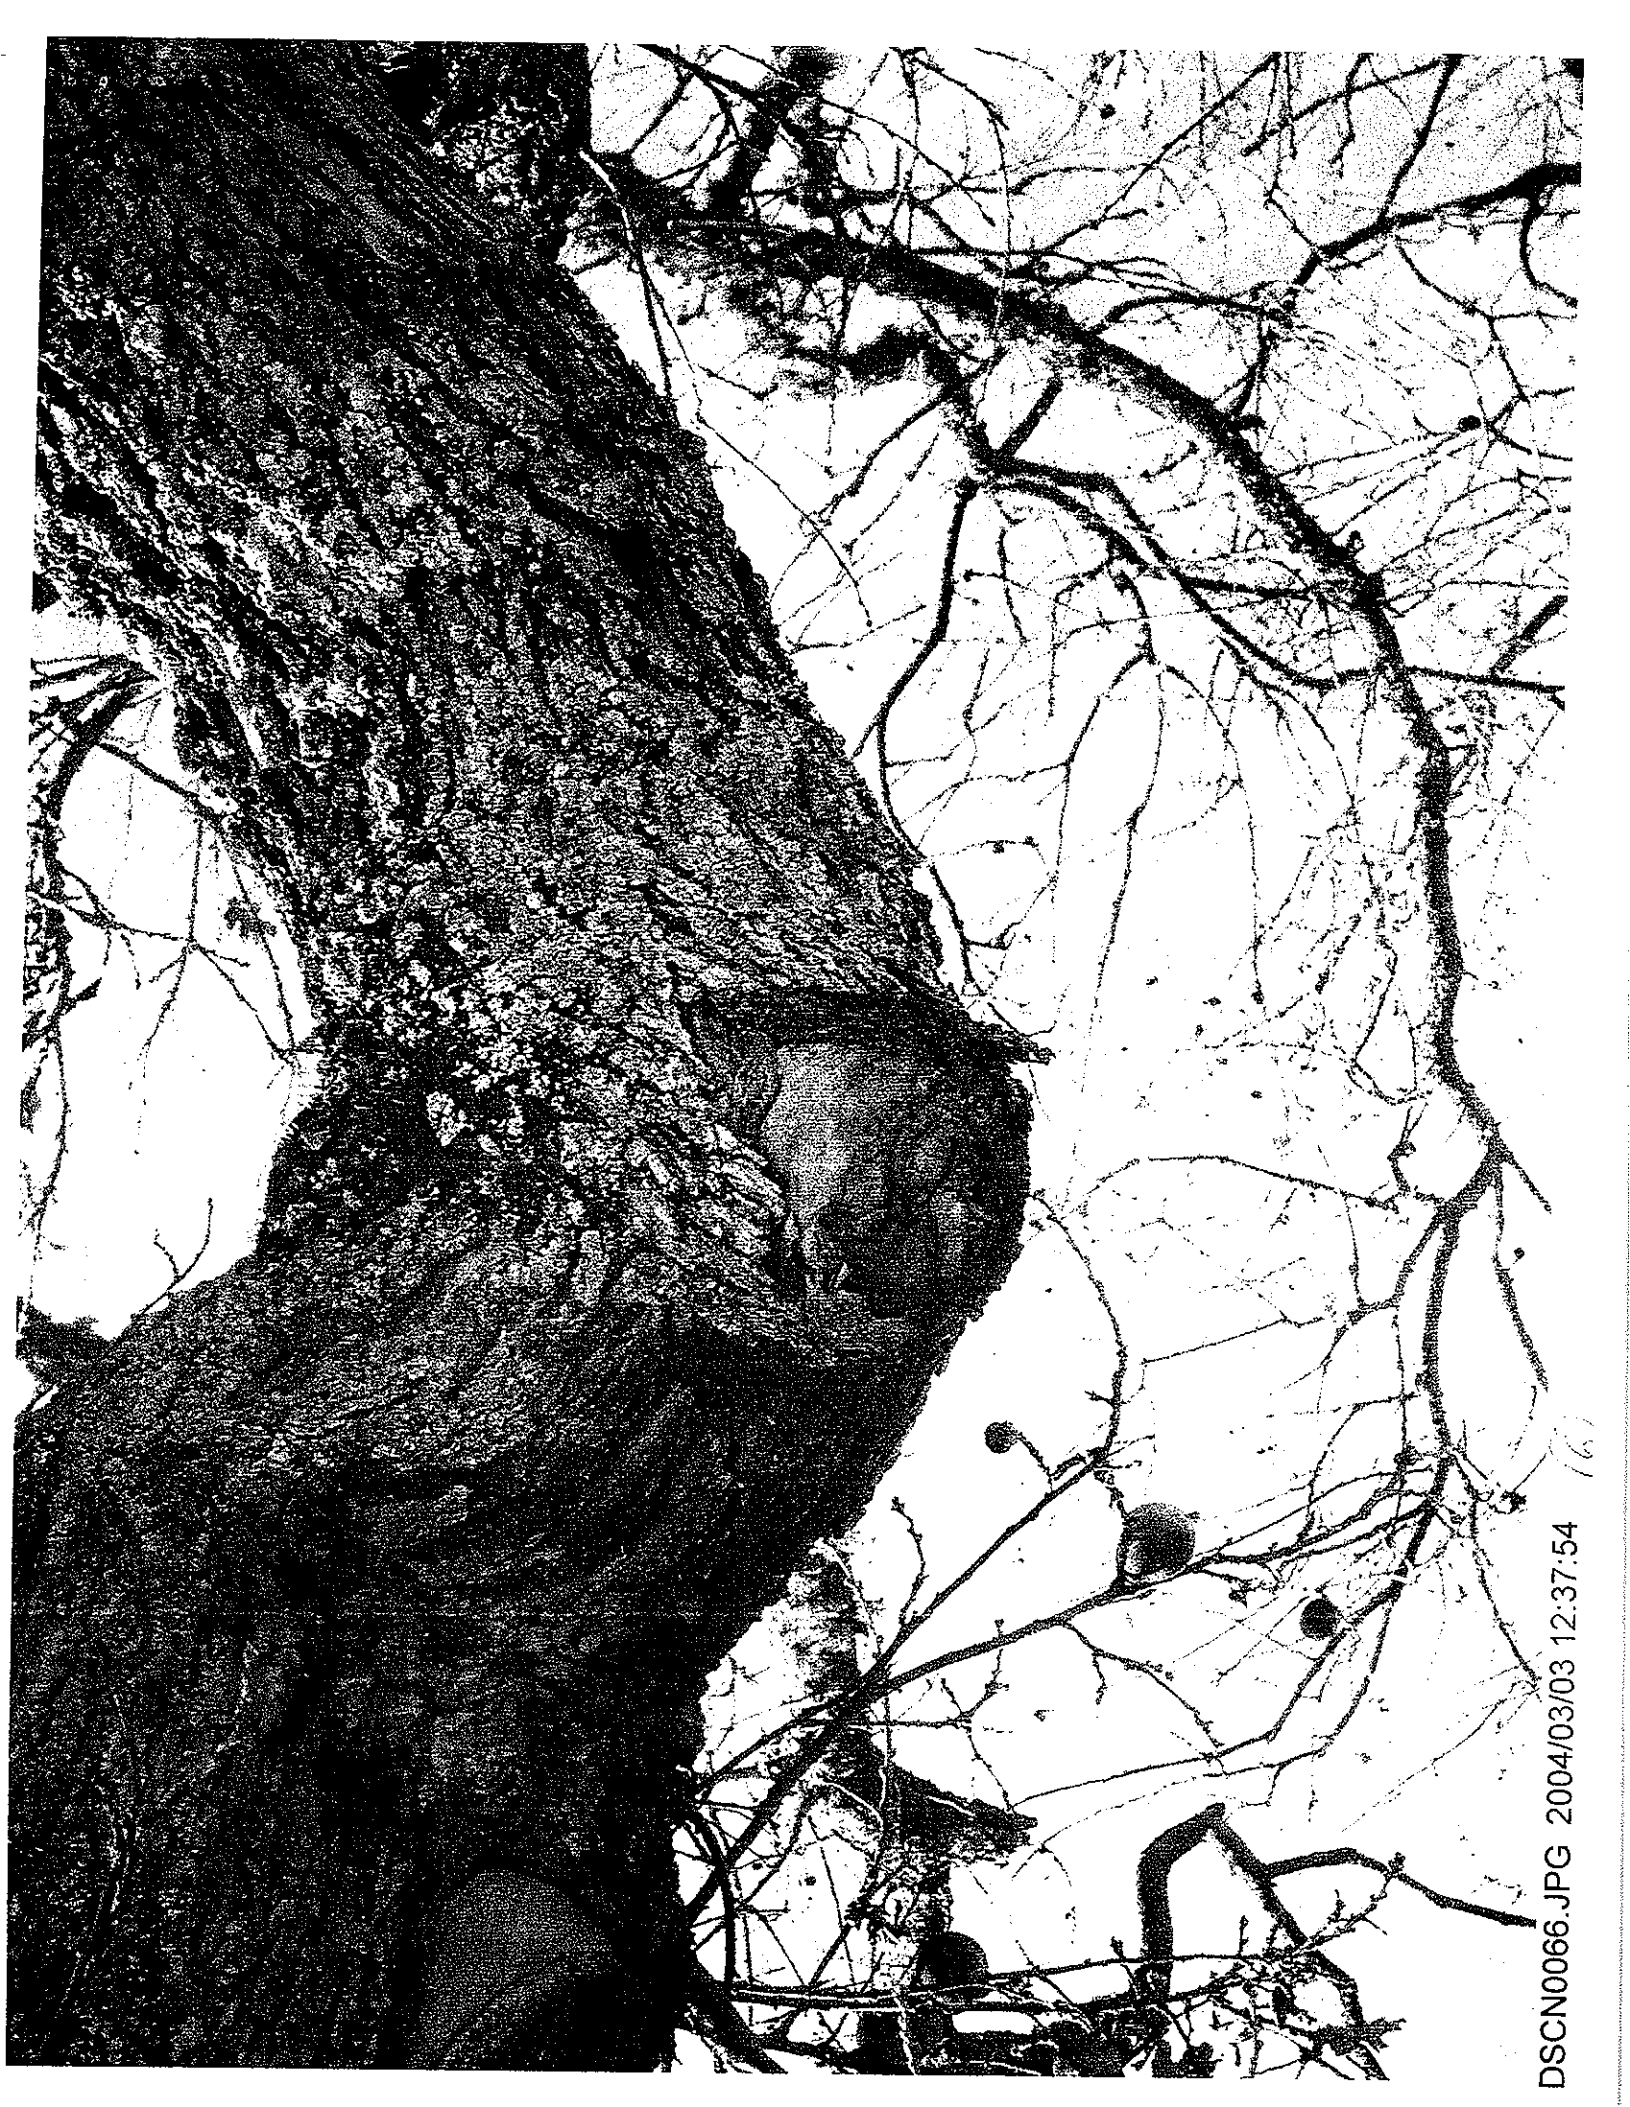
Additional damage to the tree was also noted. Pictures #3-#5 illustrate the improper pruning techniques performed on the tree. According to the International Society of Arboriculture, proper pruning requires pruning a limb back to a lateral branch at least one-third the diameter of the parent limb. This allows the secondary branch to assume dominance. This also allows for the formation of proper callous tissue to close the wound thereby preventing disease/decay. There are currently close to one dozen improper cuts that were made for home and yard clearance. The pictures also show some of the cuts are greater than six inches in diameter which requires a signed permit in the City of Paso Robles. Picture #6 illustrates probable tractor damage to one of the limbs during construction. There is also a broken limb approximately five inches in diameter that most likely is the result of tractor damage.

At this point in time, the tree appears to be approximately 50% dead. This was determined by observing the amount of live crown left on the tree. This tree will most likely not survive in its current condition unless the original grade is re-established under 70% of the drip-line with proper drainage provided and additional pruning is performed.
