TO: JAMES L. APP, CITY MANAGER
FROM: ROBERT A. LATA, COMMUNITY DEVELOPMENT DIRECTOR
SUBJECT: REQUEST TO REMOVE ONE OAK TREE IN RELATION TO THE UNION ROAD WIDENING PROJECT (CITY INITIATED)
DATE: MARCH 15, 2005

Subject: Horticulture Tree Evaluations and Report for Union Road Widening Project – Riverglen to Kleck

Project: CITY OF PASO ROBLES UNION ROAD WIDENING

Subject: TREE PHOTOGRAPHS

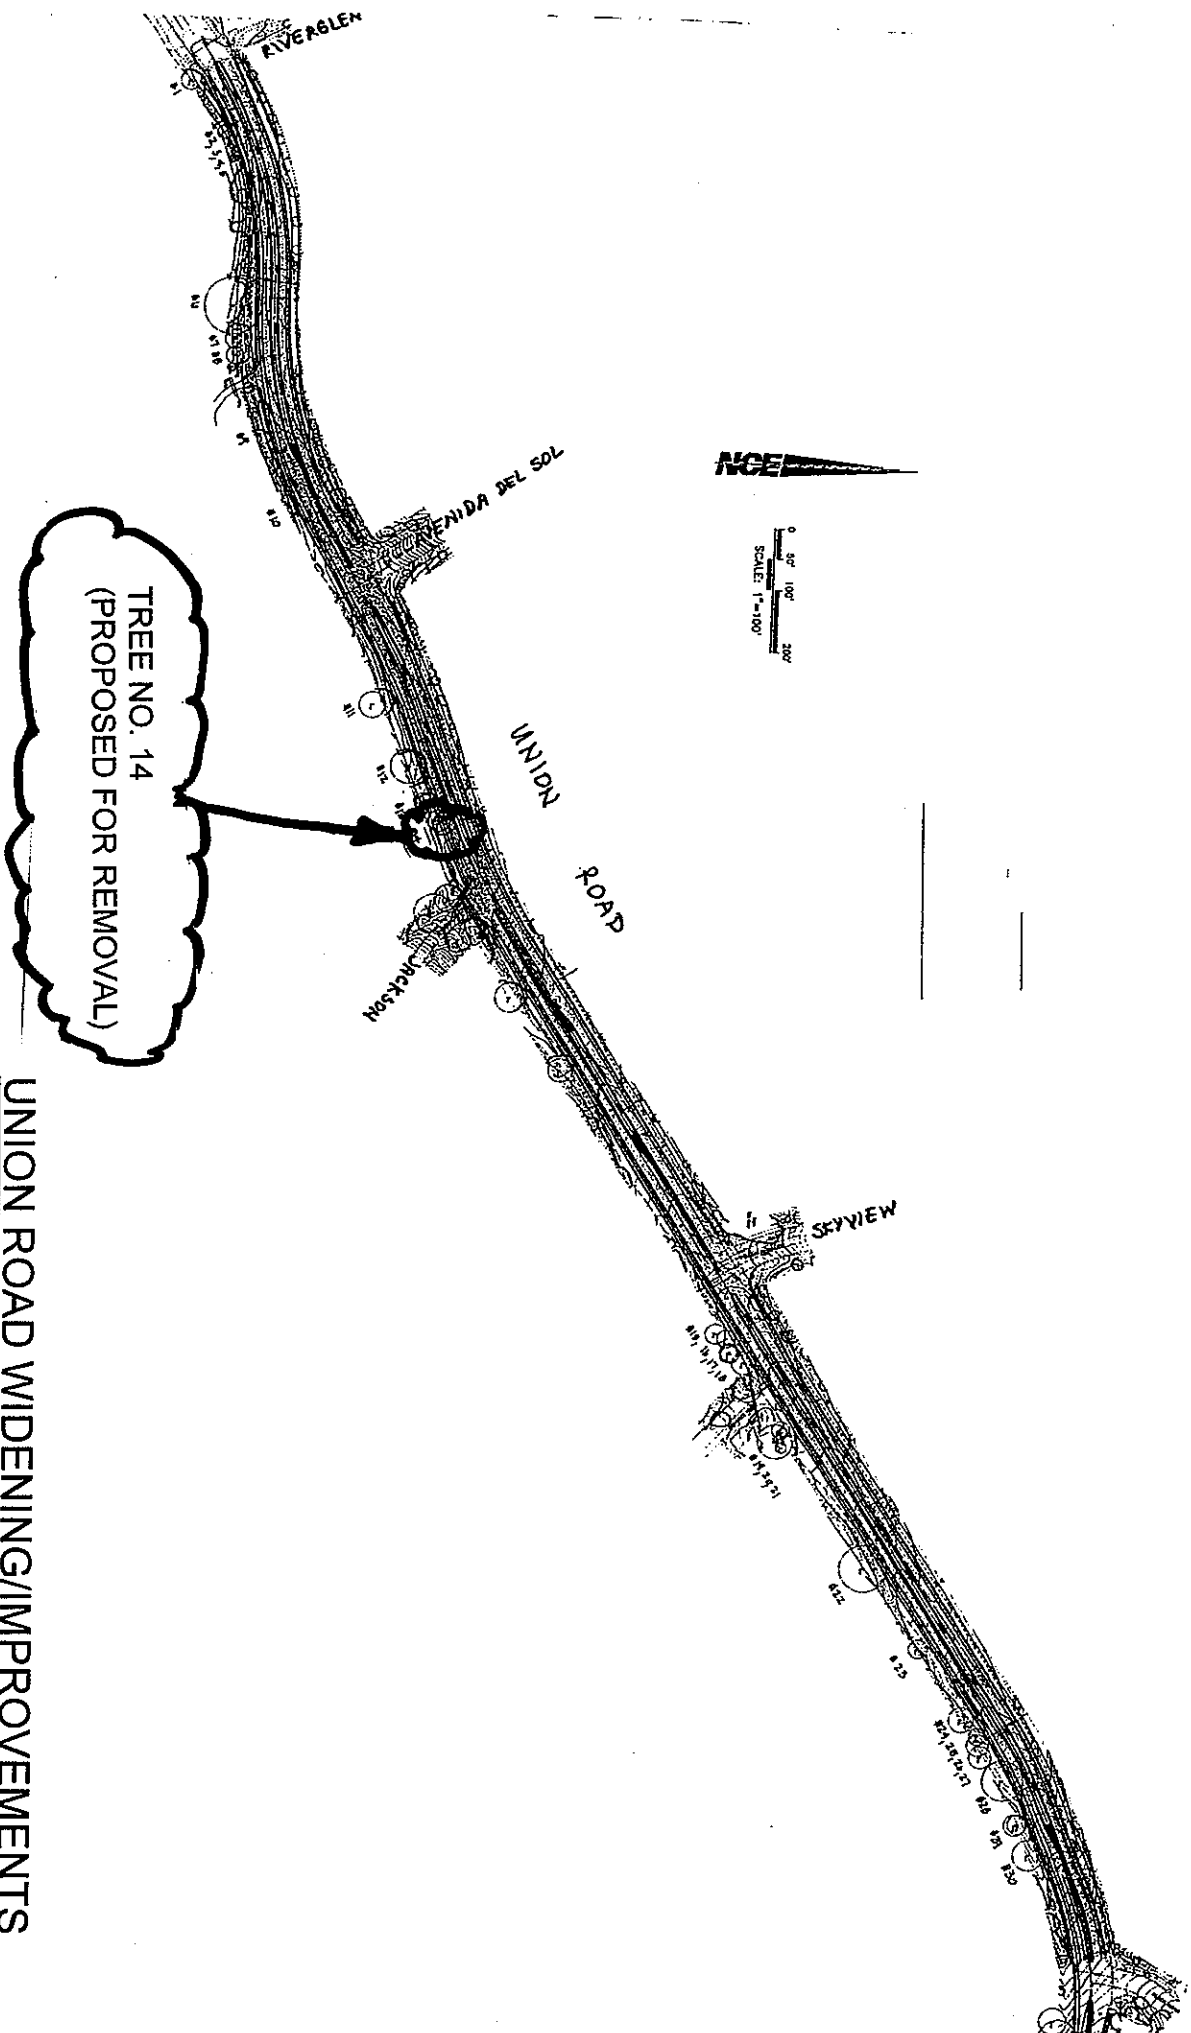
UNION ROAD WIDENING/IMPROVEMENTS
 RIVERGLEN TO KLECK
 OAK TREES LOCATION MAP

WHEREAS, the report also indicates the tree currently leans east and exhibits a weak structure, branch cavities, trunk damage and poor form. It has a low health and aesthetic rating of 3 out of 5.

Only one (1) tree is recommended for removal. Tree number fourteen (14) is located at the edge of the road shoulder which requires a 12" compacted base with paving covering one-half of the root zone. This construction would severely impact this tree and be detrimental to its future health and survival. The tree has a 19" diameter trunk with a height and spread of 40' x 37'. The tree leans east and exhibits a weak structure, branch cavities, trunk damage and poor form. It has a low health and aesthetic rating of 3 out of 5.

1. Authorize the removal of one (1) 19-inch Blue Oak tree in relation with the Union Road Widening Project, as shown on Exhibit A to this Resolution;
2. Require the planting of four (4) 1.5-inch diameter replacement blue oak trees, to be placed within the project as directed by the Arborist.
