**TO: JAMES L. APP, CITY MANAGER**  
**FROM: ROBERT A. LATA, COMMUNITY DEVELOPMENT DIRECTOR**  
**SUBJECT: REQUEST TO REMOVE ONE OAK TREE – 1733 MESA ROAD (GOMEZ)**  
**DATE: MAY 3, 2005**

# Tree Analysis of Hazardous Oak Tree

**Tara Gomez,  
1733 Mesa Road,  
El Paso de Robles, CA 93446  
(805) 712-4872**

**Elder & Elder Ltd. – Consulting Arborists/ Landscape Architects  
1207 Grassy Hollow Way,  
El Paso de Robles, CA 93446  
(805) 238-3750**

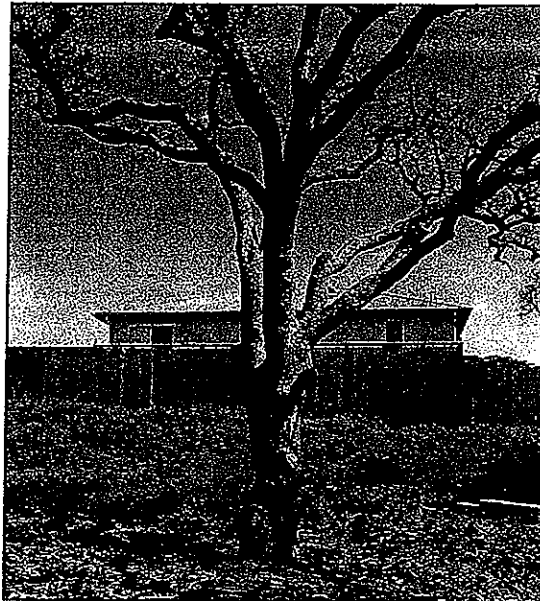
After viewing the Blue Oak Tree (*Quercus douglasii*) in question we feel that it is in such bad/poor condition that it should be taken down immediately if not sooner. The tree is in a total setting that a great deal of fire damage has been encountered over the years and many of the trees are in poor condition. The next-door neighbor has removed two (2) trees on their property due to poor tree conditions and she has many children on her property. This property does not have as many children present, however, we were informed that many children visit the property each week.

1. The tree is in very poor condition and using the ISA's letter assessment scale we would place it as a 'D' (almost dead to soon to be dead).
2. The distance views indicate that the lower area of the tree is destroyed possibly by fire.
3. The closer views show total destruction of the outer bark and cambium layer almost continuously around the tree.
4. The second page of pictures indicates rot, woodworm, scat from the burrowing insects and destroyed support system of the total tree. All areas that have died or have been injured have a large infestation of woodworm throughout. We did not think that it was necessary to drill the tree to see the extent of rot and death but upon knocking on the tree the damage is deep.

As stated in the abstract we recommend that this tree be removed as a health hazard.
