## Council Agenda Report

Subject: Oak Tree Removal Permit (OTR 17-008) - A request by Diane Duran (property owner / applicant) requesting that the City Council allow the removal of two Coast Live Oak trees (13 inch dbh / 18 inch dbh) at 1304 Fire Thorn Lane.

Date: June 20, 2017

Re: Tree assessment 1304 Fire Thorn Lane, Paso Robles, CA

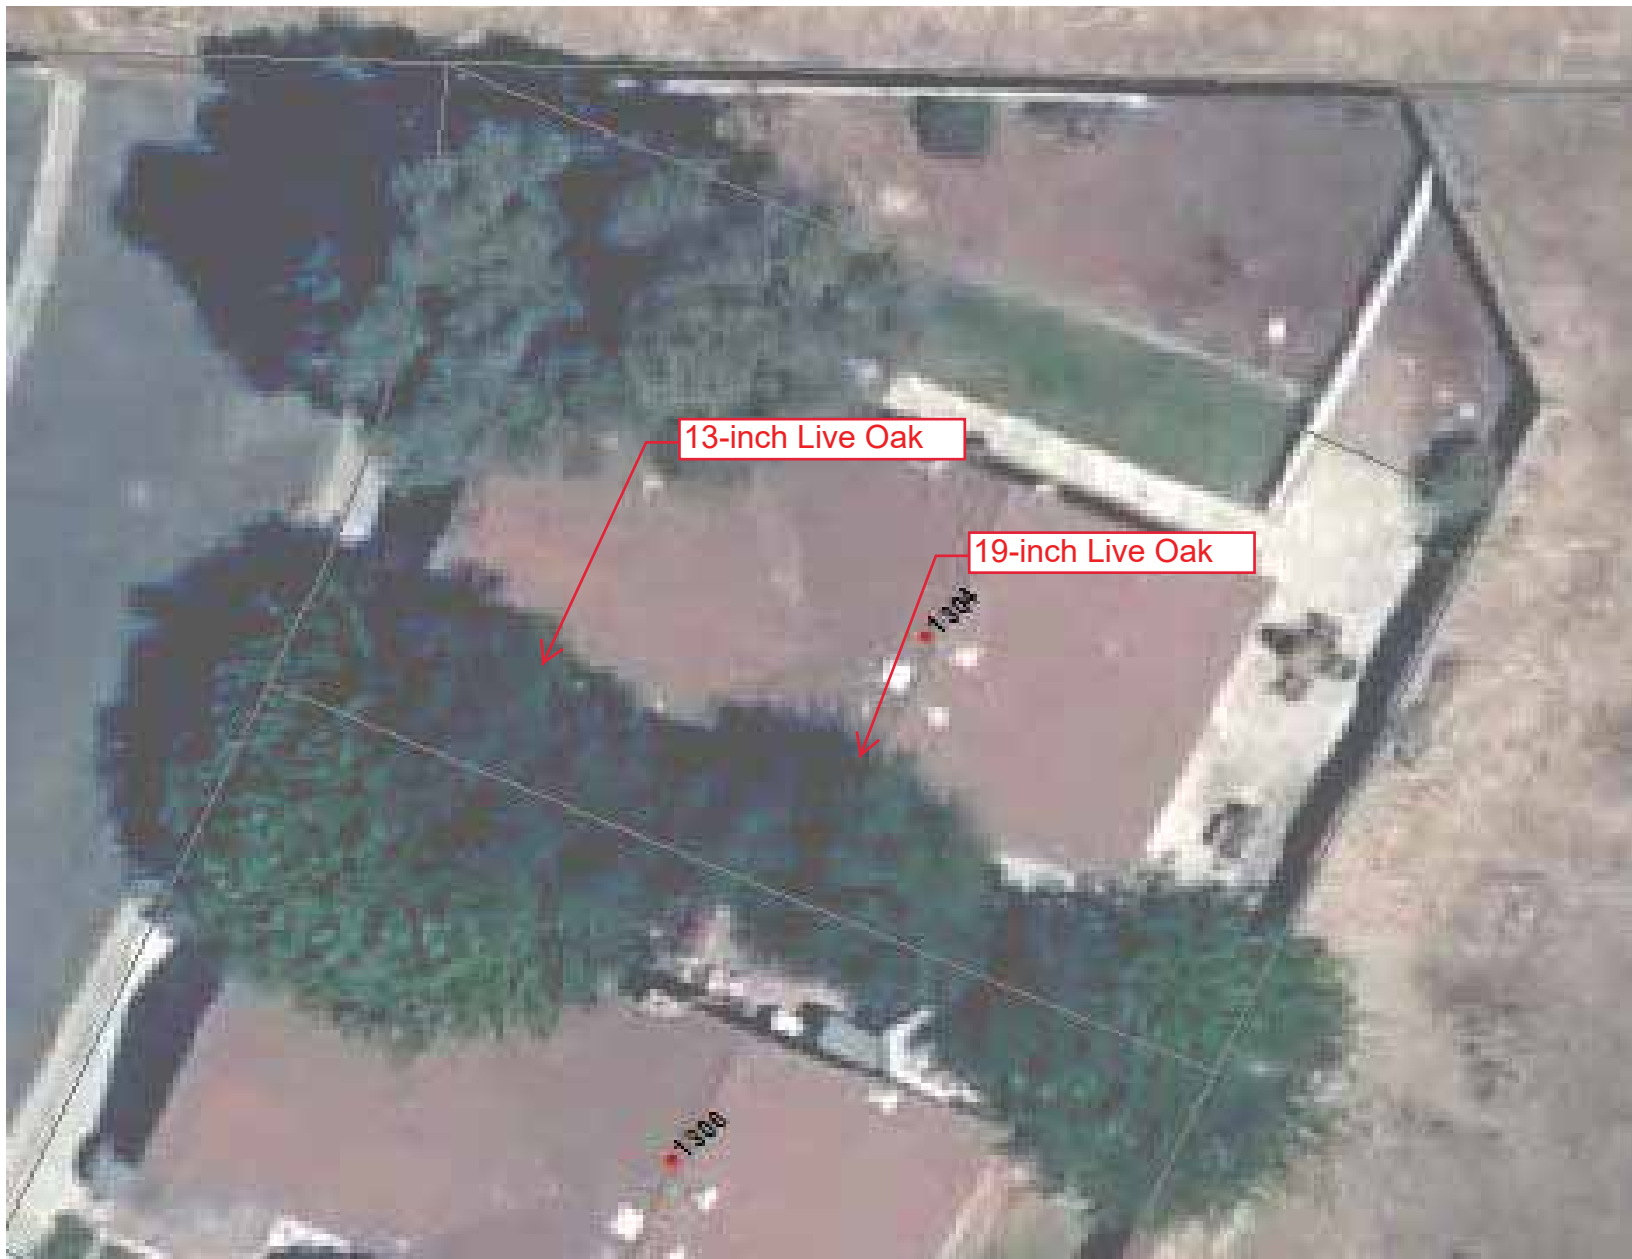
# Attachment 2

2. Both trees requested for removal are Coast Live Oak trees (*Quercus Agrifolia*), one 13-inch diameter tree and one 18-inch tree. The trees are located on the side yard of the house and were most likely planted as landscape trees in the 1980's at the time of the construction of the house. (See attached Plot Plan / Tree Location Map, Attachment 2)
