Council Agenda Report

Subject: Oak Tree Removal Permit 17-014 (Dallons Drive – Leo Tidwell III)
Council consideration of OTR 17-014 a request to remove two oak trees (Tree Nos. 2 and 3) located west of the intersection of Dallons Drive and Golden Hill Road (APN 025-423-003).

Date: September 7, 2017

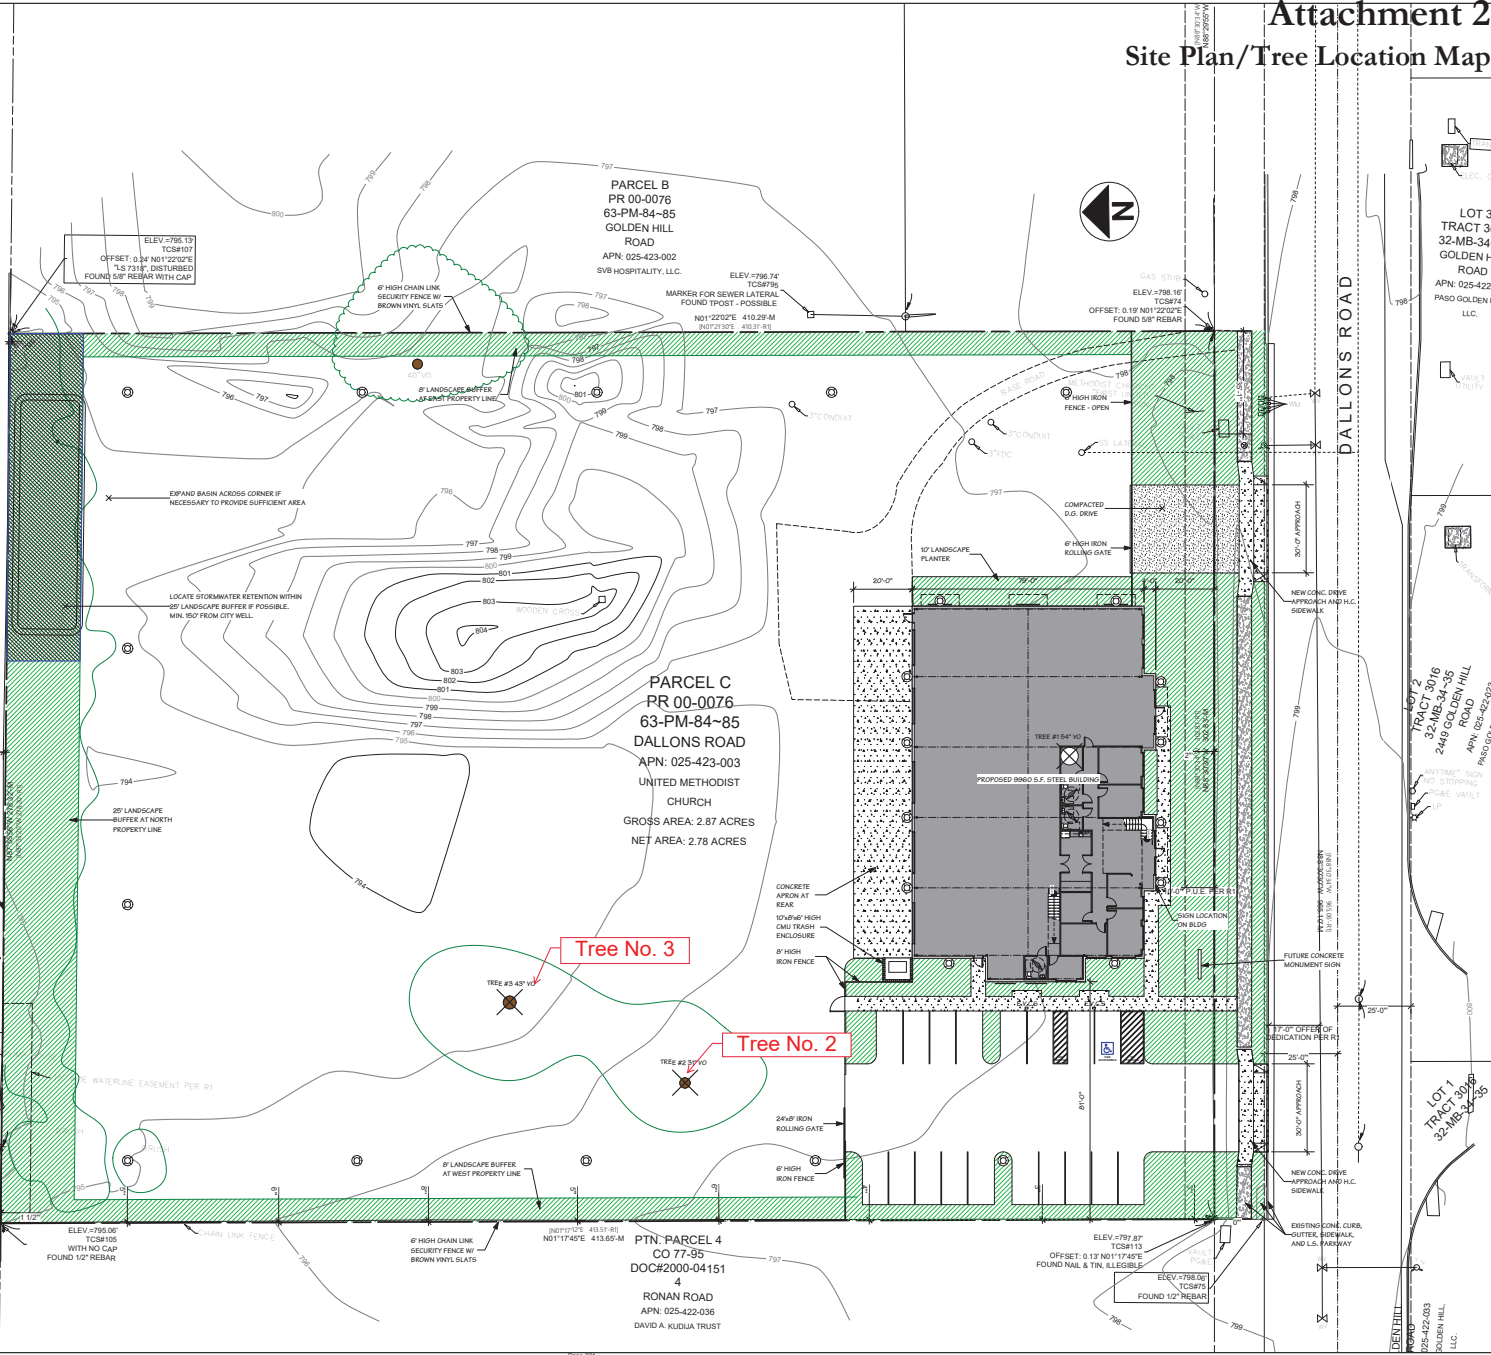
Attachment 2 Site Plan/Tree Location Map

2. Both trees proposed for removal are Valley Oak trees. Tree No. 2 is a 31-inch diameter tree and Tree No. 3 is a 43-inch diameter tree. The trees are located in the middle of the 2.78-acre lot (See attached Site Plan/Tree Location Map, Attachment 2).

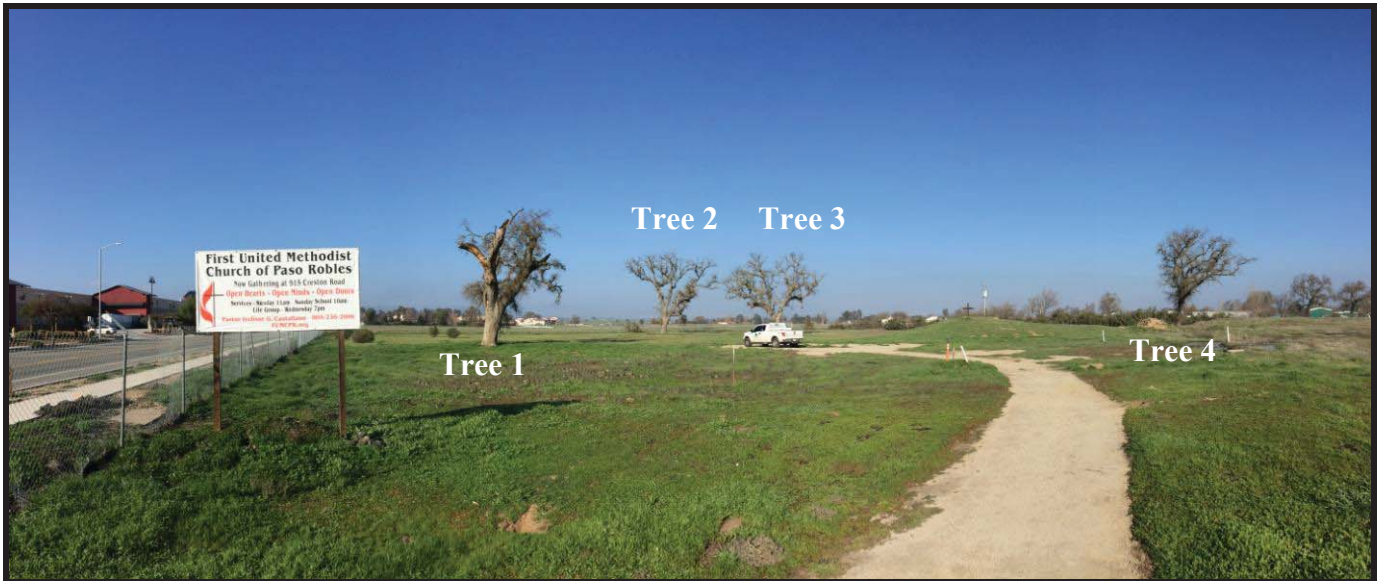
Photo 1- Panorama of site looking northwest from driveway entry on Dallons Road.

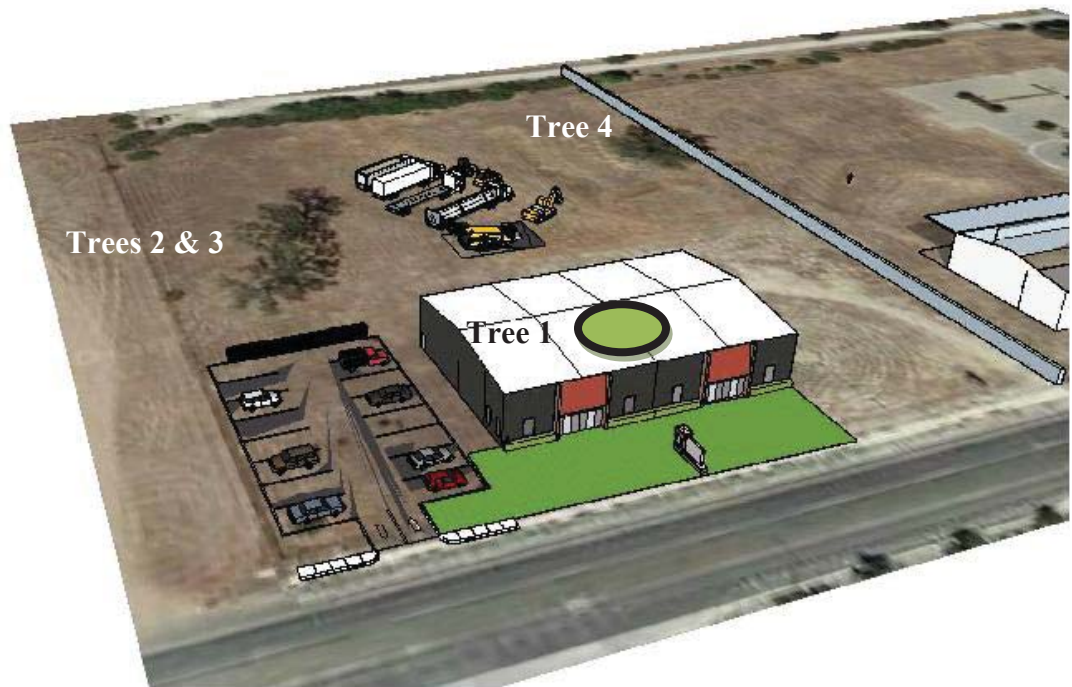
Diagram 1- Conceptual Building Plan for Site

I conducted health and condition assessments for each oak tree on the property with a diameter at breast height (DBH) Six (6) inches and greater. I numbered each of the trees with a rectangular metal tag and attached it to the trunk at approximately 6 feet above ground. Locations of each tree listed are in Appendix B- Site Diagrams- Diagram 1
