## Council Agenda Report

Subject: Oak Tree Removal Permit 17-016 & 17-017 - City of Paso Robles Initiated  
Council consideration of the request to remove multiple oak trees within the Oak Creek Park, the Senior Center, and within the Vine Street right of way, adjacent to Georgia Brown School.

Date: October 3, 2017

**Re:** Tree Health Assessment for Nate Wyatt, 270 Scott Street, Paso Robles, CA

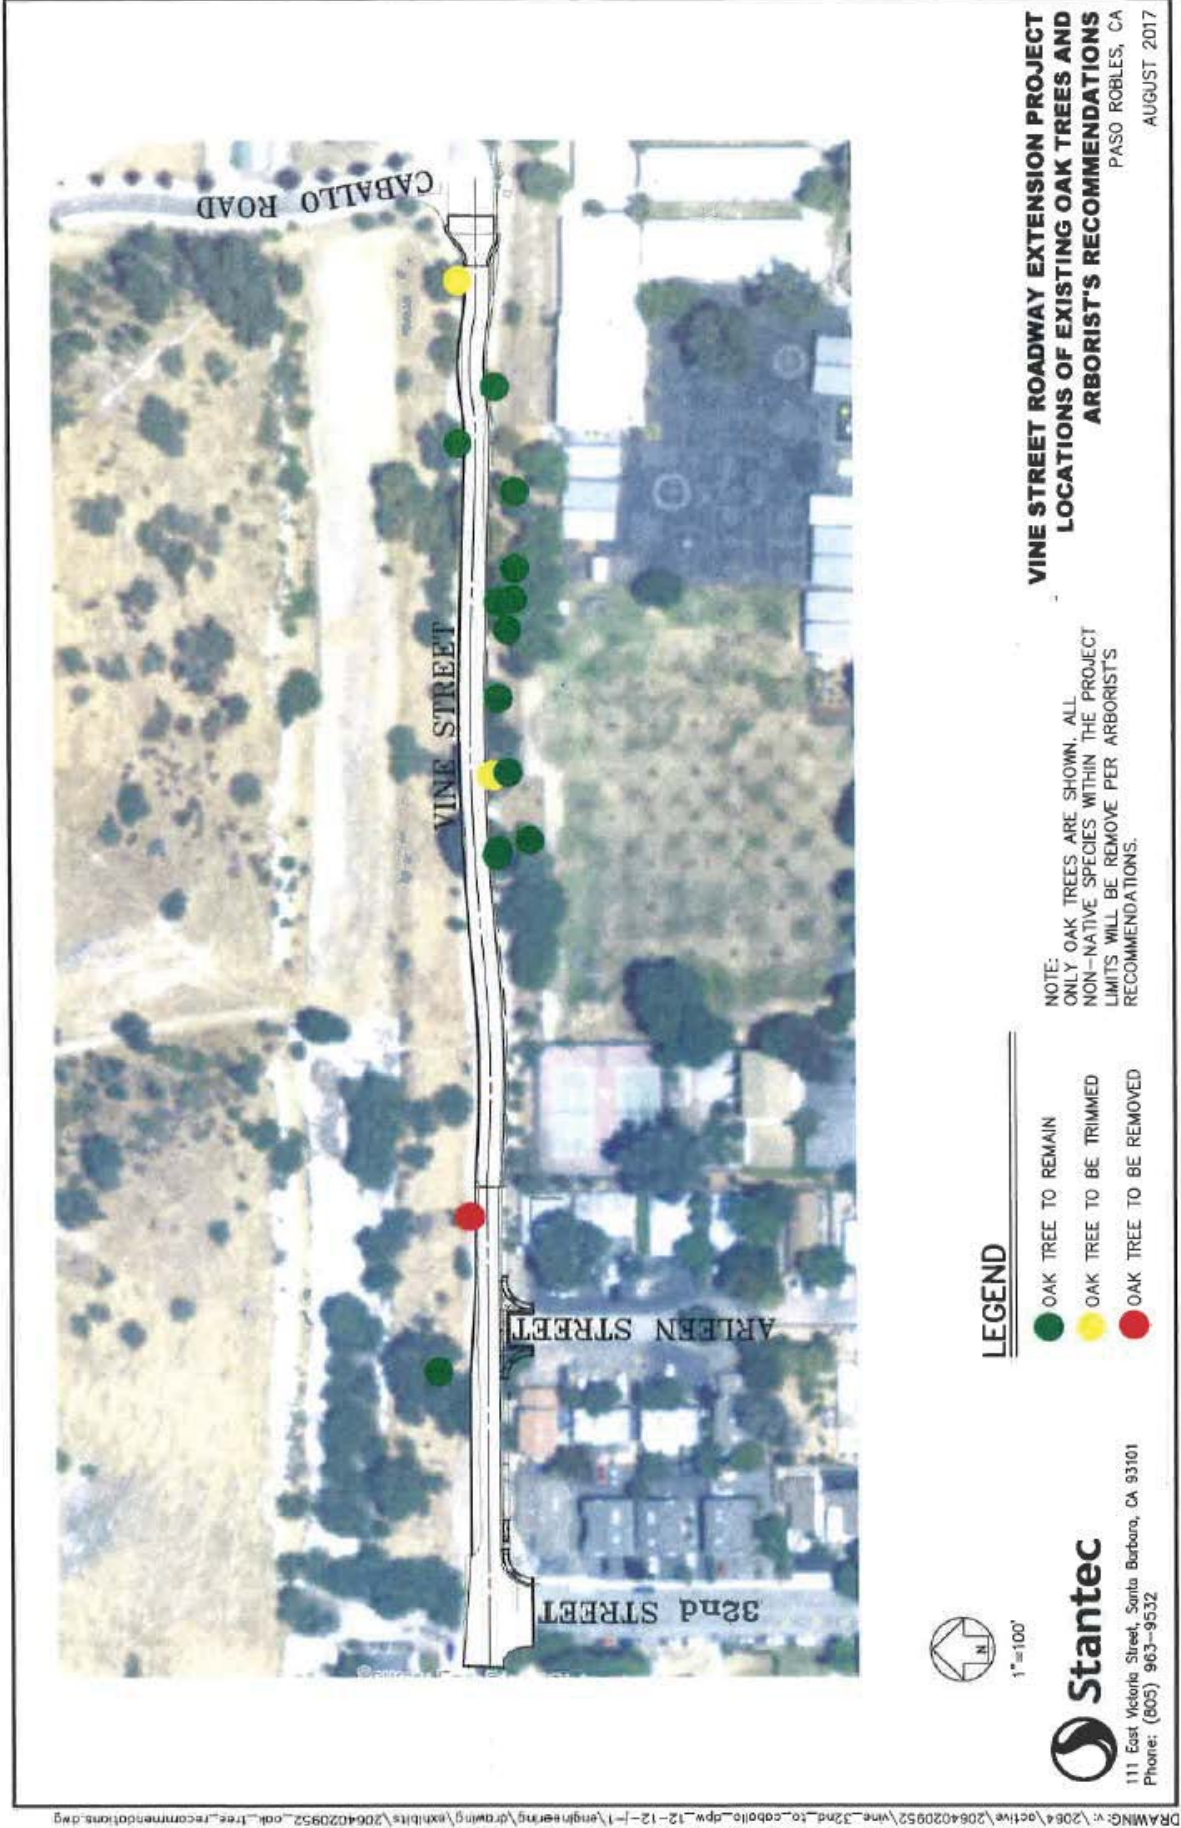
# Attachment 1

1. The Community Services Department has requested that the City Council approve the following oak tree removals:
  - **Vine Street right of way:** request to remove one (1) dual-stem 14-inch diameter Valley Oak tree. See Vicinity Map, Attachment 1.
  - **Oak Creek Park:** request to remove three (3) Coast Live Oaks and four (4) Blue Oaks within Oak Creek Park, east of Creston Road, south of Scott Street. See Vicinity Map, Attachment 2.
  - **Senior Center:** request to remove one (1) 50-inch Blue Oak, located at 270 Scott Street. See Vicinity Map, Attachment 2.

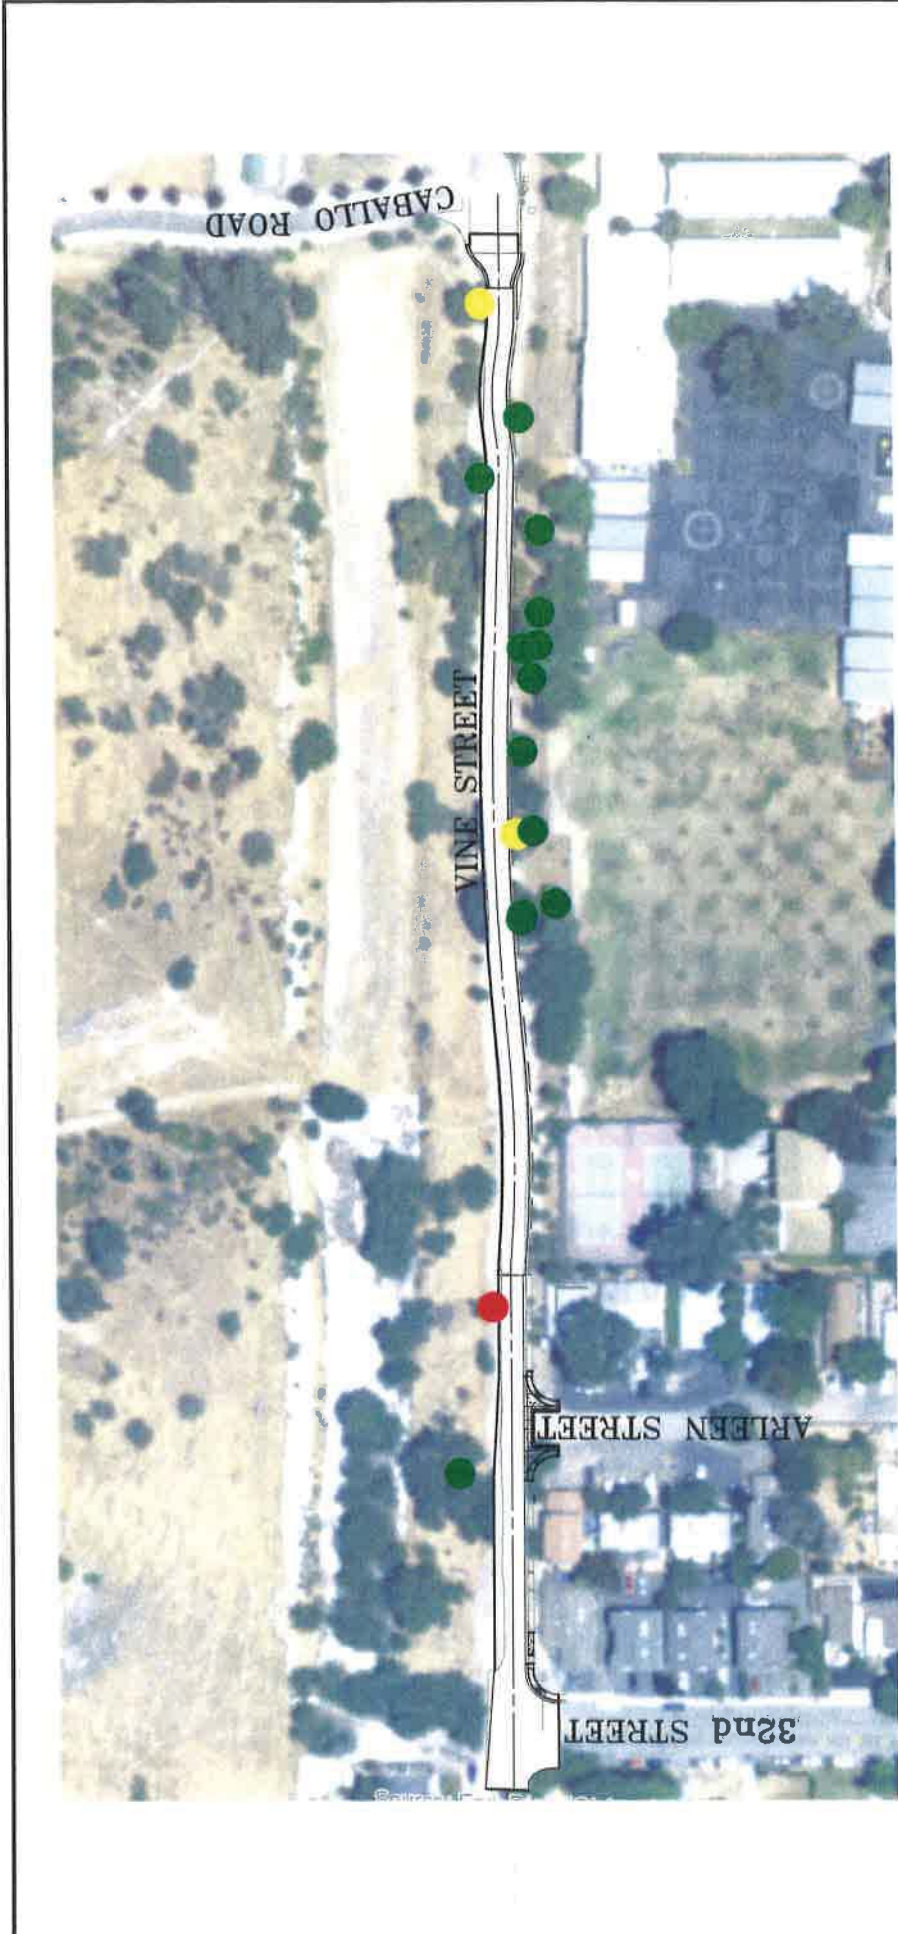
**VINE STREET ROADWAY EXTENSION PROJECT  
LOCATIONS OF EXISTING OAK TREES AND  
ARBORIST'S RECOMMENDATIONS**  
PASO ROBLES, AUGUST 2007

In total, I inventoried a total of 16 native oaks within the project boundaries, that measure 6 inches diameter and larger. Of those 16 trees, I have only recommended one (1) for removal, which means 96 percent of the native oaks within this project will be retained.

In the Tree Inventory Data Sheet below I have given recommendations for removal of one (1) oak tree and trimming of two (2) other oak trees within the Vine Street Roadway Connection between 32<sup>nd</sup> Street to Caballo Road. Each tree is numbered with an aluminum tag that is attached to the base of the trunk. All numbers are in reference to the tree protection plan that I prepared for Buddy Hain of Stantec Inc. Please refer to the tree protection report for additional detail.

**Tree 7** is a 14" diameter two-stem valley oak located at the west side of Vine Street approximately ¼ of the way north of 32<sup>nd</sup> street toward Caballo Road. This tree has a major area of included bark in the trunk which makes it prone to failure. It is located within the grading zone of the project and will impede road construction. This tree should be removed.

**Tree 10** is a 29" diameter valley oak located on the east side of Vine Street approximately ½ way between 32<sup>nd</sup> street and Caballo Road. This tree has a major area of included bark in the trunk which makes it prone to failure. The stem leaning over the roadway should be removed to eliminate the risk of branch failure. Yellow dashed line indicates branch to be removed. No significant grade cuts are planned for this area of road construction. Exploratory excavations in the critical root zone of the roadbed found no significant roots. This tree can be retained.
