Subject: Oak Tree Removal Permit (OTR 16-010) - A request by James Ralls (property owner /

applicant) requesting that the City Council allow the removal of two Coast Live Oak trees

(16 inch dbh / 17 inch dbh) at 803 Hogan Place

Re: Oak Tree Removal for 803 Hogan Place, Paso Robles

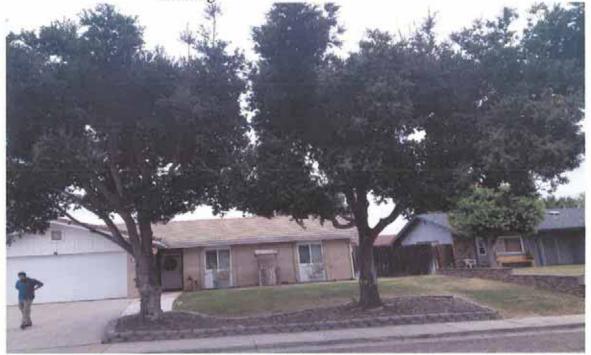
There has been three recent issues with the roots from these two trees. The roots invaded the septic line which caused a backup that had to be serviced. The roots lifted and cracked the concrete on the side of the driveway which had to be removed and replaced. Just recently, the roots broke the main waterline coming from the street to the home.

Area where the roots broke the water line

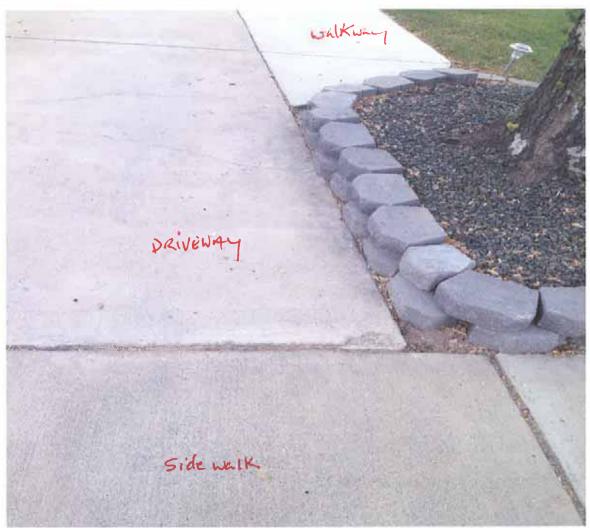
The owner, James Ralls is seeking to remove both of these trees before more damage occurs which is inevitable. There are new cracks in the driveway that will most likely begin heaving in the near future.

Concrete that was replaced at the top and the crack in the old concrete
