## Council Agenda Report

**Subject:** Recoating the Arsenic Removal Vessel at Sherwood Well No. 11

**TITLE: PHOTOS OF CARBON VESSEL - INTERNAL**

**PROJECT:** City of Paso Robles, Sherwood Well 11 Vessel Rehabilitation Project

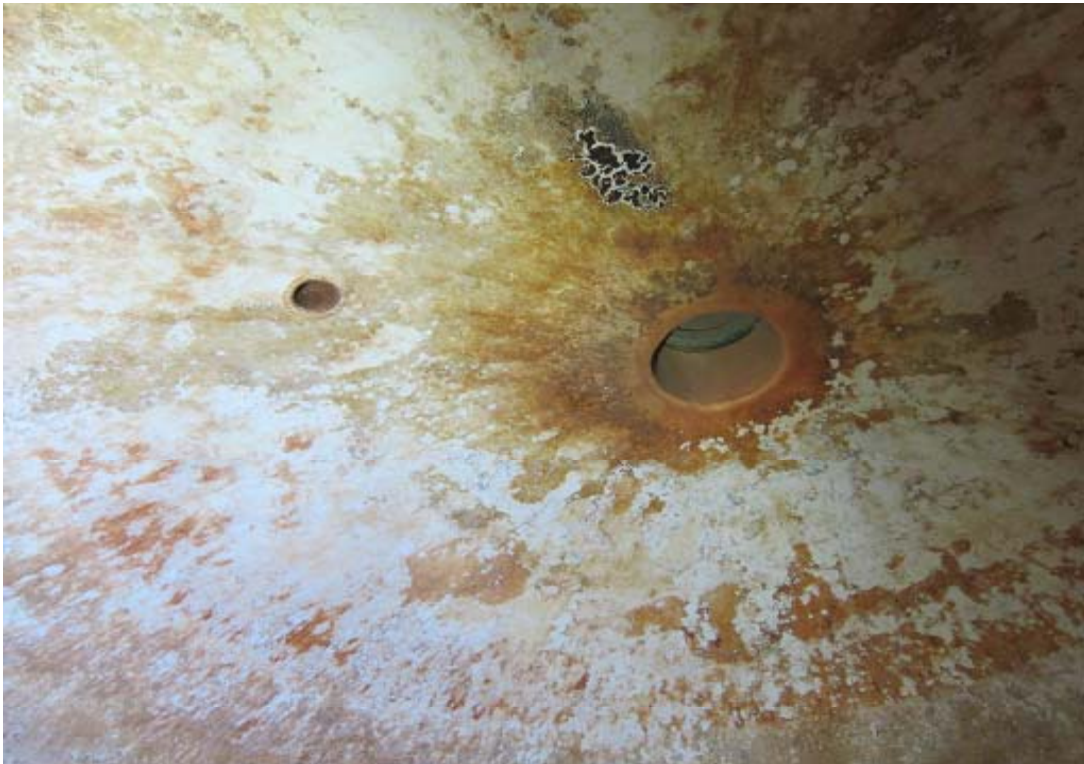
Vessel top head with nozzles with staining and scattered general corrosion. Interior view (existing condition, 4/11/17).

Recoating of this type of treatment vessel is a tried and true method of maintaining these tanks. The City recently and successfully had some other vessels (like this) recoated at the other Sherwood well site. Replacing the tanks would be costly and unnecessary as these tanks are structurally sound.

Authorize the City Manager to enter into an agreement with Crosno Construction, Inc. for the amount of \$30,800 (including a 10% contingency) for recoating plus 11 hours at \$110/hour for a total cost of \$32,010 for Sherwood Well No. 11, and authorize the City Manager and City Attorney to make minor changes to the agreement fully consistent with overall Council direction;

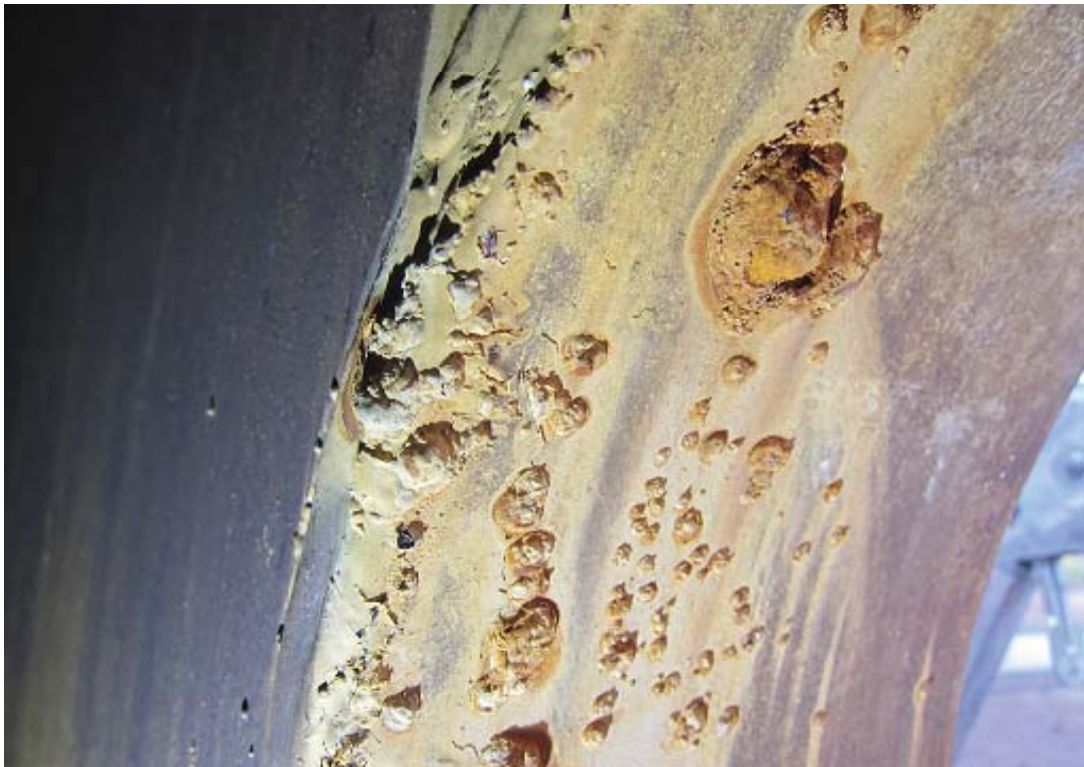
Nodules from localized corrosion on the interior at the manway neck (existing condition, 4/11/17).
