TO: HONORABLE CHAIRMAN AND PLANNING COMMISSION
FROM: ED GALLAGHER, COMMUNITY DEVELOPMENT DIRECTOR

SUBJECT: CERTIFICATE OF APPROPRIATENESS 12-002
(VANSTEENWYK) APN: 009-021-023

Exhibit A 1 - A 10
 PROJECT PLANS
 HPC 12-002 et al
 1301 CHESTNUT STREET
 (VanSteenwyk)

PROPOSED REMODEL/ADDITION FOR:
BRETT VAN STEENWYK RESIDENCE
1301 CHESTNUT STREET
PASO ROBLES, CALIFORNIA

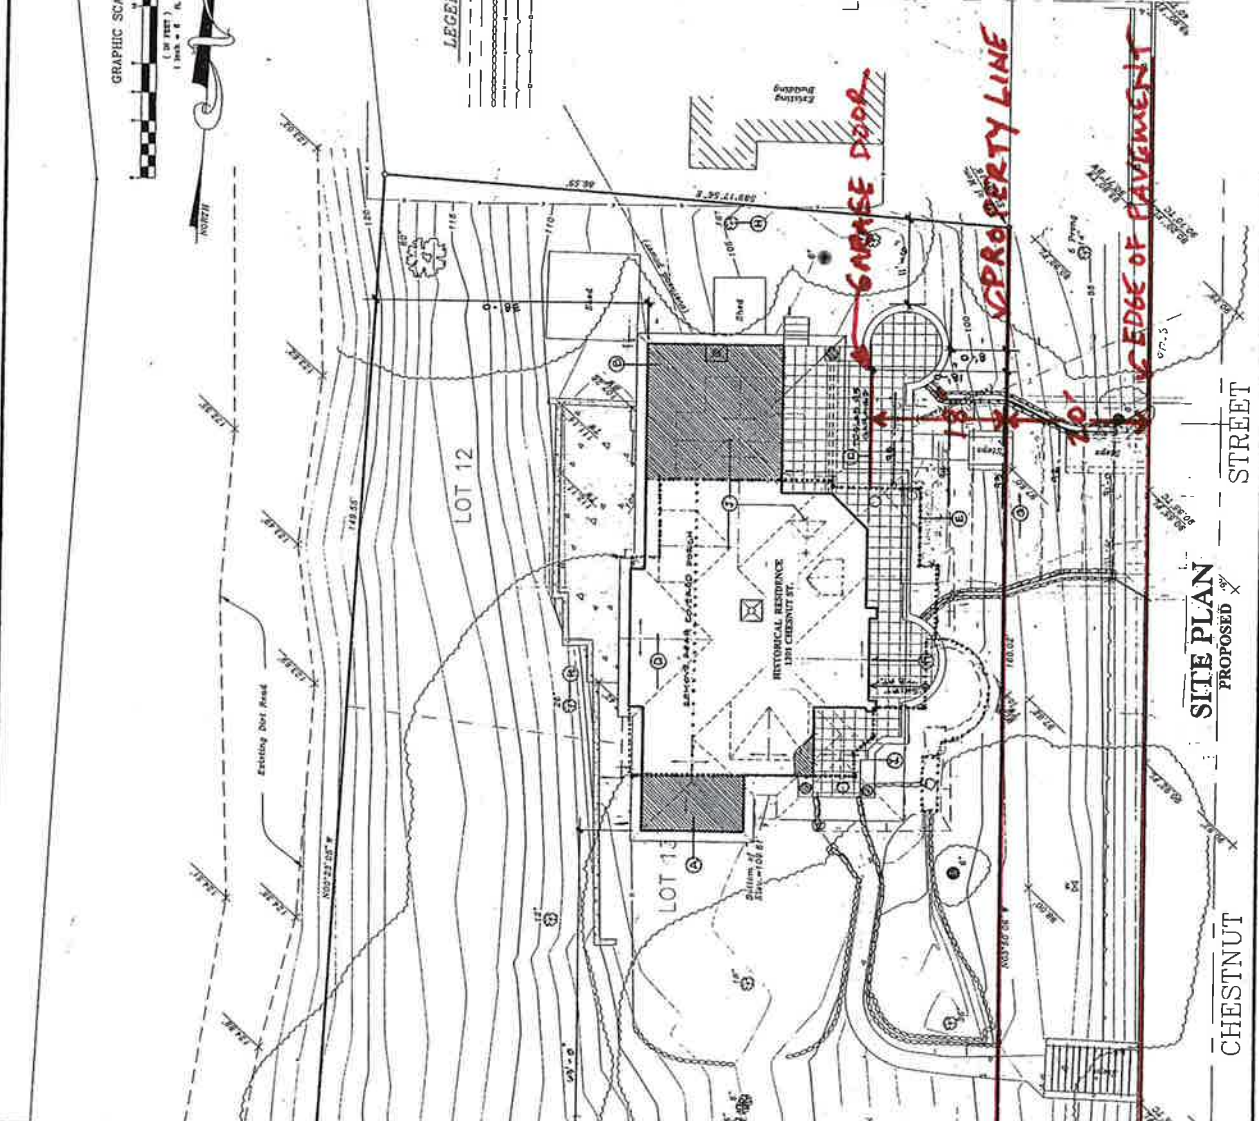
Attachment 2
 Site Plan
 HPC 12-002 et al
 (VanSteenwyk)

TOPOGRAPHICAL SURVEY
 LOTS 12 & 13 OF
 A DIVISION OF VILLA LOT 7 IN THE
 CITY OF PASO ROBLES
 A.P.N. 009-021-023
 SAN LUIS OBISPO COUNTY, STATE OF CALIFORNIA
